COMMENT RESPONSE DOCUMENT

EASA PAD No. 21-013

[Published on 02 February 2021 and officially closed for comments on 02 March 2021]

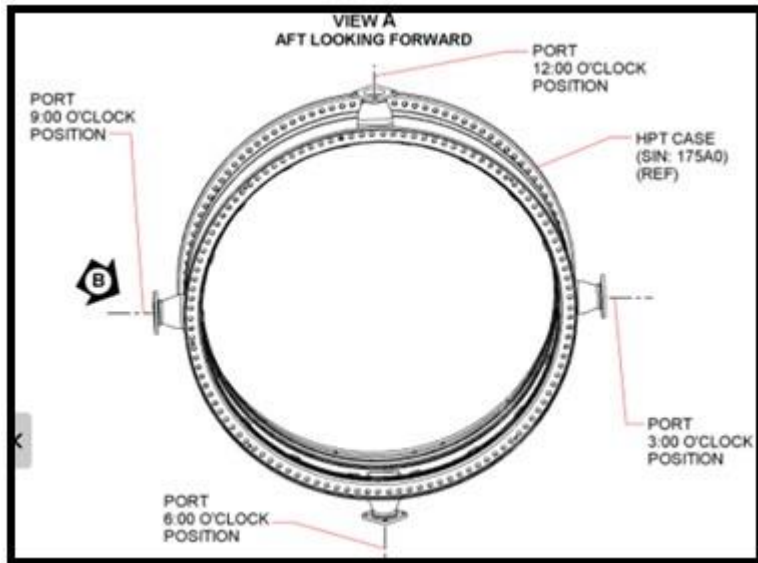
HPT Case with cast ports (brazed/welded) – item is tracked by HPT Case S/N.

Port serial numbers are not identified on the records provided to operators.

BAW would strongly recommend that the AD identifies the affected HPT Case Ports AND their parent HPT Case serial number (tracked item), to ensure parts can be more easily identified on the records usually provided with an engine (i.e. the tracked/life limited parts list).

Comment noted. EASA agrees. EASA has communicated this comment to CFM and requested CFM to use the information collected with SB LEAP-1A-72-00-0417-01A-930A-D for future updates of LEAP-1A-72-00-0421-01A-930A-D in order to facilitate the identification of the affected HPT cases. CFM also confirmed that HPT cases not listed in LEAP-1A-72-00-0417-01A-930A-D are assured to not contain an affected port casting. This information is used to amend the definition of a serviceable HPT case in the final AD.
