Notification of a Proposal to issue an Airworthiness Directive

PAD No.: 21-041

PA-28 and PA-32 aeroplanes

ATA 57 – Wings – Lower Main Wing Spar Caps – Inspection

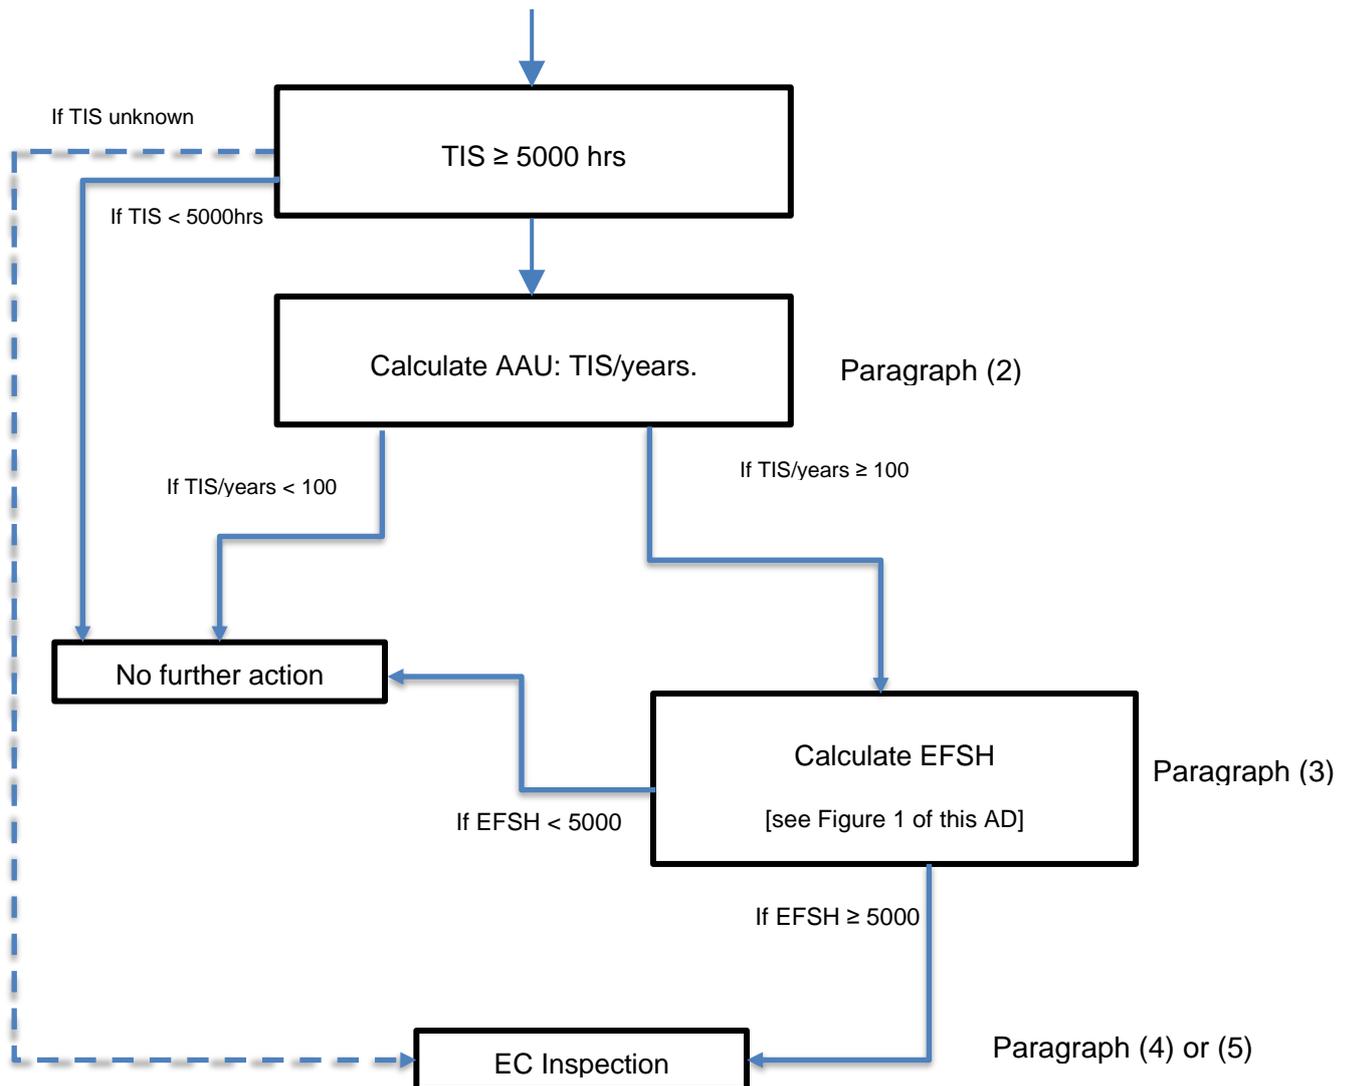
Appendix 2 – Flowchart / Examples of Calculation

Example 1:

For an a/c with 8 years in service and 700 hours TIS (TIS=700), the results would be:

1. Paragraph (2): $TIS/years = 700/8 = 87,5 < 100 \rightarrow$ no action required.

Example 2:

For an a/c with 8 years in service and 3 000 hours TIS Hours (TIS=3 000), the results would be:

1. Paragraph (2): $TIS/years = 3\ 000/8 = 375 > 100 \rightarrow$ go to paragraph (3);
2. Paragraph (3): $EFSH = (3\ 000 - 100 \times 8) + (100 \times 8)/15 = 2\ 253 < 5\ 000 \rightarrow$ no further action

Example 3:

For an a/c with 8 years in service and 6 000 hours TIS (TIS = 6 000), the results would be:

1. Paragraph (2): $TIS/years = 6\ 000/8 = 750 > 100 \rightarrow$ go to paragraph (3);
2. Paragraph (3): $EFSH = (6\ 000 - 100 \times 8) + (100 \times 8)/15 = 5\ 253 \rightarrow$ go to paragraph (4).
