## Airworthiness Directive

**AD No.:** 2021-0107R1

PA-28 and PA-32 aeroplanes

### ATA 57 – Wings – Lower Main Wing Spar Caps – Inspection

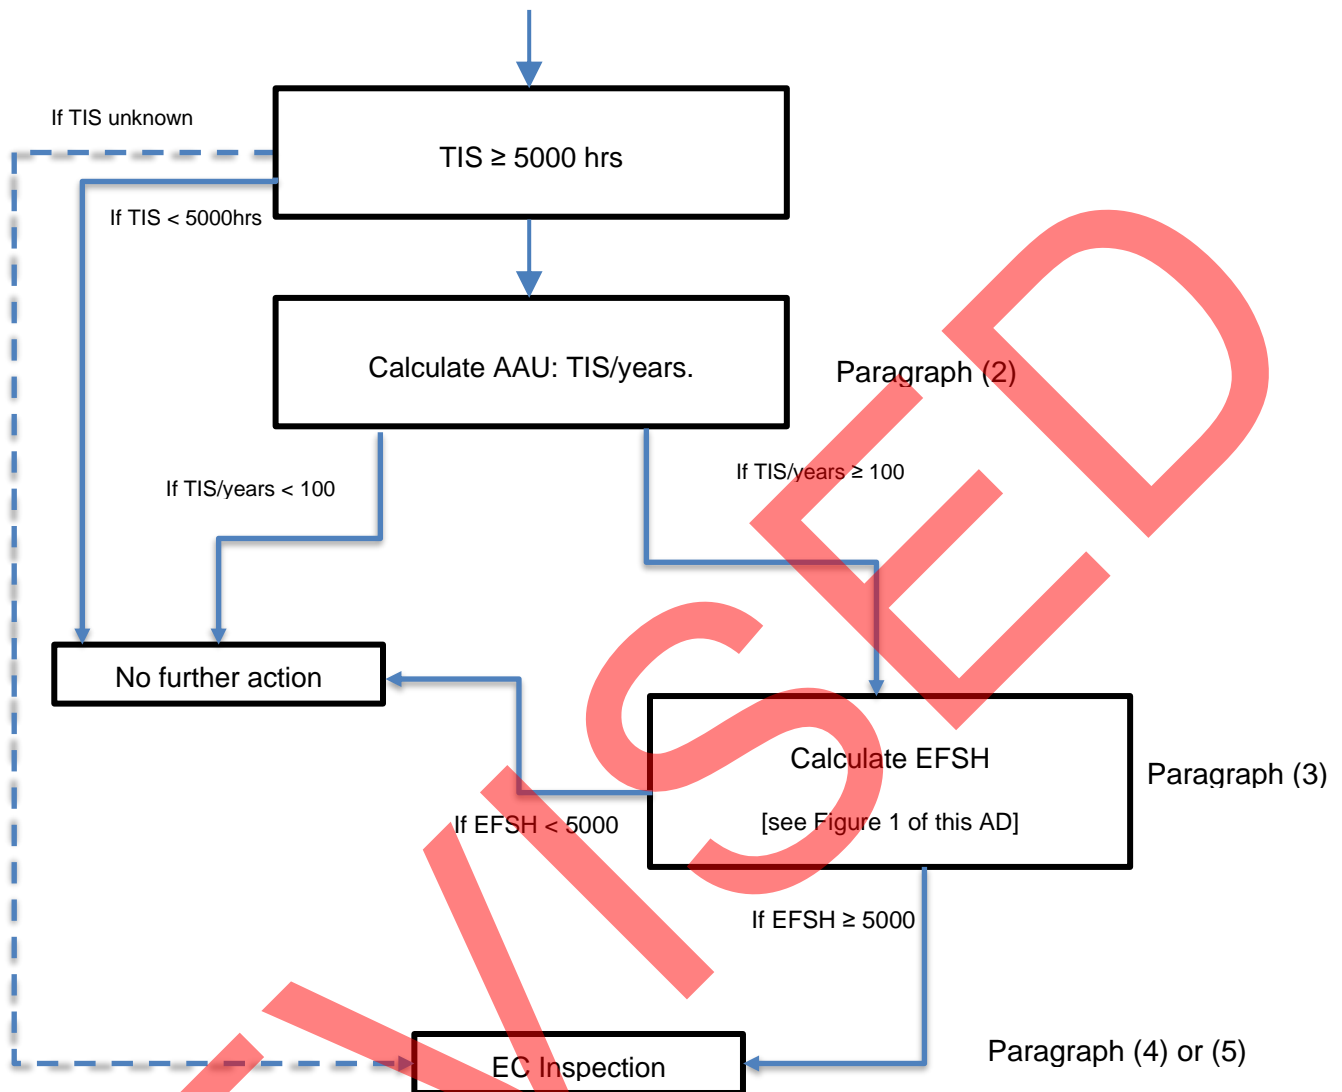
## Appendix 2 – Flowchart / Examples of Calculation

**Example 1:**

For a spar with 8 calendar years and 700 hours TIS (TIS=700), the results would be:

1. Paragraph (2):  $TIS/years = 700/8 = 87,5 < 100 \rightarrow$  no action required.

**Example 2:**

For a spar with 8 calendar years and 3 000 hours TIS Hours (TIS=3 000), the results would be:

1. Paragraph (2):  $TIS/years = 3\,000/8 = 375 > 100 \rightarrow$  go to paragraph (3);
2. Paragraph (3):  $EFSH = (3\,000 - 100 \times 8) + (100 \times 8)/15 = 2\,253 < 5\,000 \rightarrow$  no further action

**Example 3:**

For a spar with 8 calendar years and 6 000 hours TIS (TIS = 6 000), the results would be:

1. Paragraph (2):  $TIS/years = 6\,000/8 = 750 > 100 \rightarrow$  go to paragraph (3);
2. Paragraph (3):  $EFSH = (6\,000 - 100 \times 8) + (100 \times 8)/15 = 5\,253 \rightarrow$  go to paragraph (4).
