## Airworthiness Directive

**AD No.: 2022-0147**
**[Correction: 17 August 2022]**
**Issued: 14 July 2022**

A318, A319, A320 and A321 aeroplanes

### ATA 36 – Pneumatic – Overheat Detection System Sensing Elements – Inspection

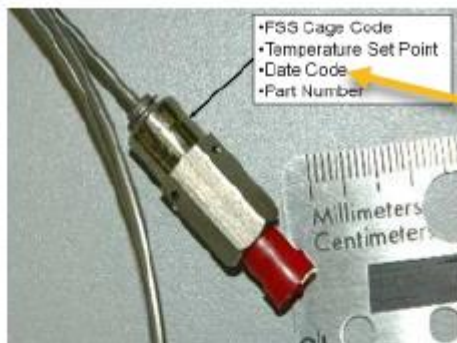
Figure 4-50. Identification Markings on Coaxial SE Male (Pin) Connector

For the reasons described above, this AD requires a one-time special detailed inspection (SDI) of each affected part installed at an affected position, as defined in this AD, and, depending on findings, replacement of the affected part with a serviceable part. Appendix 1 of this AD provides information on how to identify affected parts (P/N and date code).
