TAY SERIES PROPULSION SYSTEM SERVICE BULLETIN

This document transmits the Initial Issue of Non-Modification Service Bulletin TAY-72-A1797.

ALERT TAY-72-A1797

ENGINE – HIGH PRESSURE (HP) TURBINE ROTOR DISCS AND BLADES STAGE 1 AND STAGE 2 –
BORESCOPE INSPECTION OF THE CAVITY SURROUNDING THE HP TURBINE STAGE 2 INTERMEDIATE
AIR SEAL – NON-MODIFICATION SERVICE BULLETIN

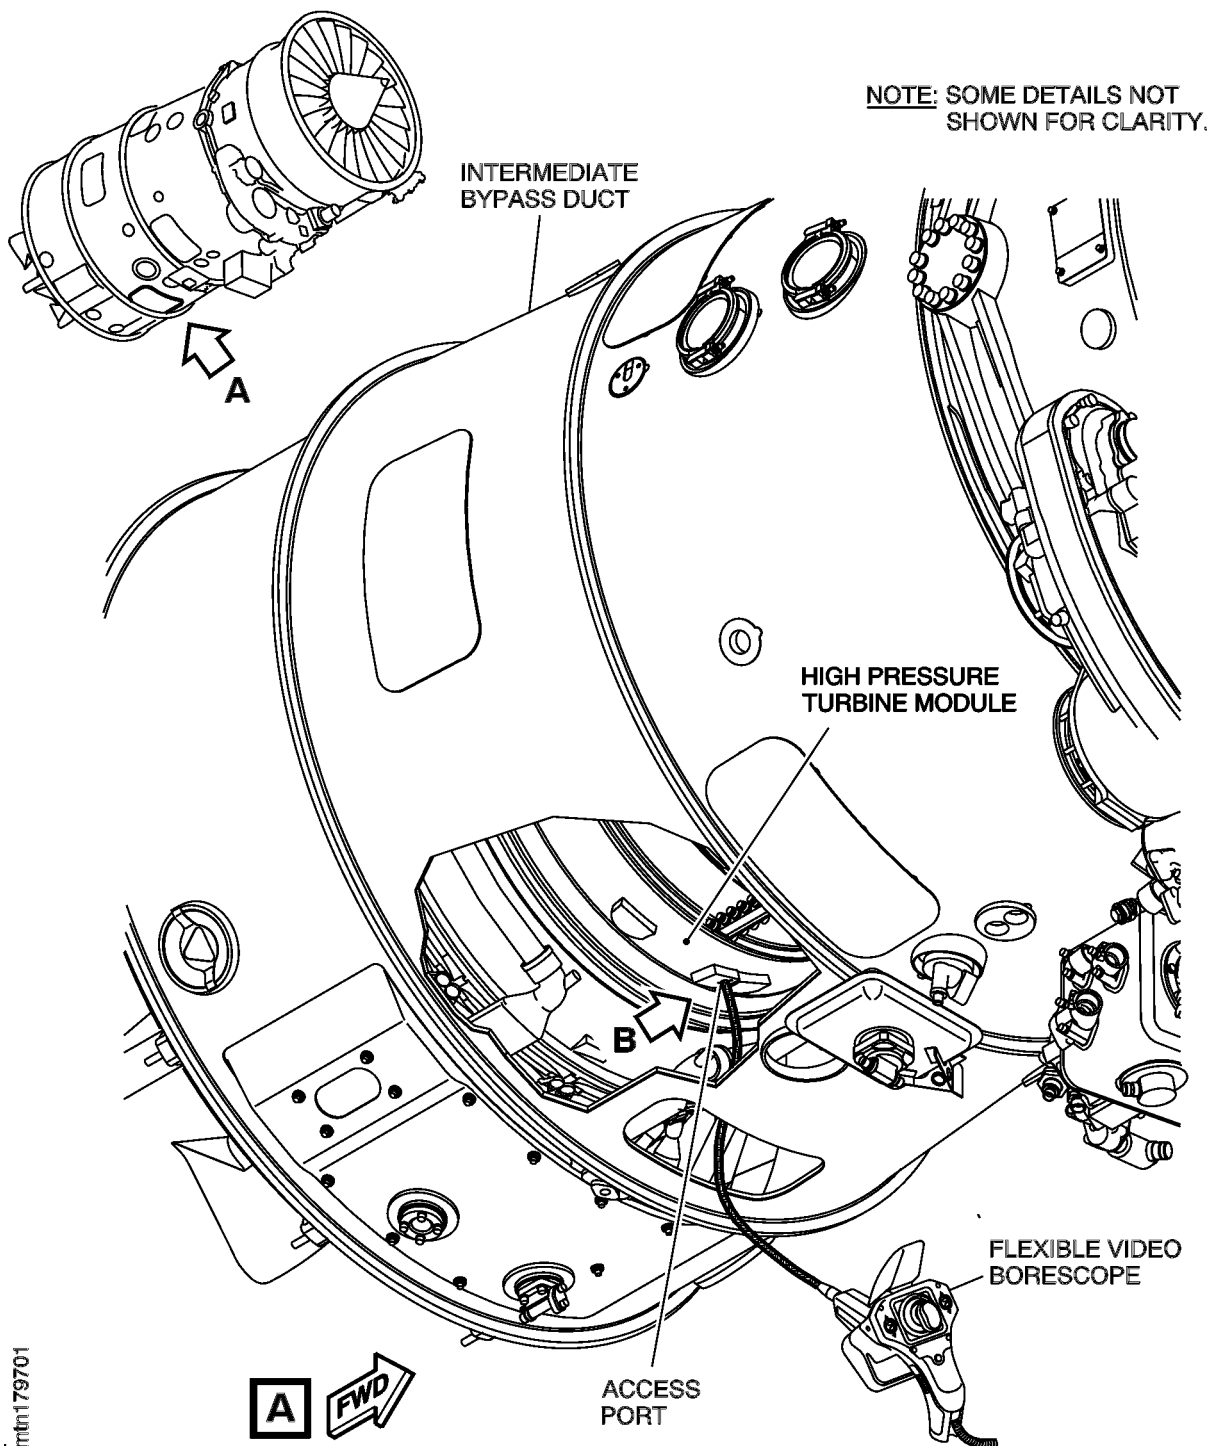
Borescope Inspection Path to the High Pressure Turbine Stage 2 Intermediate Air Seal Surrounding Cavity
Figure 1 (Sheet 1 of 6)

Cracking of the High Pressure (HP) turbine stage 2 intermediate air seal bolts (72-41-21, 01-862), P/N AS26710 in service has been reported that could lead to a failure of these bolts in this location and subsequent secondary damage to surrounding critical parts (HP turbine stage 1 and stage 2 rotor discs).

Examine the HP turbine stage 2 on the front side of the HP turbine stage 2 rotor disc in accordance with the following steps D.(1)(a) to D.(1)(g) (Refer to Figure 1)

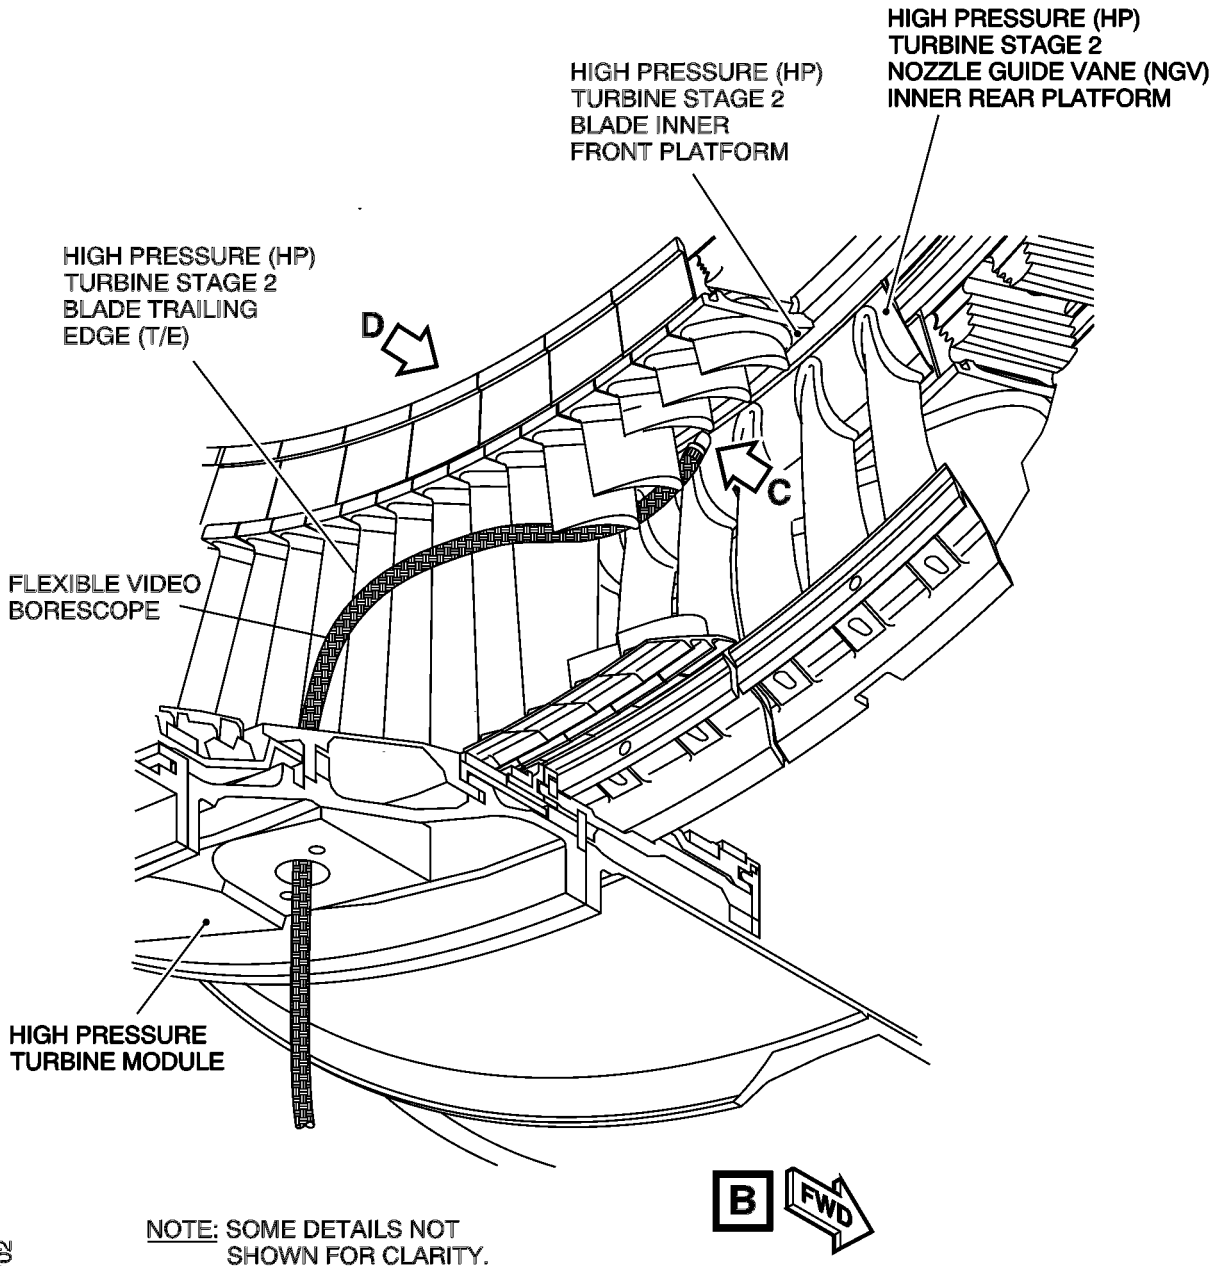
Borescope Inspection Path to the High Pressure Turbine Stage 2 Rotor Disc Front Side

This Non-Modification Service Bulletin instructs a visual borescope inspection of the HP turbine stage 2 on the front side of the HP turbine stage 2 rotor disc. The intent is to identify if cracked bolts (72-41-21, 01-862), P/N AS26710 from the HP turbine stage 2 intermediate air seal assembly are directly visible or if indications of secondary damage can be found on the HP turbine stage 2 rotor disc front side.

- (a) Insert a 3,9 to 4,0 (0.15 to 0.16 in.) diameter flexible video-borescope through the borescope access port for the HP turbine stage 2 blade examination.
- (b) Move the tip adapter of the flexible video-borescope in between two HP turbine stage 2 blades until you reach the HP turbine stage 2 Nozzle Guide Vanes (NGV) Trailing/Edge (T/E).
- (c) Move the tip adapter of the flexible video-borescope to the gap between the HP turbine stage 2 blade inner front platform and the HP turbine stage 2 NGV inner rear platform.
- (d) Put the tip adapter of the flexible video-borescope in a position so that you can examine the HP turbine stage 2 rotor disc front side through the gap between the HP turbine stage 2 blade inner front platform and the HP turbine stage 2 NGV inner rear platform

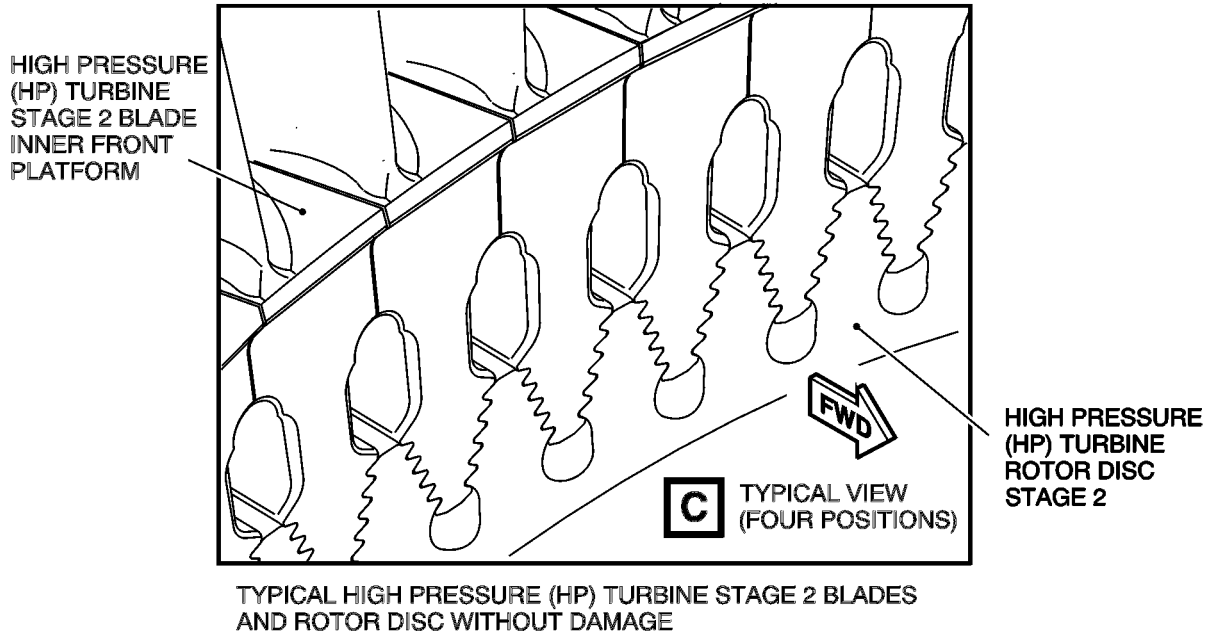
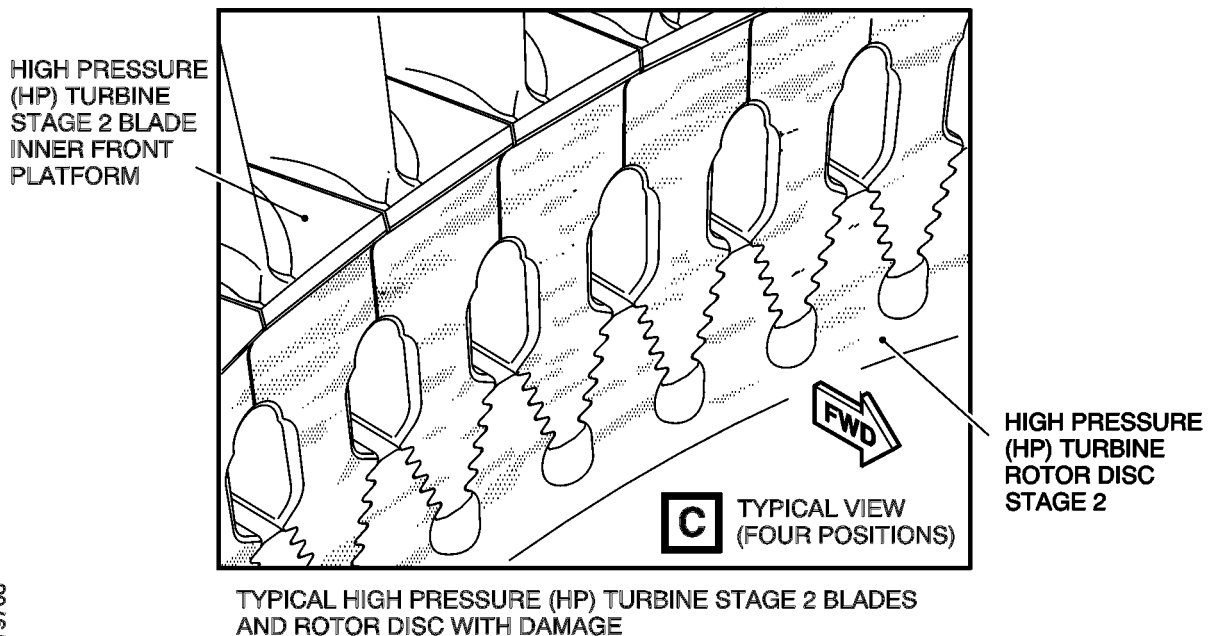
Borescope Inspection of the High Pressure Turbine Stage 2 Rotor Disc Front Side
Figure 1 (Sheet 3 of 6)

[1] Examine the HP turbine stage 2 rotor disc front side for indications of damage

[b] If you find indications of damage, reject the engine

- a) Replace the engine and send the removed engine to an approved TAY overhaul facility for detailed inspection and required corrective actions.

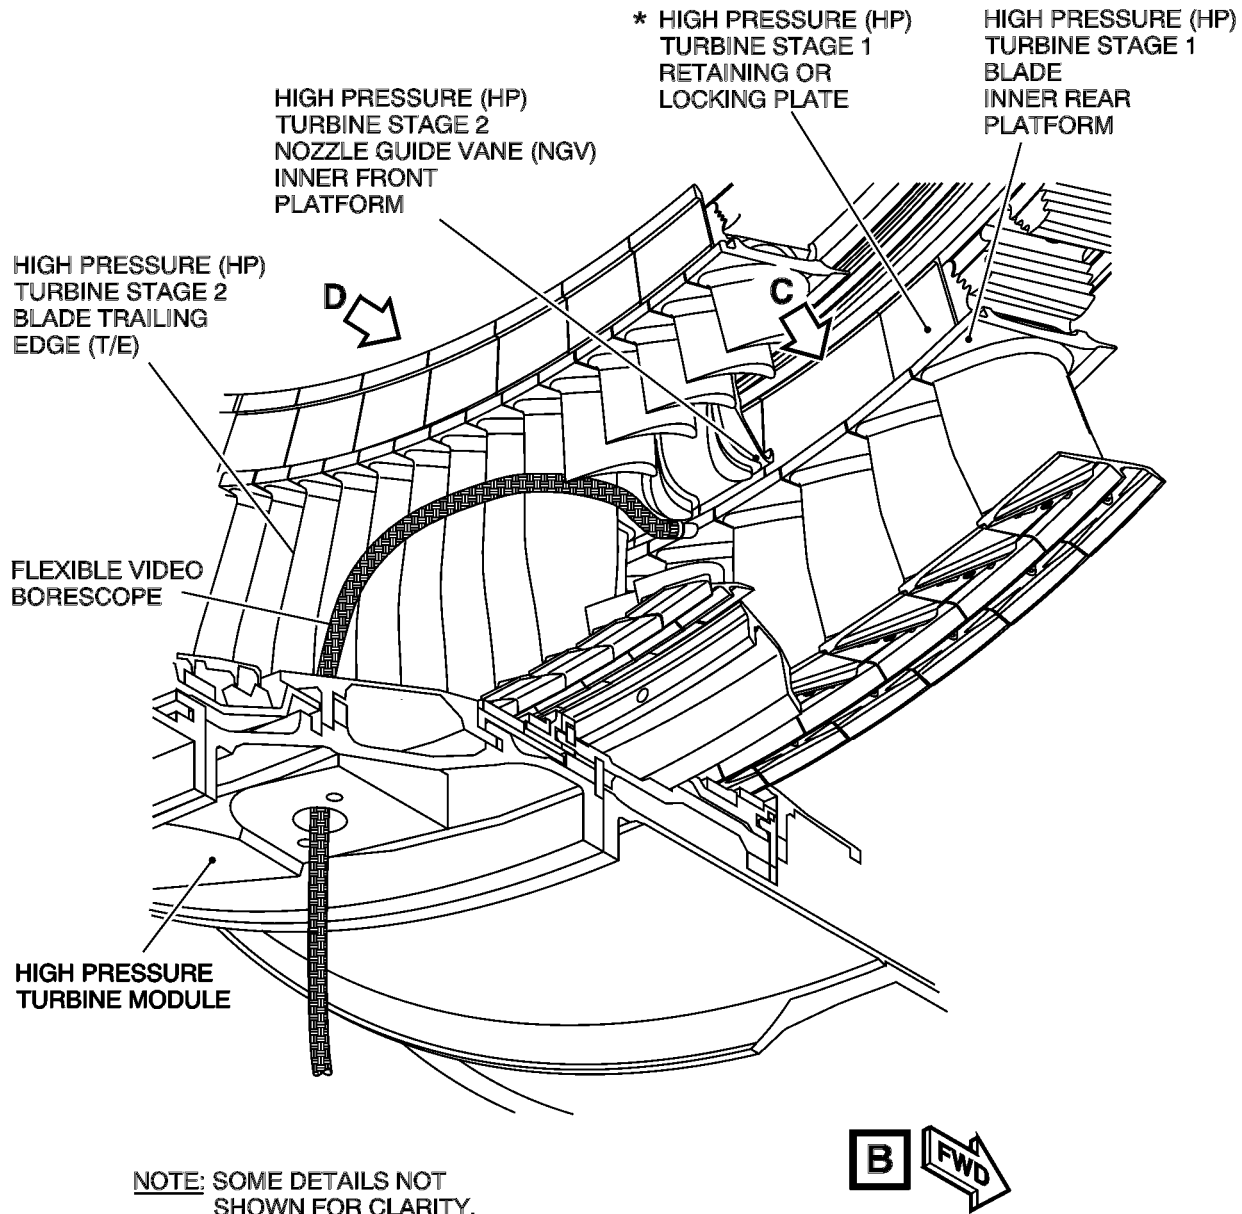
Borescope Inspection Path to the High Pressure Turbine Stage 1 Blade Retaining and Locking Plates
Figure 1 (Sheet 4 of 6)

This Non-Modification Service Bulletin instructs a visual borescope inspection of the HP turbine stage 1 blade retaining and locking plates on the rear side of the HP turbine stage 1 rotor disc. The intent is to identify if cracked bolts (72-41-21, 01-862), P/N AS26710 from the HP turbine stage 2 intermediate air seal assembly are directly visible or if indications of secondary damage can be found on the HP turbine stage 1 blade retaining and locking plates.

- (a) Insert a 3,9 to 4,0 (0.15 to 0.16 in.) diameter flexible video-borescope through the borescope access port for the HP turbine stage 2 blade examination.
- (b) Move the tip adapter of the flexible video-borescope in between two HP turbine stage 2 blades, through in between two HP turbine stage 2 NGVs until you reach the HP turbine stage 1 rotor blade T/E.
- (c) Move the tip adapter of the flexible video-borescope to the gap between the HP turbine stage 1 rotor blade inner rear platform and the HP turbine stage 2 NGV inner front platform.
- (d) Put the tip adapter of the flexible video-borescope in a position so that you can examine the HP turbine stage 1 rotor blade retaining and locking plates through the gap between the HP turbine stage 1 rotor blade inner rear platform and the HP turbine stage 2 NGV inner front platform

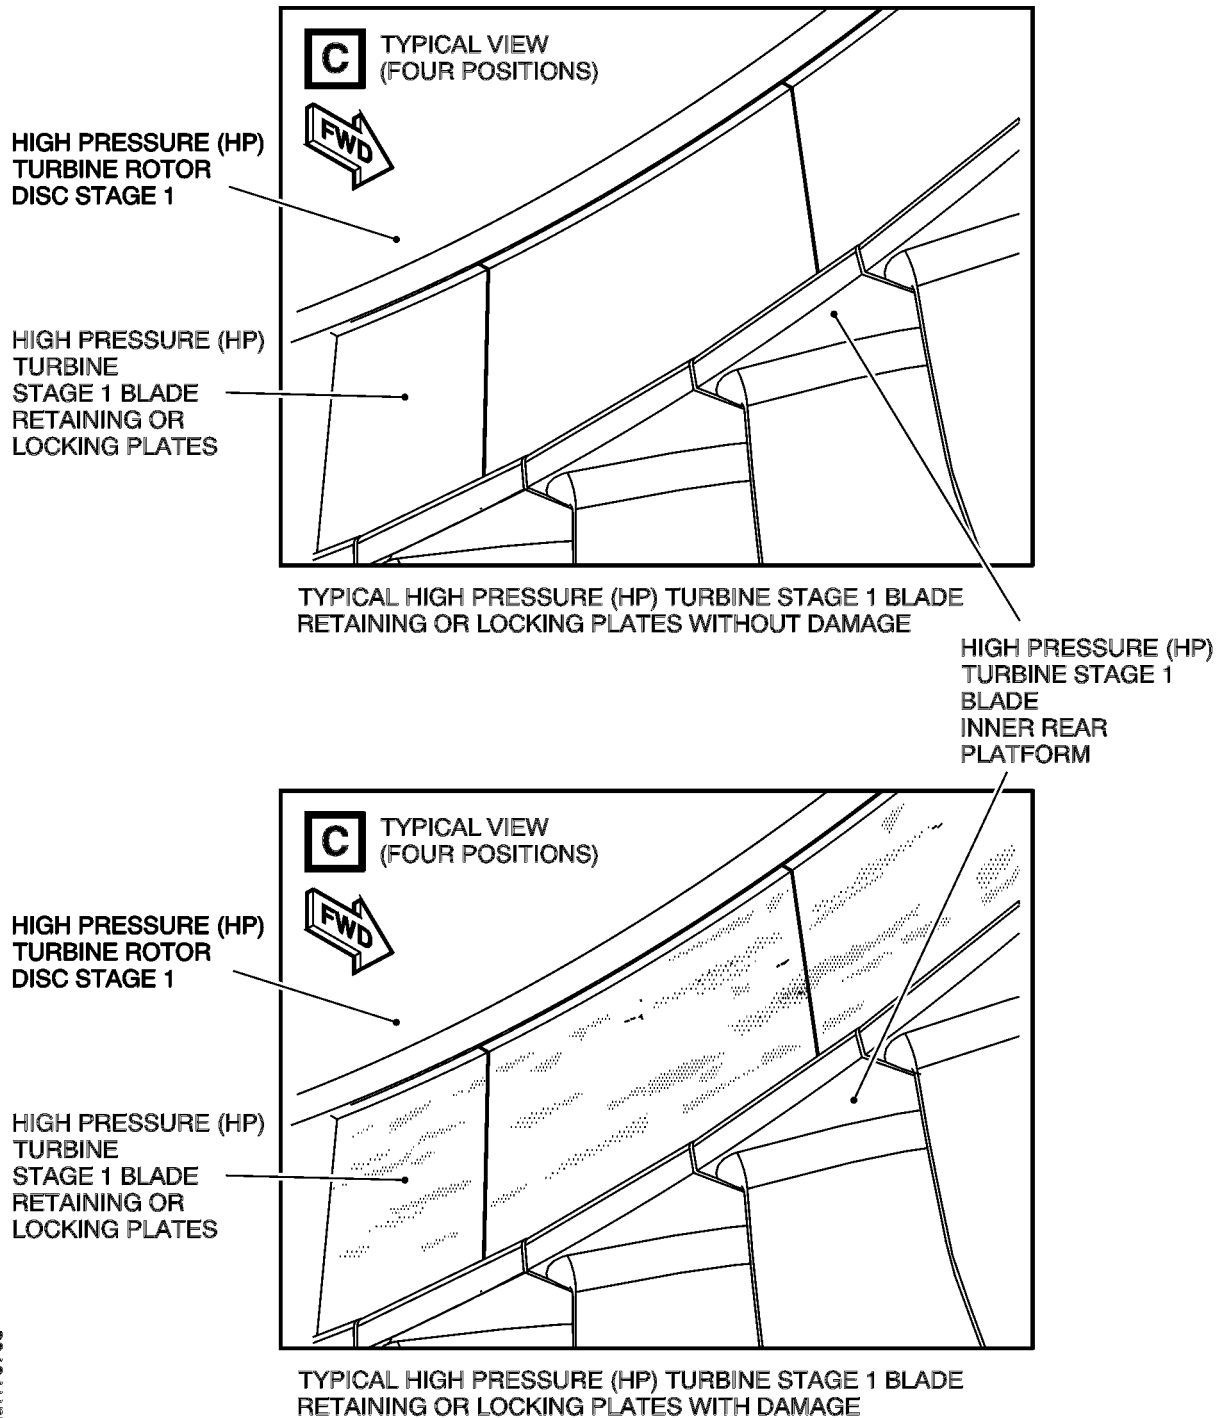
Borescope Inspection of the High Pressure Turbine Stage 1 Blade Retaining and Locking Plates

[1] Examine the HP turbine stage 1 rotor blade retaining and locking plates for indications of damage

[b] If you find indications of damage, reject the engine

- a) Replace the engine and send the removed engine to an approved TAY overhaul facility for detailed inspection and required corrective actions.

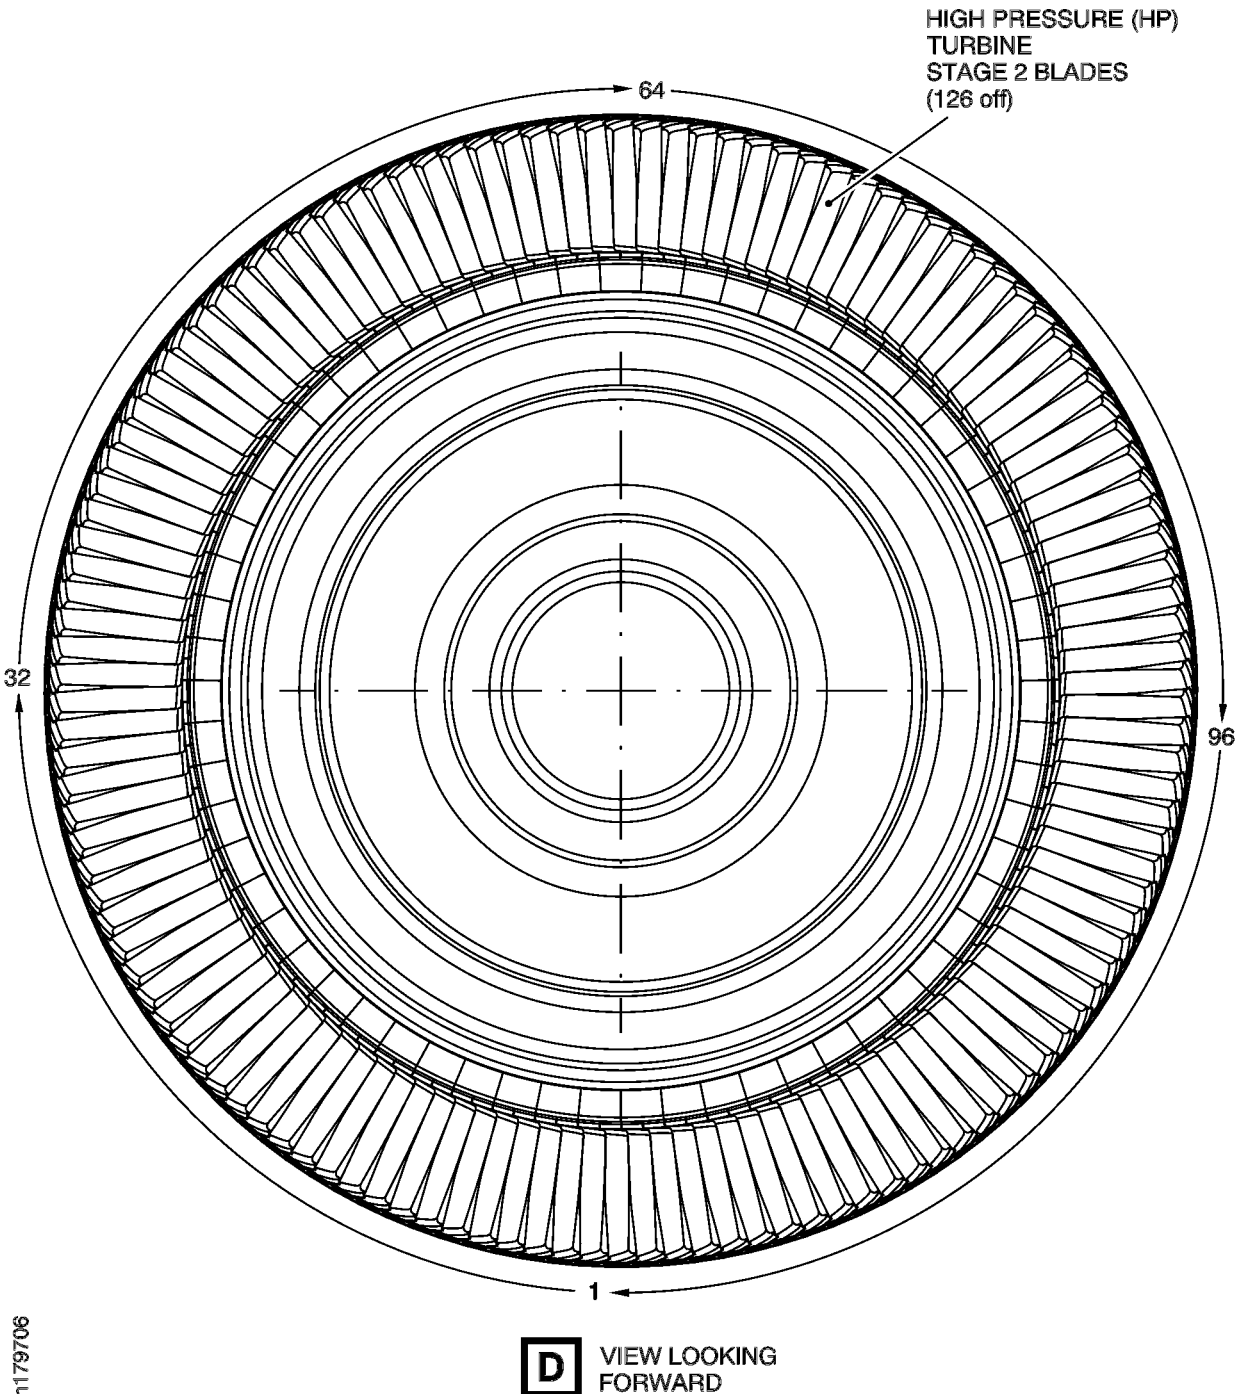
Identification of the Four Positions for the High Pressure Turbine Stage 2
Intermediate Air Seal Surrounding Cavity Borescope Inspection
Figure 1 (Sheet 6 of 6)

NOTE: The borescope inspection of the HP turbine stage 2 on the front side of the HP turbine stage 2 rotor disc is necessary at four positions. The access for the borescope inspection of the HP turbine stage 2 on the front side of the HP turbine stage 2 rotor disc is from the rear through the HP turbine stage 2 blades. The identification of the four different borescope inspection positions is ensured by turning the HP turbine rotor and counting the HP turbine stage 2 blades at the same time. The HP turbine stage 2 contains in total 126 blades. The HP turbine stage 2 blades are illustrated on Figure 1, detail D.

NOTE: The borescope inspection of the HP turbine stage 1 blade retaining and locking plates is necessary at four positions. The access for the borescope inspection of the HP turbine stage 1 blade retaining and locking plates is from the rear through the HP turbine stage 2 blades. The identification of the four different borescope inspection positions is ensured by turning the HP turbine rotor and counting the HP turbine stage 2 blades at the same time. The HP turbine stage 2 contains in total 126 blades. The HP turbine stage 2 blades are illustrated on Figure 1, detail D.
