Notification of a Proposal to issue an Airworthiness Directive

PAD No.: 23-096

Turbocharger exhaust systems

ATA 78 – Exhaust – Engine / Turbocharger Exhaust System / Components – Inspection

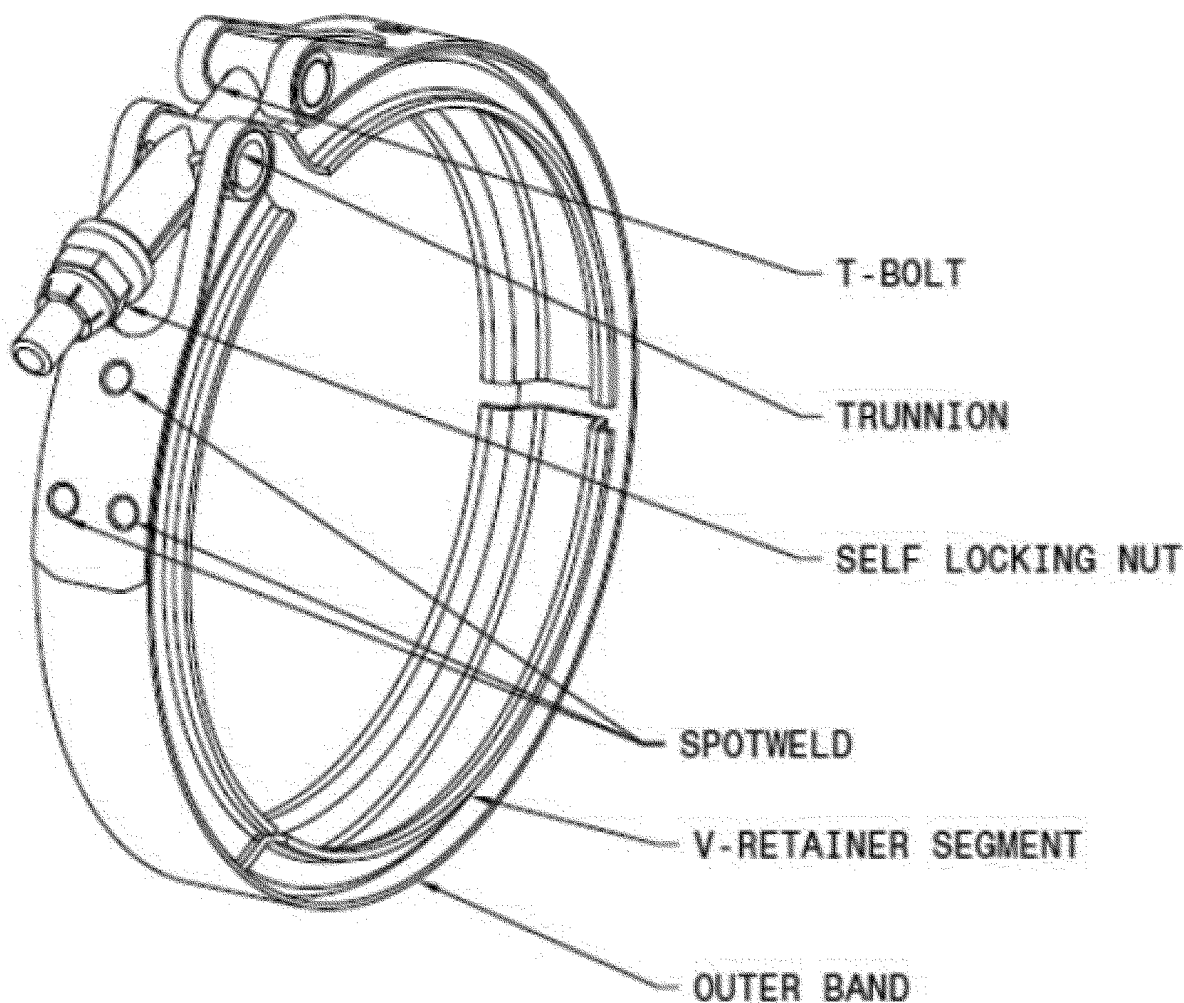
Figure 1 – Spot-Welded, Multi-Segment Exhaust Tailpipe V-Band Coupling

Affected part: Spot-welded, multi-segment v-band couplings installed at the tailpipe of the turbocharger exhaust housing flange.

Failures have been reported of spot-welded, multi-segment v-band couplings, installed at the tailpipe to the turbocharger exhaust housing flange. Over the years, this has resulted in a significant number of incidents and accidents (fatal and non-fatal) on both aeroplanes and helicopters. To address this safety subject, EASA issued AD 2016-0203 for Diamond DA40 aeroplanes, while the FAA has issued multiple ADs (listed in Appendix 2 of this AD) for specific type designs, as well as several Special Airworthiness Information Bulletin (SAIB).

Since those actions, the FAA constituted a working group to study v-band coupling failures associated with turbocharged reciprocating engine-powered aircraft depending on each specific coupling type (spot-welded, riveted, or single piece). The working group's final report determined that riveted couplings are not affected by a safety concern, and concluded that the common denominator in the incidents and accidents reviewed is the spot-welded, multi-segment exhaust tailpipe v-band coupling (see Figure 1 of this AD). These couplings come in either two or three segment varieties. The segments are the number of v-retainer segments, which are attached to the outer band via spot welds. The majority of the events studied by the working group indicated fatigue failure of affected parts as a result of stress corrosion cracking that originated at or near a spot weld.

This condition, if not detected and corrected, could lead to failure of the affected part, leading to detachment of the exhaust tailpipe from the turbocharger and allowing high-temperature exhaust gases to enter the engine compartment, possibly resulting in smoke in the cockpit, in-flight fire, and loss of control of the aircraft.

- (2) For Group 1 aircraft: Within the compliance times specified in Table 1 of this AD, and, thereafter, at intervals not to exceed 500 FH, remove each affected part from service and install a serviceable part, as defined in this AD, and apply correct torque, as applicable, to the affected part nut.
