# Notification of a Proposal to issue an Airworthiness Directive

**PAD No.: 23-106**

FB6 Double Burner Assembly

## ATA – Hot Air Balloon Burner Assembly and Hanger – Inspection / Modification

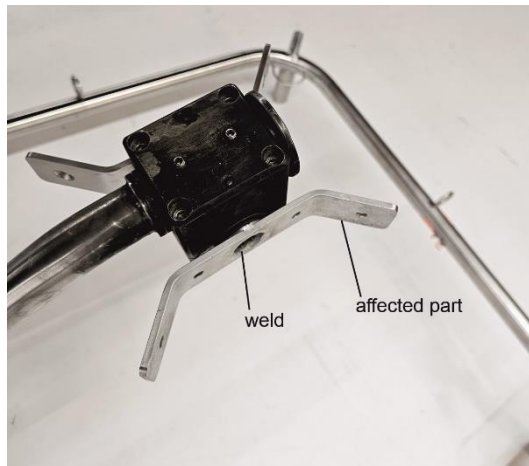
Figure 1 – Affected Part

**Affected part:** Connector of FB6 double burner hanger, except a Serviceable part. See Appendix 1 to this AD.

An occurrence was reported of a burner type FB6 S/N 2.1239-1 where the connector between the burners was found detached during transportation, leaving one burner unit detached from the load frame. Investigation revealed that the welding process may have been improperly done, due to an insufficiently detailed description of that process in production. The suspected direct cause of failure is fatigue cracking of the weld, mainly due to improper handling during transportation.

- (1) Within 12 months or 100 flight hours (FH), whichever occurs first after the effective date of this AD, accomplish an inspection of the weld of each affected part, installed on a balloon, in accordance with the instructions of the TN.

- (2) If, during the inspection as required by paragraph (1) of this AD, any crack is detected or evidence of a weld with insufficient filler material is found, before next flight, replace the affected part with a serviceable part, in accordance with the instructions of the TN.
