COMMENT RESPONSE DOCUMENT

EASA PAD No. 25-032

[Published on 07 February 2025 and officially closed for comments on 07 March 2025]

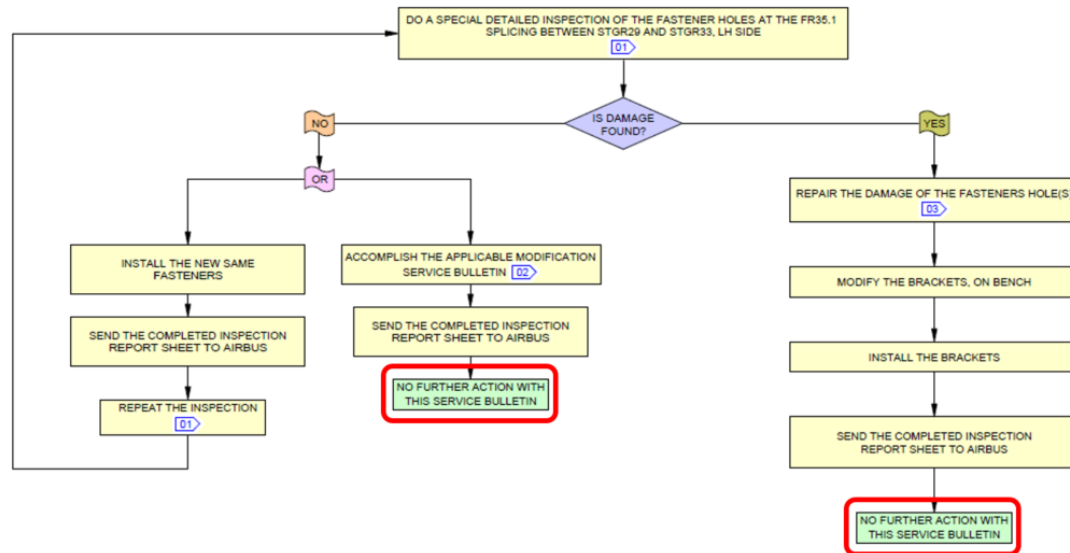
Example of SB A320-53-1308:

In paragraph (3) of EASA PAD 25-032, is mentioned if a repair is performed in accordance with any Inspection SB of Table 2, this is not a terminal action for the inspections of paragraph (1). However, in the instructions of the inspection SBs of Table 2 of EASA PAD 25-032, it is mentioned that if fastener holes have been repaired, no further action is required with this SB.

In accordance with the flow chart, if the modification SB is accomplished or if holes are repaired, no further action is required, otherwise if no damages are found, the SDI should be performed again in the intervals given.

If the instructions of the applicable inspection SB provide terminating action for the repetitive SDI as required by paragraph (1) of this AD, the applicable inspection SB can be considered “instructions provided by Airbus”, as described in paragraph (3) of this AD.

Note 2 was added to the final AD in response to this comment.
