Airworthiness Directive

AD No.: 2025-0205R1

ATR 42 and ATR 72 aeroplanes

ATA 53 – Fuselage – Passenger Seat Tracks – Inspection / Replacement

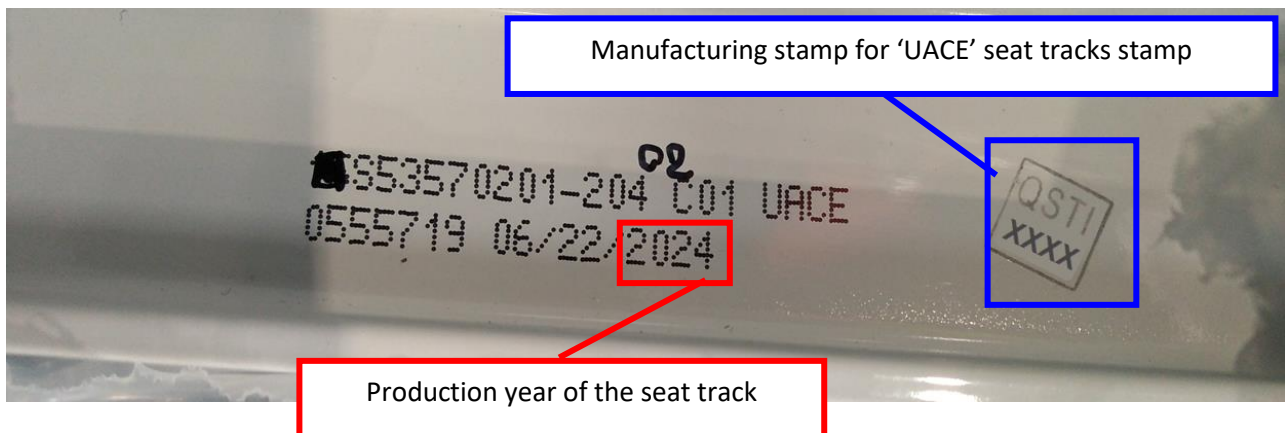
Appendix 2- Identification of 'UACE' seat tracks manufactured in or after 2024

The identification of the seat track is located on the lower face of the seat track.

The manufacturing stamp of the seat track on the illustration corresponds to 'UACE' manufacturer, where 'XXXX' represents any numerical sequence.

The production year of the seat track on the illustration is 2024.

All the seat tracks having this manufacturing stamp and a production year equal to or above 2024, do not have to be considered as affected parts.

All the seat tracks with the manufacturing stamp and/or production year not visible/legible, have to be considered as potential affected parts.
