Airworthiness Directive

AD No.: 2025-0205R2

ATR 42 and ATR 72 aeroplanes

ATA 53 – Fuselage – Passenger Seat Tracks – Inspection / Replacement

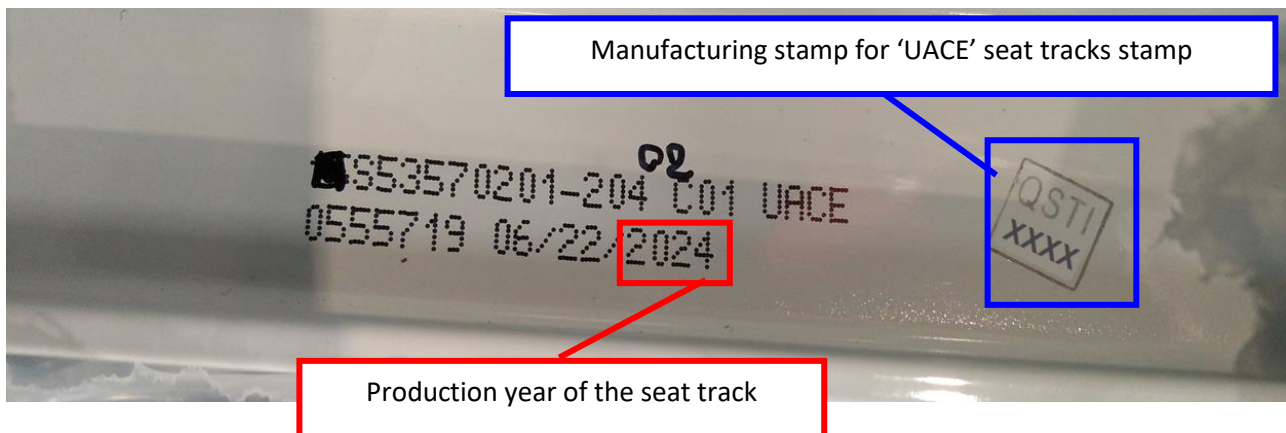
Appendix 2- Identification of 'UACE' seat tracks manufactured in or after 2024

The identification of the seat track is located on the lower face of the seat track.

The manufacturing stamp of the seat track on the illustration corresponds to 'UACE' manufacturer, where 'XXXX' represents any numerical sequence.

The production year of the seat track on the illustration is 2024.

All the seat tracks having this manufacturing stamp and a production year equal to or above 2024, do not have to be considered as affected parts.

All the seat tracks with the manufacturing stamp and/or production year not visible/legible, have to be considered as potential affected parts.
