## Airworthiness Directive

**AD No.:** 2025-0205R1

ATR 42 and ATR 72 aeroplanes

### ATA 53 – Fuselage – Passenger Seat Tracks – Inspection / Replacement

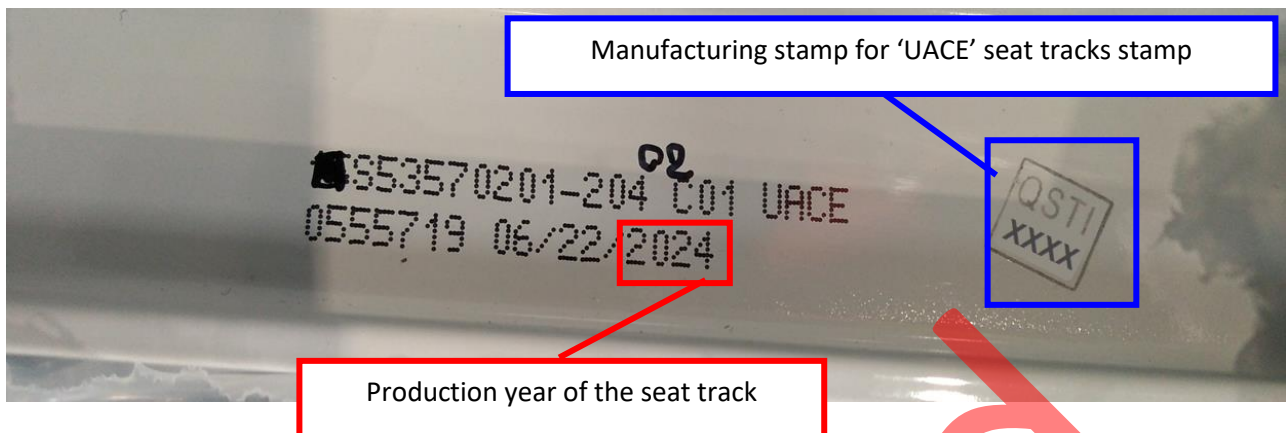
**Appendix 2-** Identification of 'UACE' seat tracks manufactured in or after 2024

The identification of the seat track is located on the lower face of the seat track.

The manufacturing stamp of the seat track on the illustration corresponds to 'UACE' manufacturer, where 'XXXX' represents any numerical sequence.

The production year of the seat track on the illustration is 2024.

All the seat tracks having this manufacturing stamp and a production year equal to or above 2024, do not have to be considered as affected parts.

All the seat tracks with the manufacturing stamp and/or production year not visible/legible, have to be considered as potential affected parts.
