Airworthiness Directive

AD No.: 2025-0205R3

ATR 42 and ATR 72 aeroplanes

ATA 53 – Fuselage – Passenger Seat Tracks – Inspection / Replacement

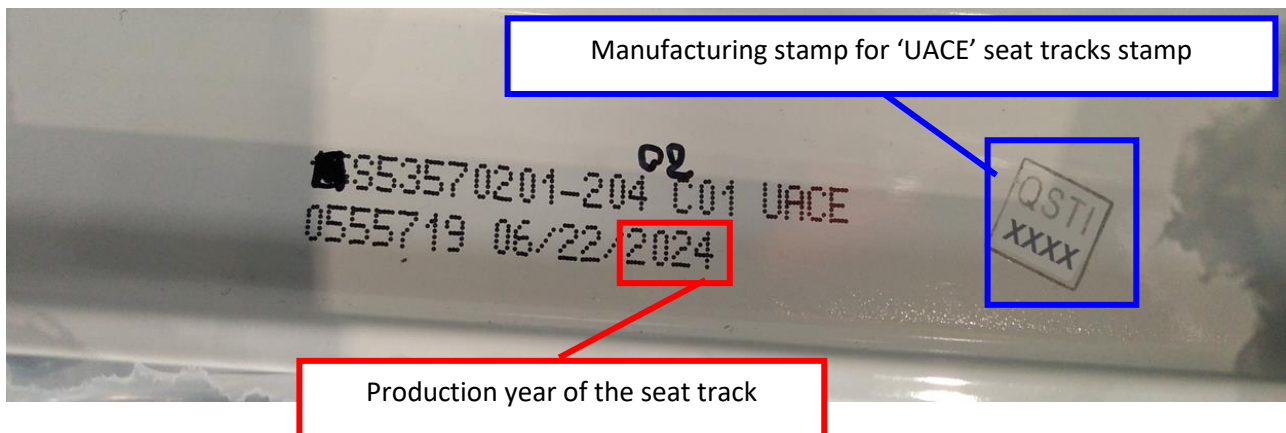
Appendix 2- Identification of 'UACE' seat tracks manufactured in or after 2024

The identification of the seat track is located on the lower face of the seat track.

The manufacturing stamp of the seat track on the illustration corresponds to 'UACE' manufacturer, where 'XXXX' represents any numerical sequence.

The production year of the seat track on the illustration is 2024.

All the seat tracks having this manufacturing stamp and a production year equal to or above 2024, do not have to be considered as affected parts.

All the seat tracks with the manufacturing stamp and/or production year not visible/legible, have to be considered as potential affected parts.
