Notification of a Proposal to issue an Airworthiness Directive

PAD No.: 25-112

ATR 42 and ATR 72 aeroplanes

ATA 53 – Fuselage – Passenger Seat Tracks – Inspection / Replacement

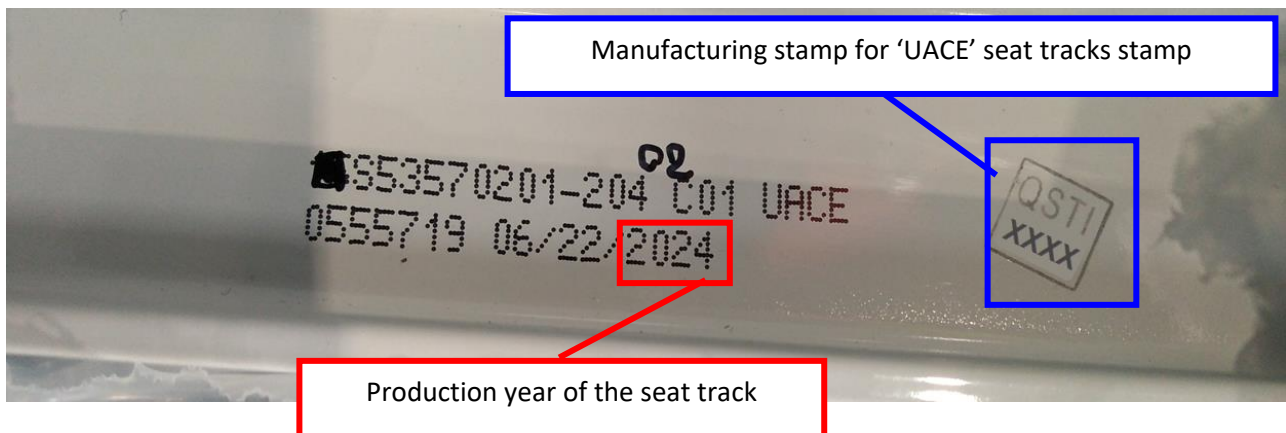
Appendix 2- Identification of 'UACE' seat tracks manufactured in or after 2024

The identification of the seat track is located on the lower face of the seat track.

The manufacturing stamp of the seat track on the illustration corresponds to 'UACE' manufacturer, where 'XXXX' represents any numerical sequence.

The production year of the seat track on the illustration is 2024.

All the seat tracks having this manufacturing stamp and a production year equal or above 2024, do not have to be considered as affected parts.

All the seat tracks with the manufacturing stamp and/or production year not visible/legible, have to be considered as potential affected parts.
