Notification of a Proposal to issue an Airworthiness Directive

PAD No.: 26-038

Design Approval Holder's Name: AIRBUS HELICOPTERS DEUTSCHLAND GmbH **Type/Model designation(s):** MBB-BK117 helicopters

ATA – Rotorcraft Flight Manual – Section Emergency Procedures – Amendment ATA 42 – Integrated Modular Avionics – Ethernet Network – Inspection / Modification

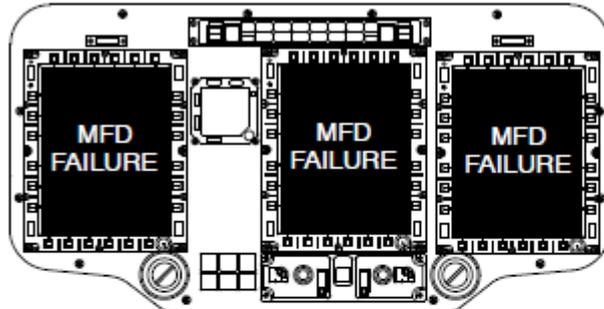
- MFDs:

- MFD FAILURE displayed on all MFDs
- If autopilot upper modes were coupled, they may decouple after 10 seconds (indicated by an „autopilot decouple“ voice message).
