Airworthiness Directive

AD No.: 2026-0096

AIRBUS HELICOPTERS DEUTSCHLAND GmbH

MBB-BK117 helicopters

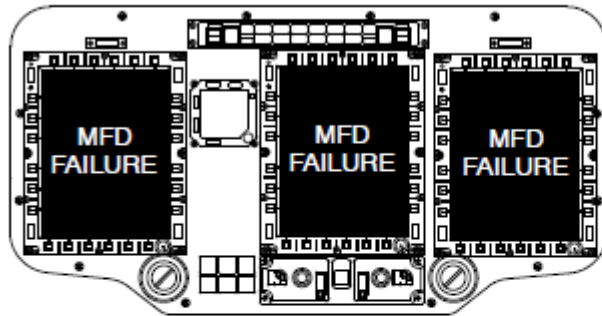
- MFDs:

- MFD FAILURE displayed on all MFDs
- If autopilot upper modes were coupled, they may decouple after 10 seconds (indicated by an „autopilot decouple“ voice message).
