# Notification of a Proposal to issue an Airworthiness Directive

**PAD No.:** 26-093

A318, A319, A320 and A321 aeroplanes

## ATA 92 – Electrical Systems Installation – Battery Retaining Rods – Identification / Replacement

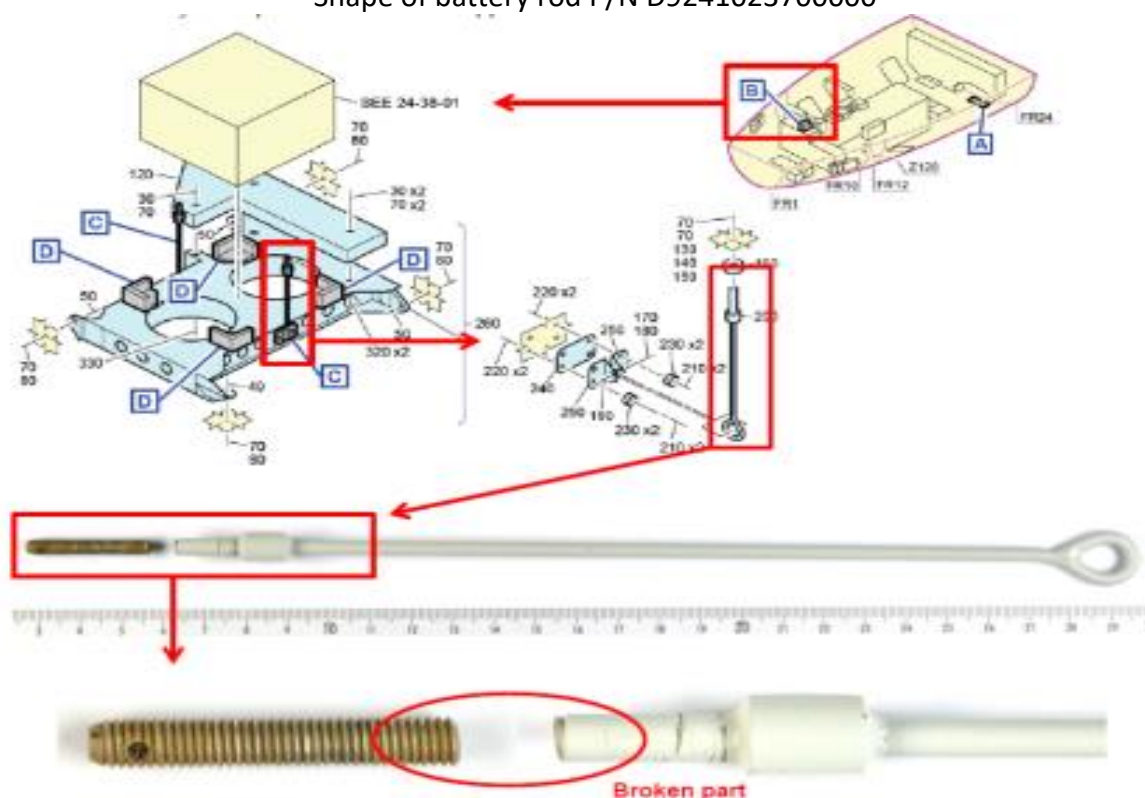
# **Appendix 1** Shape of battery rod P/N D9241023700000

Note 3: The requirement for identification with a label applies only to rods having P/N D9241023700000. See Appendix 1 of this AD for information about the shape of affected parts.
