Safety Information Bulletin

SIB No.: 2015-26

Subject: Overwing Emergency Exit – Potential Interference Preventing Removal of an Exit Hatch

Gulfstream G280, G200 and G150 aeroplanes modified in accordance with any Gulfstream Aerospace Corporation Cabin Interior Supplemental Type Certificate.

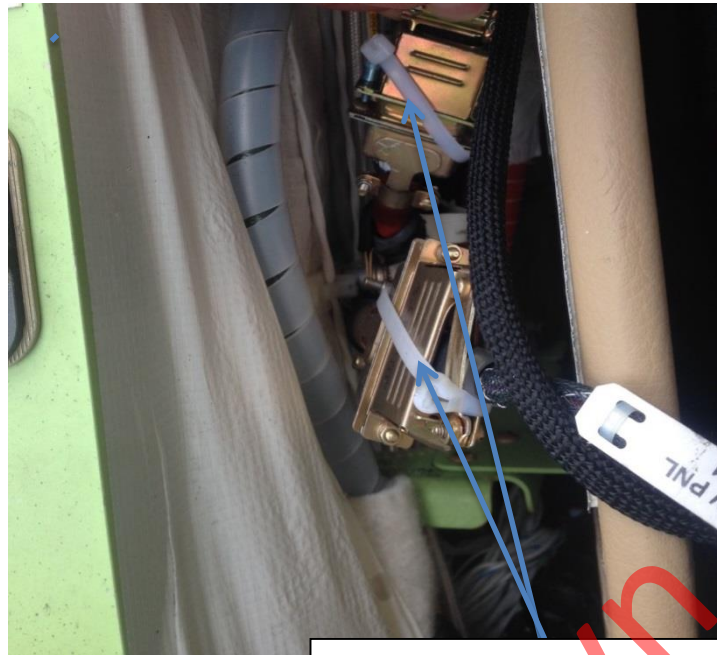
Appendix 1 – Improper Installation of Cable Ties

During a routine check on a modified Gulfstream G 150 aeroplane, which included removal of the overwing emergency hatches, it was discovered that the harness connectors were secured with cable ties preventing disconnection of the affected wiring connections, see Appendix 1 of this AD. Consequently, the removal of the affected emergency hatches was obstructed.

Cable ties or other fixation devices should not be installed here.

- The connectors are attached together without any additional fixation, and
- The connectors are not secured together with any additional devices such as cable ties.

- Ensuring an unobstructed connector openings,
- Ensuring the absence of any fixation (e.g. cable ties) of the affected wire connectors, see Appendix 1 of this SIB for details of the installation.
