## Safety Information Bulletin

SIB No.: 2016-16R1

**Subject:** AMSAFE Restraint Systems – Jammed Cockpit Seat Belt Buckles

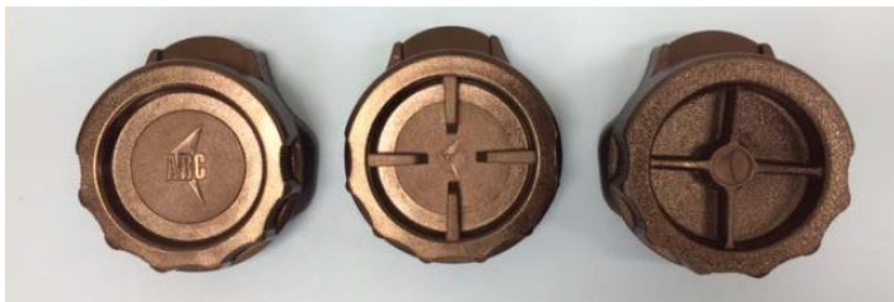
Figure 1: 1150004-SERIES Rotary Buckles

AMSAFE Rotary Buckles (RB) Part Numbers (P/N) 1150004-Series (see Figure 1 below), manufactured between December 2013 and April 2016 (inclusive).

Reports were received by EASA of occurrences where pilots were unable to release their seat belt buckles. This issue occurred on RSA, identified as IPECO P/N 1180010-( )-( ), equipped with AMSAFE RB P/N 1150004-Series. Investigation conducted by AMSAFE on RB P/N 1150004-Series concluded that the thread locker may not have been properly applied on the RB central screw. This is a quality production issue, which may lead to the central screw progressively unscrewing, up to a point where it would prevent the unlocking of the seat belt buckle.

EASA recommends operators to accomplish the actions as specified in AMSAFE ASB 1150004-25-A01, Revision 7. IPECO SB 063-25-11 Revision 2 also contains useful information and instructions concerning this safety subject.
