**Subject: SZD-50-3 - Notification of uncertified parts installed**

Allstar PZL SZD-50-3 "Puchacz" sailplanes, all serial numbers.

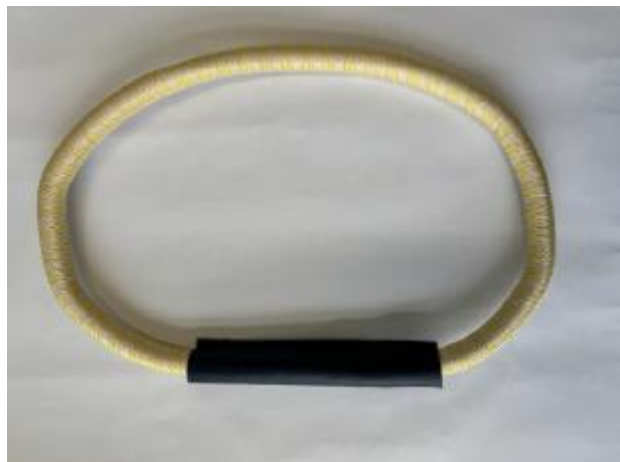
EASA has been informed that the Type Certificate Holder, Allstar PZL, has been making uncertified rubber shock absorbers available for installation (hereinafter referred to as the uncertified part) in the Main Landing Gear (MLG) assembly of SZD-50-3 sailplanes. This uncertified part consists of a shock ring in the form of a closed-loop hoop that does not require the ends to be joined (see Figure 1). Two rubber shock absorbers are installed in each MLG assembly.

According to Allstar PZL, this practice has been in place since at least 2018 and was related to market unavailability of the certified rubber shock absorber.

Figure 1 - Uncertified Part

EASA recommends owners, operators and maintenance organisations to inspect, before the next flight, the MLG rubber shock absorbers and determine whether the MLG rubber shock absorbers comply with the approved type design.

If any uncertified part is found during the inspection, it is recommended that the uncertified part is quarantined to prevent re-installation and that Allstar PZL is contacted for further guidance on replacement parts. Owners, operators and maintenance organisations should also ensure that the sailplane complies with its approved type design and remains airworthy before returning it to service.
