Civil Aviation Authority  
**EMERGENCY  
AIRWORTHINESS  
DIRECTIVE**

**Number: G-2024-0001-E**

Lindstrand Technologies Limited

**ATA - Hot Air Balloons - Envelopes with Polyester Filled Aramid (Kevlar) Load Tapes – Removal from Service**

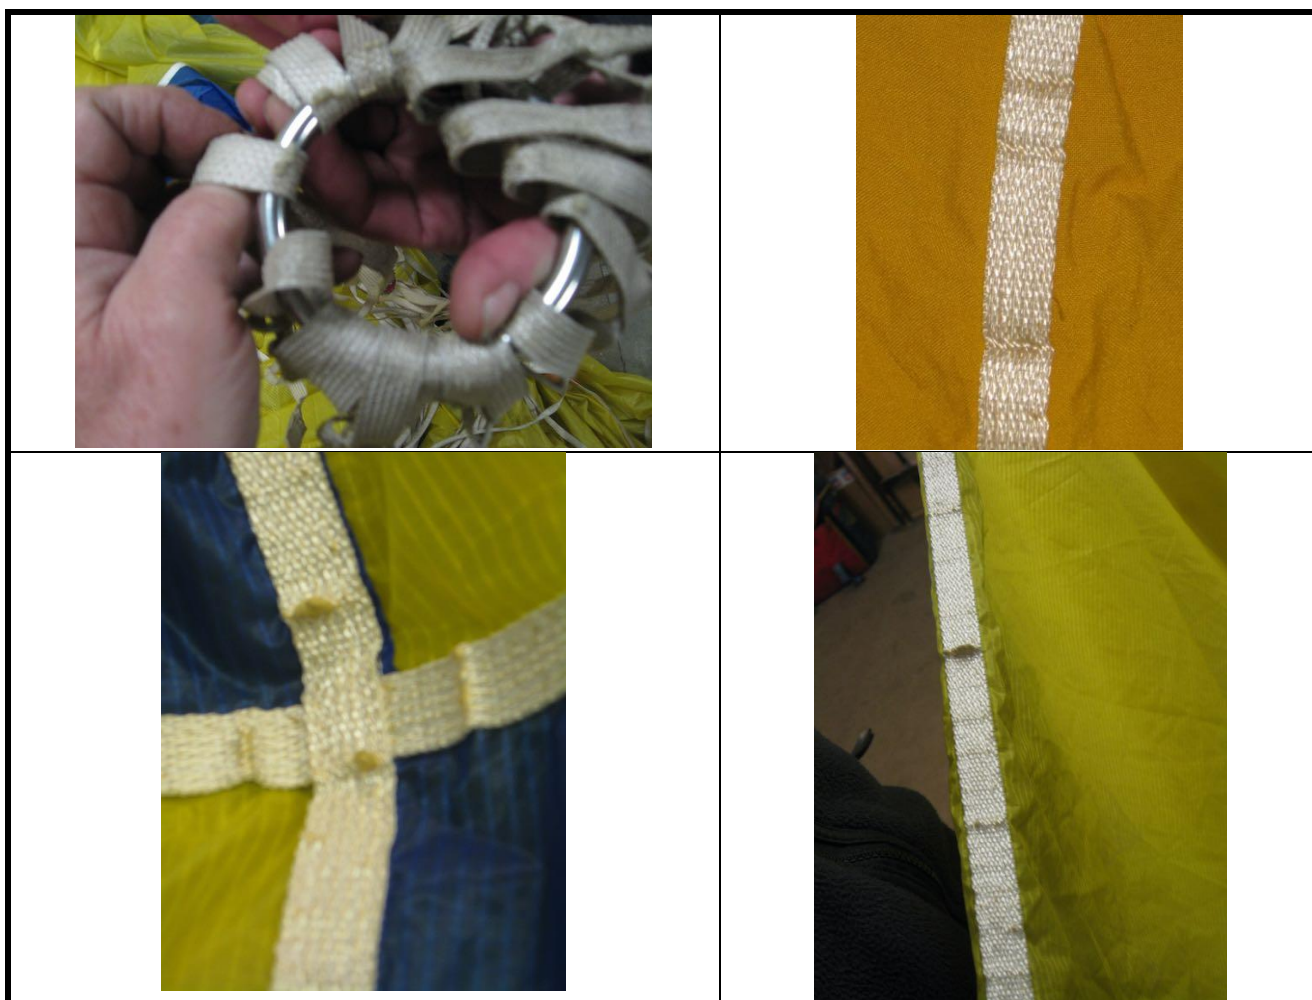
During a routine 100 hr/Annual inspection of an envelope, it's been discovered that the polyester filled aramid load tapes have degraded significantly (see Figure 1).

The damage has allowed the Kevlar core (coloured yellow) to become exposed which would degrade the strength of the tape due to ultraviolet exposure. Both horizontal and vertical tapes are affected and there is significant distortion to the horizontal types.

Additionally, in the area where the tape loops around the crown ring, the polyester has failed completely, and Kevlar is totally exposed. In other areas the load tapes have stretched and frayed.

Although the maintenance manual states no damage to the load tapes is acceptable, an unsafe condition could exist as the rate of degradation is unknown and the residual strength of the tape, following exposure to UV, cannot be determined.

**Figure 1: Examples of load tape damage**

1. Before further flight from the effective date of this AD carry out a visual inspection to determine the date of manufacture (from the envelope data plate) and whether the envelope is fitted with Polyester Filled Aramid (Kevlar) load tapes.

2. If the date of manufacture is after March 2017 **and** the envelope has been found, by inspection, to be fitted with optional Polyester Filled Aramid (Kevlar) Load Tapes, the envelope must be considered as an **Affected Serial Number** for the purposes of this AD.
3. If the envelope is an **Affected Serial Number**, carry out a 100% visual inspection of the load tapes.
4. If damage is visible, no further flight is permitted until the damage has been rectified.
5. **If no damage is visible, amend the aircraft maintenance programme to include a 100% visual inspection of both the horizontal and vertical load tapes before each flight.**

Note: this visual inspection can be performed by the pilot/owner. In cases of doubt, the envelope should be inspected by a suitably qualified engineer.

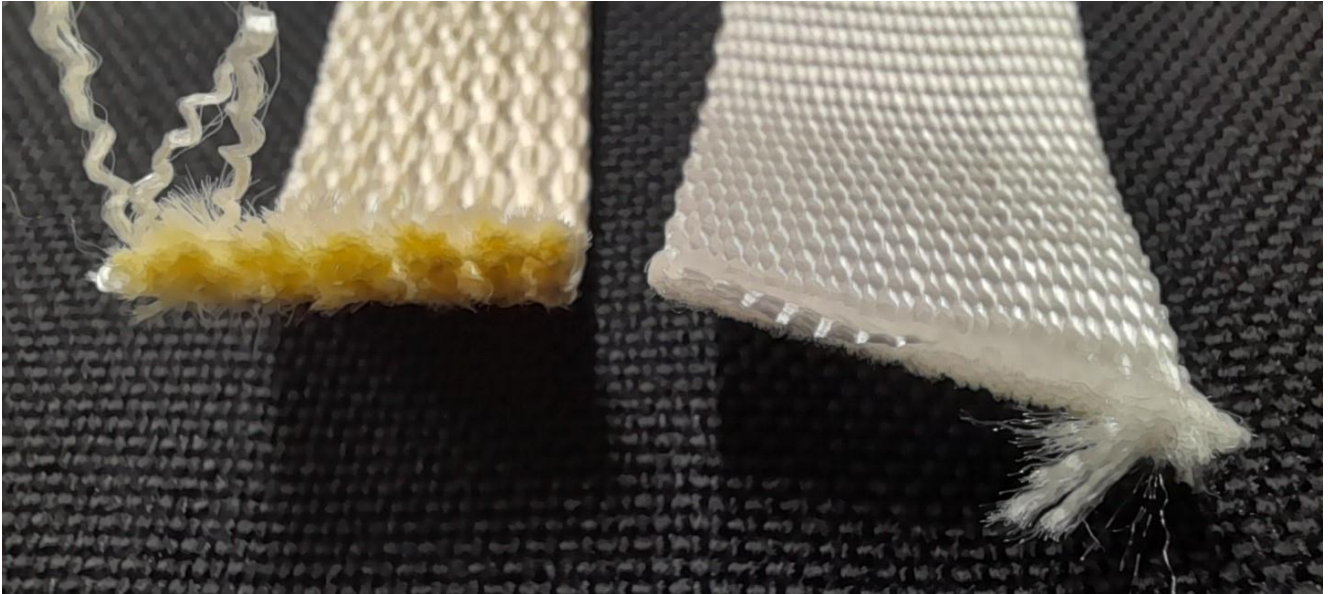
The Polyester Filled Aramid (Kevlar) load tapes (shown on left) have a distinctive yellow core which will become visible if damage has occurred.

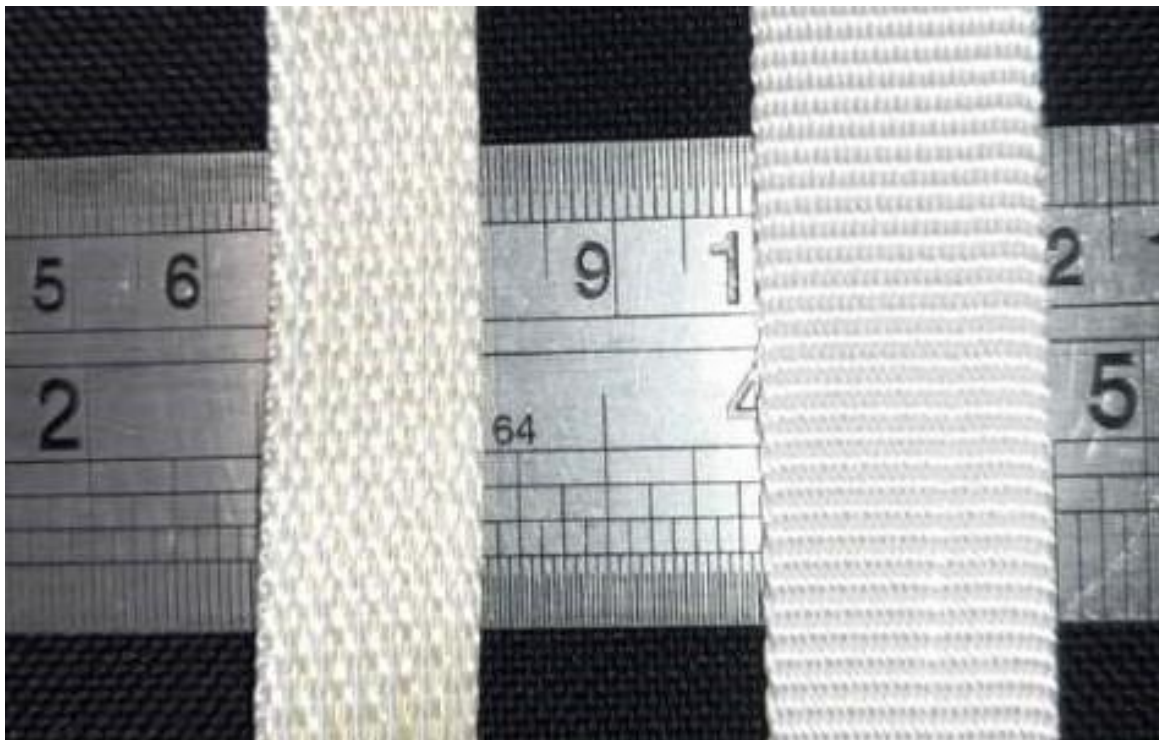
The Polyester Filled Aramid (Kevlar) load tapes (shown on left) is 15 mm wide; the standard polyester tape is 20 mm wide.
