| ATA 53 | Fuselage – Upper FWD Stringer left / right |
| Subject : | Corrosion Inspection between FWD Windshield Frame Angle LH/RH and Upper FWD Stringer left and right |
| Applicability : | FFA AS202 all Modell and S/N |

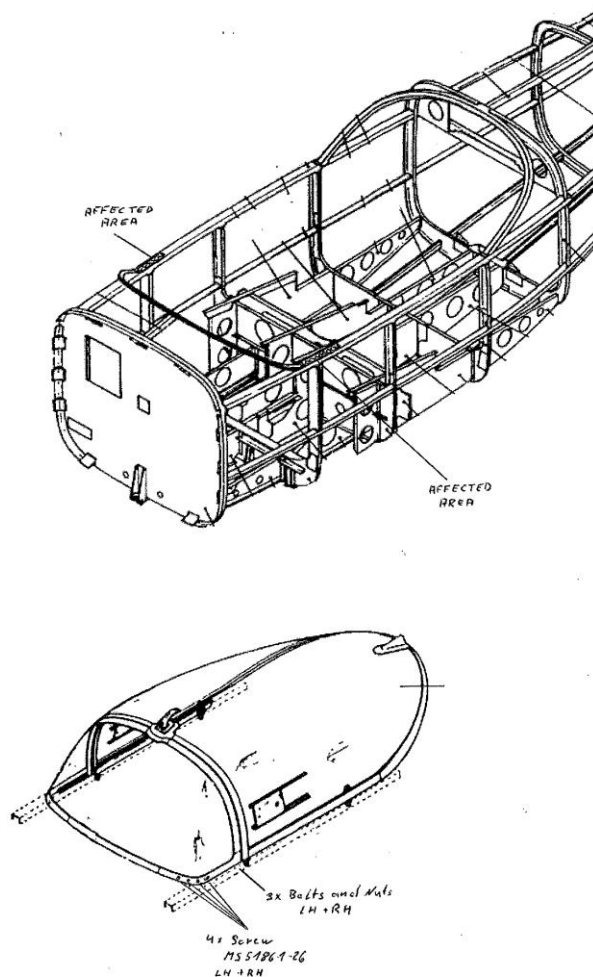
Figure 1:

| Instructions : | <ol style="list-style-type: none">1. Perform Detailed Visual Inspection of FWD upper stringer LH/RH top side for evidence of corrosion or missing corrosion protection (refer to Figure 1 for the area to be inspected).<ol style="list-style-type: none">a. For access remove L/H and R/H cockpit side covers, remove Glare shield in accordance with AS202 AMMb. Remove each side three bolts and nuts holding windshield frame in place i.a.w. AS202 AMMc. At outside windshield cover, remove screws holding windshield in place (see Picture 1).d. Carefully lift windshield and frame to get a clear view to affected area, use flashlight for adequate lighting to inspect area (see Picture 2).e. If any sign of corrosion or damaged corrosion protection is evident, area has to be repaired prior to further operation.f. Little⁽¹⁾ or minor⁽²⁾ surface corrosion can be removed i.a.w. the applicable Maintenance Manual and AC43.13-1B. No corrosion is allowed in an area of 20 mm around the cutout for the front attachment of the canopy. Max area of corrosion to be removed shall not exceed 0,2 mm over the length of one flange (horizontal or vertical flange of the U-profile) in the affected area. |

- (1) Little Corrosion: Surface Corrosion only, can be removed by any means, however no techniques approved resulting in weakening the structure, showing a clean and bright surface thereafter.
- (2) Minor Corrosion: Surface Corrosion only, can be hand wiped off with a Scotch Brite or equivalent, showing a clean and bright surface thereafter.
- g. Apply corrosion protection i.a.w. AS202 AMM
- h. Fill in evidence report and return to below address.
2. Assemble all previous removed parts in accordance with AS202 AMM
3. If no corrosion was found or if the corrosion could be removed i.a.w. instruction 1.f), release aircraft to service. In all other cases contact Gomolzig Flugzeug- und Maschinenbau GmbH for the development of an appropriate repair procedure.
4. Repeat inspection at an interval of one year

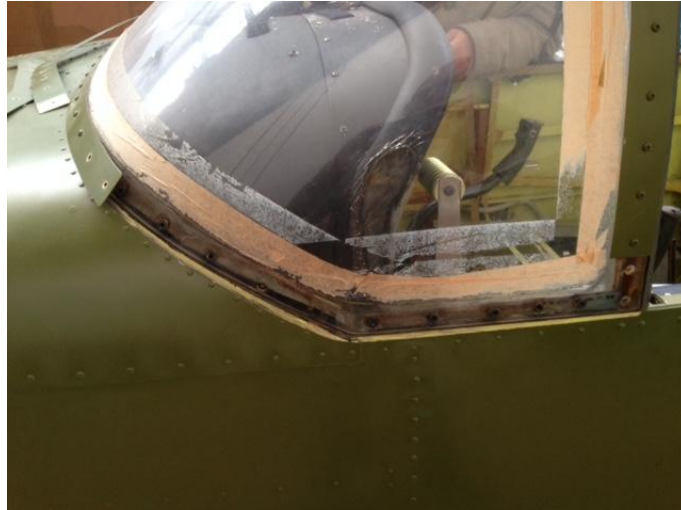
Picture 1

| Reason : | At annual inspection during windshield replacement heavy corrosion was evident between windshield frame and FWD upper stringer LH/RH. Corrosion was not to be detected at general visual inspection from below. Undetected corrosion may result in loss of structural integrity of affected area. |
