SPECIAL AIRWORTHINESS INFORMATION BULLETIN

SAIB: NE-15-21

SUBJ: Fuel Injector Nozzle

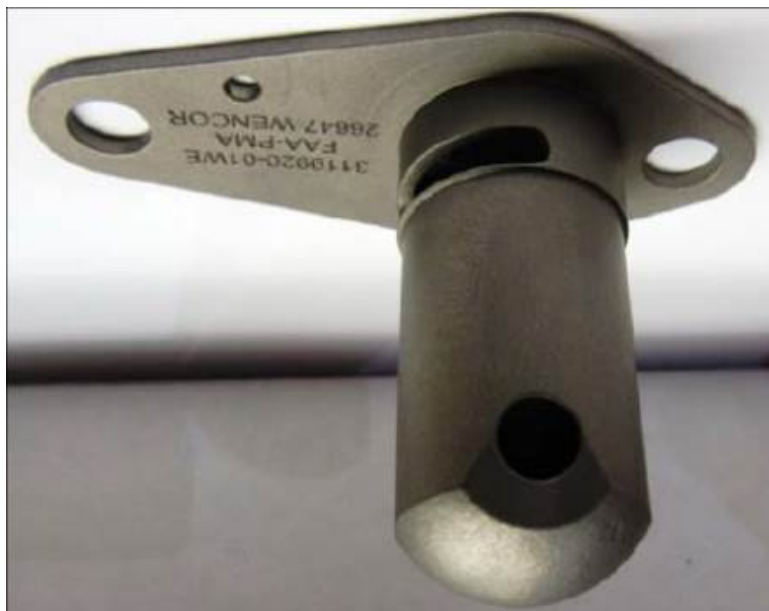
Figure 1 – Fuel Nozzle Sheath

While developing the fuel nozzle sheath, P/N 3119920-01WE, Wencor made the lower portion of the cap thicker than the OEM fuel nozzle sheath, P/N 3119920-01. A technician installing the PMA fuel nozzle sheath, P/N 3119920-01WE, on a PT-6A engine found he/she could not install the part (Figure 1), without it contacting the fuel nozzle (Figure 2) because the fuel nozzle was contacting the sheath.

1. The FAA recommends removing all Wencor PMA fuel nozzle sheaths, P/N 3119920-01WE, from service at the earliest maintenance opportunity not to exceed 600 flight-hours after August 1, 2015.
2. The FAA also recommends that all spare Wencor PMA fuel nozzle sheaths, P/N 3119920-01WE, be removed from inventory and not installed in any engine.
3. In addition, the FAA recommends that all removed fuel nozzle sheaths and spares be returned to Wencor.

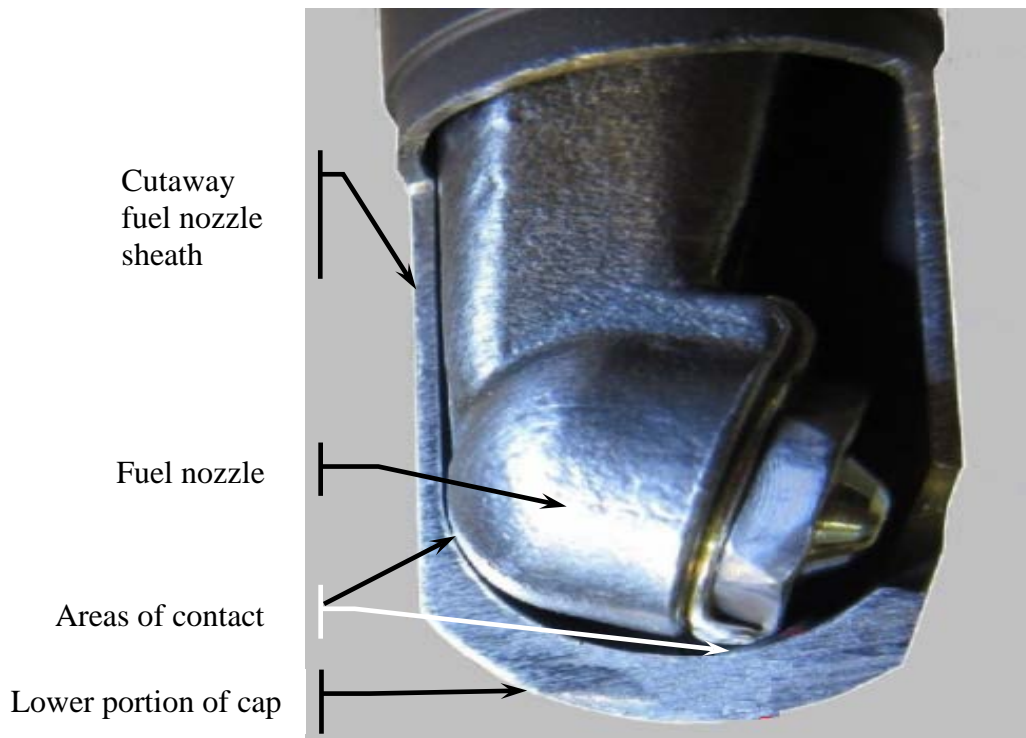
Figure 2 – Fuel Nozzle inside Cutaway Sheath

A fuel nozzle that is bottomed out in the fuel nozzle sheath might affect the performance, temperature, or integrity of the engine in service. There have been no reports of operational issues to date, but since the fuel nozzle sheaths do not fit with the fuel nozzles as designed, and the effect of this condition is unknown, the FAA recommends removing all Wencor PMA fuel nozzle sheaths, P/N 3119920-01WE, from service.
