Airworthiness Directive of the Netherlands

BLA nr : 1999-053

Model F.27 series

WINGS - FUSELAGE ATTACHMENT FITTINGS - INSPECTION

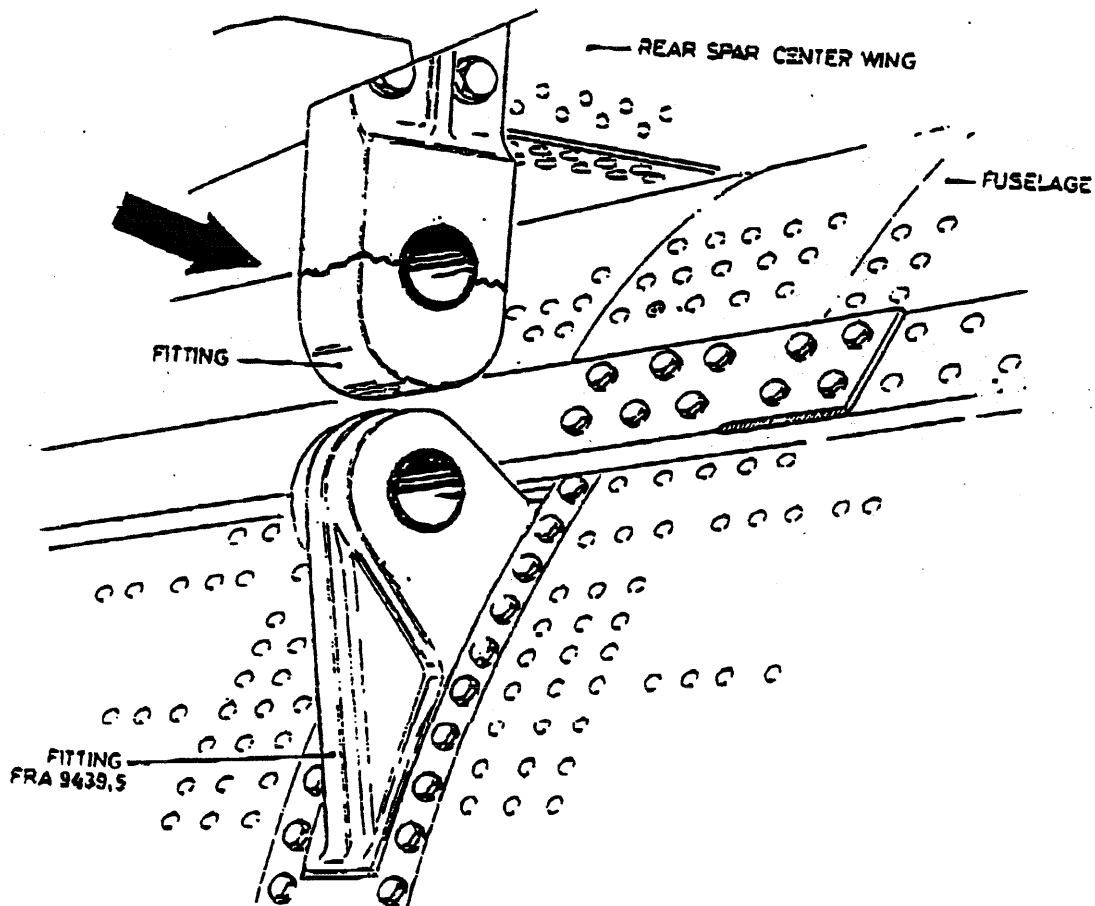
Recently, RLD have received a report from an F.27 "Friendship" operator concerning the discovery of a cracked wing-to-fuselage attachment fitting. There are four such fittings on the wing front- and rear spars, two on each spar on both sides of the fuselage. This particular fitting was located at Wing STA.1040, on the rear spar RH side. Subsequent investigation revealed that the cracking had resulted from stress corrosion. Subject fittings are manufactured from 7079-T6 aluminium, which is known to be sensitive to this type of corrosion. The affected aircraft had been inspected and modified in accordance with Fokker Service Bulletin (SB) F27/57-54 some eight (8) years prior to the cracked fitting being found. Since an unsafe condition has been identified that may exist or develop on other aircraft of the same type design, this Airworthiness Directive (BLA) requires a one-time inspection of the affected wing-to-fuselage fittings (see Figure 1 of this directive) and the reporting of all findings to the present Type Certificate holder. RLD considers this directive to be a precautionary measure and further requirements may follow.

Figure 1
Location of cracked fitting (links removed)

(a) Within the next 6 months after the effective date of this directive, inspect the wing-to-fuselage fittings in accordance with the Accomplishment Instructions of STORK Fokker SB F27/57-77 dated April 1, 1999 or a later RLD-approved revision;
