SAIB: NM-07-39R1

Date: October 10, 2008

SUBJ: Powerplant System: Forward bearing fitting attach bolts

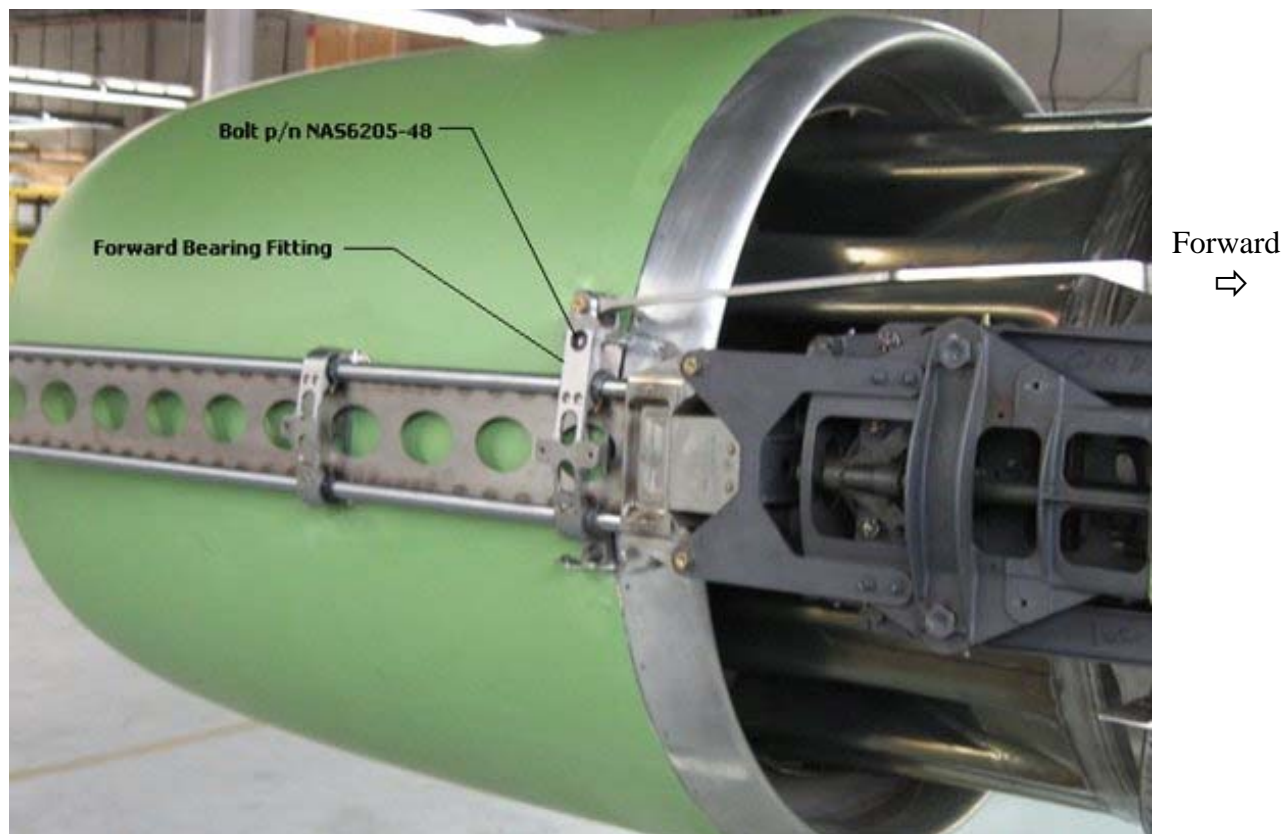
**Figure 1 – View of QTA Hushkit Ejector Assembly Forward Bearing Fitting
(Shown on engine removed from aircraft; fairings removed)**

SAIB NM-07-39 was a result of findings of several failed, cracked, or yielded forward bearing fitting attach bolts on QTA Stage 3 Hushkits installed in accordance with STC ST02618AT. The bolts are located adjacent to the thrust reverser translating link attach point and connect the forward bearing fitting to the ejector. Note that the subject bolt is installed on both the inboard and outboard side of each engine; however, it is located on the top of the forward bearing fitting on one side, and on the lower side of the forward bearing fitting on the other side of the engine.

Failure of these bolts can lead to overload on the opposite side forward bearing fitting attach bolt and allow binding on the ejector rails. In one case, a bent translating link was found. QTA released Service Bulletin QTA-002 to specify replacing NAS6205-48 bolts with NAS6705-48 bolts.

Since the issuance of SAIB NM-07-39, QTA and the FAA worked to determine the cause of the cracking and the aircraft level effect of such failures. Fatigue testing and analysis were accomplished on several configurations of bolt installations. The conclusion of that investigation is that if the subject bolts are replaced every 400 flight cycles, in-service cracking and failure will be prevented. The examined failures result in a configuration that does not endanger the flight crew, passengers, or the public, and thus is not an unsafe condition that would warrant airworthiness directive (AD) action under Title 14 of the Code of Federal Regulations (14 CFR) part 39.

We recommend that aircraft owners or operators replace the subject forward bearing fitting bolts every 400 flight cycles with an approved replacement. Currently, the approved replacement bolts are NAS6705-48 and QTA part number G23-EJ-4024. We do not recommend re-installation of the NAS6205-48 bolts.

For aircraft with bolt installations already exceeding 400 flight cycles, we recommend replacing the bolts within 6 months to minimize the risk of an in-service bolt failure.
