DCA/R2000/23B Rudder Pedal Bars – Inspection and Replacement

Applicability: Model R 2100, R 2100 A, R 2112, R 2120 U, R 2160, R 2160 D and R 2160 I aircraft, S/Ns 1 through 378 not fitted with reinforced rudder bars P/N 27.40.31.010 and P/N 27.40.31.020.
Model HR 200/100, HR 200/100S, HR 200/120, HR 200/120B and HR 200/160 aircraft, S/Ns 1 through 378 not fitted with reinforced rudder bars P/N 27.40.31.010 and P/N 27.40.31.020.

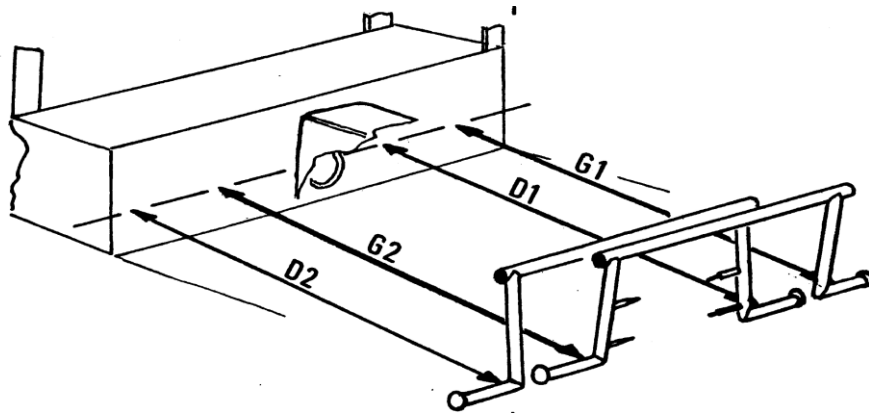
Figure 1

Requirement: To prevent distortion of the rudder bars due to rudder control forces during aerobatic operation and nose wheel steering reaction forces, accomplish the following:

Check the geometrical shape of both the rudder bars in accordance with Fig 1. Maintain the rudder bars in the neutral position and measure distances G1, G2 and D1, D2 (the distance between the foot tubes and the front face of the frame box located under the seats). The difference between G1 and G2, or D1 and D2 is the distortion.

- a. If $D1 = D2$ and $G1 = G2$ (+/- 5mm), there is no significant distortion and no action is required, re-inspect at intervals not to exceed 500 hours TIS.
- b. If the distortion is between 5 and 10 mm re-inspect at intervals not to exceed 100 hours, until replaced by rudder bars P/N 27.40.31.010 and P/N 27.40.31.020 per AA-SB-27-003.
- c. If the distortion is equal to or greater than 10mm, replace both rudder bars per AA-SB-27-003.
