U.S. Department  
of Transportation  
**Federal Aviation  
Administration**

SAFO 15007  
DATE: 6/19/15

**Subject:** Pratt & Whitney R-985-AN-14B Flyweight Hardware Failures

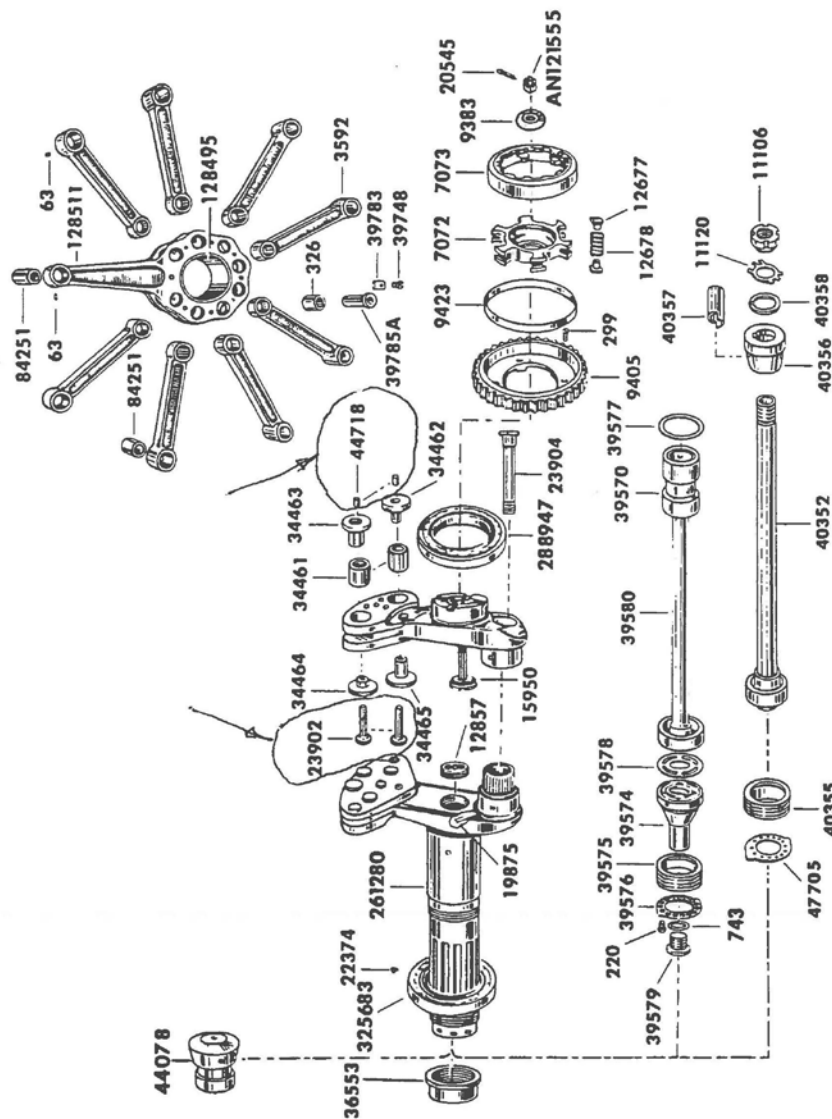
Figure 4. Crankshaft and Connecting Rods

Additional engine models that could be affected by this issue due to similar design include all Pratt & Whitney Wasp Jr (R-985 Series) and Wasp (R-1340 Series) engines, reference image on pg 3.

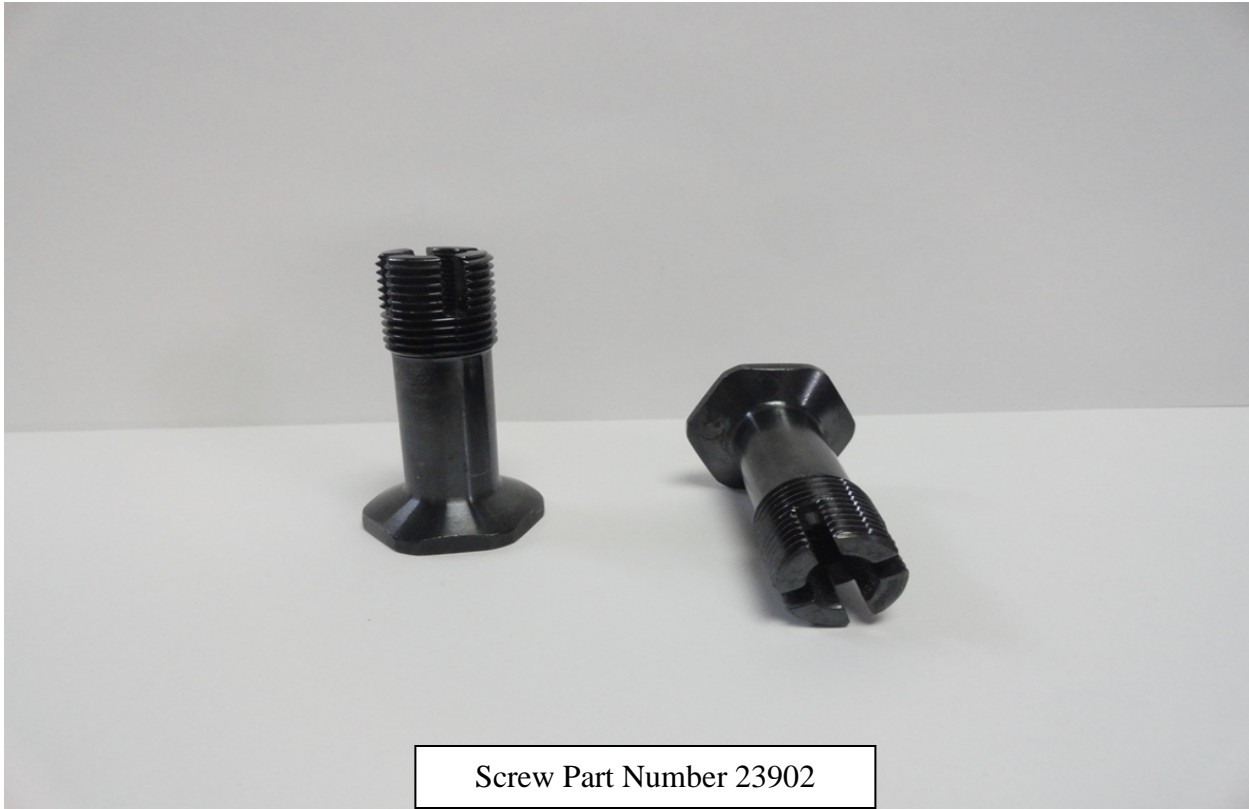
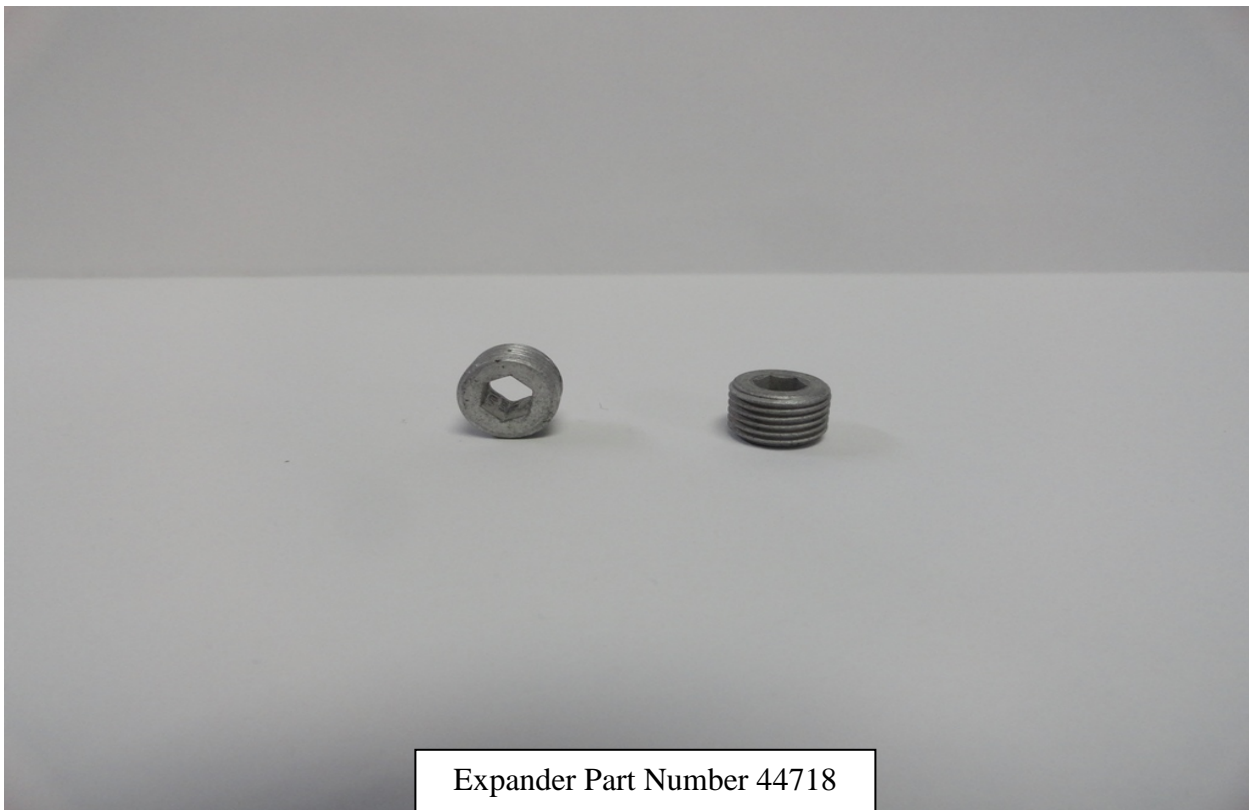
**Background:** Since June of 2013, there have been three documented engine failures caused by failed flyweight screws. These failures occurred during flight, resulting in forced landings. At the time of the failures, engine time since overhaul ranged from 2.5 hours to 671.6 hours. The engine crankshaft assemblies were overhauled by three different repair facilities. Additionally, inspections of at least four other engines have found cracked screws (P/N 23902, reference image on pg 4) and under torqued and/or improperly modified expanders (P/N 44718, reference image on pg 4) used to secure the screws in the flyweights.

After torquing the flyweight screw, the overhaul manual requires the expander plug be threaded into the screw and torqued 200 to 225 inch-pounds. The manual then provides a maximum measurement of 0.060 inch for the expander to protrude beyond the end of the screw. During engine inspections, multiple expanders have been found that have been modified by removal of up to half of the height of the expander. The FAA is currently not aware of any document, process or guidance that authorize removing material from the expander to meet the projection measurements. If, during inspection of an engine, an expander is found to have been modified in any way, the expander should be replaced. Continued use of an altered expander plug, which may not engage the proper amount of threads in the screw, could result in improper torque and subsequent fatigue failure of the screw.

- Certain maintenance actions accomplished between overhauls may provide visual access to the engine flyweights, i.e. cylinder replacement, etc. Owners, operators and repair facilities are urged to inspect the assemblies at those times for any signs of displacement of the screws, expanders, or flyweights. If any abnormalities are observed, the engine should be immediately removed from service and disassembled for further inspection, and the owner/operator should ensure that any affected flyweight screws and expanders are replaced.
- During overhaul these screws and expanders should be replaced with serviceable parts.
