**FAA  
Aviation Safety**

**SPECIAL AIRWORTHINESS  
INFORMATION BULLETIN**

**SUBJ:** Equipment / Furnishings - Restraint Systems

**SAIB:** 2026-10R1

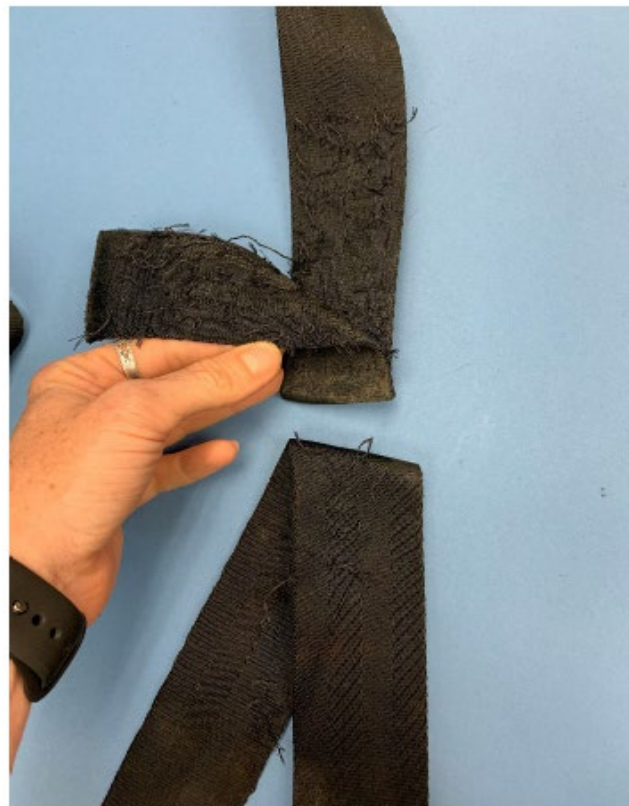
A search of NTSB public dockets identified at least fifteen other general aviation accidents resulting in full or partial failure of the occupants' restraint system. Many of these failures occurred at the Y-junction threading as shown in Figure 2. These accidents often involved serious or fatal injuries of the occupants. Further inspection of the accident findings revealed that these restraints are often designed to obsolete TSO requirements. Minimum torso restraint system performance requirements are currently prescribed in [TSO-C114](#) dated March 27, 1987. Minimum safety belt performance requirements are currently prescribed in [TSO-C22g](#) dated March 5, 1993. Both TSOs provide standards equivalent to SAE Aerospace Standard (AS) Document No. AS8043, "Torso

Figure 2  
Four-point restraint assembly with separation at shoulder harness Y-junction threading

- Perform routine preflight and annual visual inspections of both the shoulder and pelvic restraints to check for signs of wear, deformation, discoloration, defects, or fraying. Special attention should be paid to the threading on the Y-junction that separates the two shoulder straps and connects to the fuselage attach strap behind the occupant’s head as well as the fastener hardware.
- Report findings of damage to the FAA point of contact. Please include the make, model, and serial number of the restraint and aircraft; a description of the damage; photographs; recommended inspection techniques to locate the damage; the damaged parts’ time in service; and any other information that may assist in our evaluation of this issue.

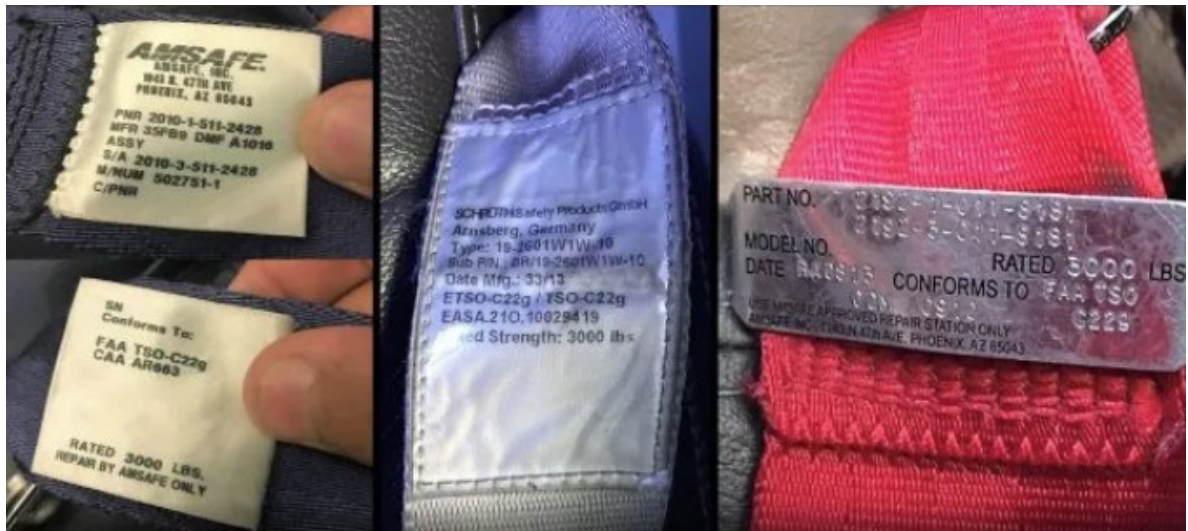
Figure 3  
Example label markings of restraints that do meet TSO-C114 or TSO-C22g requirements  
(Photo credit: AeroSavvy Aviation Insight)

- Positively identify that their restraints meet these minimum performance requirements through visual inspection of the manufacturer’s label markings on the restraint assemblies. These markings may list the TSO numbers and/or the rated strength of the restraint assembly. The assembly’s rated strength to meet the current performance requirements is 3000 lbs or more. Figure 3 and Figure 4 show examples of label markings of restraints which do and do not meet TSO-C114 or TSO-C22g requirements.

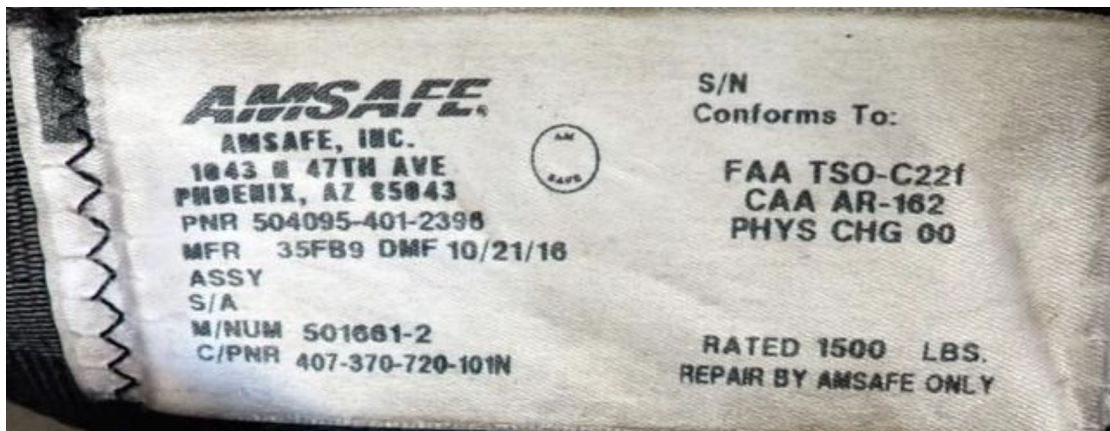
Figure 4  
Example label marking of restraint that does not meet TSO-C114 or TSO-C22g requirements

- Replace torso and pelvic restraints which are not labeled as meeting TSO-C114 or TSO-C22g or later revisions, respectively; which do not meet or exceed an assembly rated strength of 3000 lbs or more; or which have a missing, illegible, or unreadable label or marking on the restraints with restraints which meet these TSO minimum performance requirements.
