**SAIB:** 2026-16

**Date:** September 10, 2026

**SUBJ:** Elevator Control System

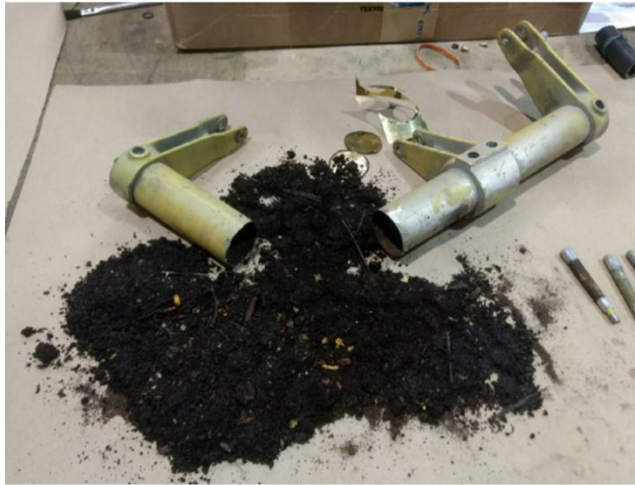
The FAA received a report of extensive corrosion on the inside of an elevator torque shaft on a Textron Aviation Inc. King Air Model A100 airplane that was manufactured in 1977. During a scheduled inspection, the elevator torque shaft was found to show signs of surface corrosion. Further investigation revealed extensive corrosion on the inside of the elevator torque shaft as shown in Figure 1. It was determined that the rig pin hole on the elevator torque shaft assembly is susceptible to water ingestion and accumulation. This condition has the potential to cause corrosion on the inner diameter of the elevator torque shaft and on the taper pins, as shown in Figure 2. A contributing factor to the severity of the corrosion is the absence of an established inspection procedure for the interior of the elevator torque shaft.

Figure 1  
Corrosion on the inside of elevator torque shaft

The FAA recommends inspection and replacement of the elevator torque shaft assembly in accordance with Beechcraft Mandatory Service Letter MTL-27-03, dated June 6, 2023.

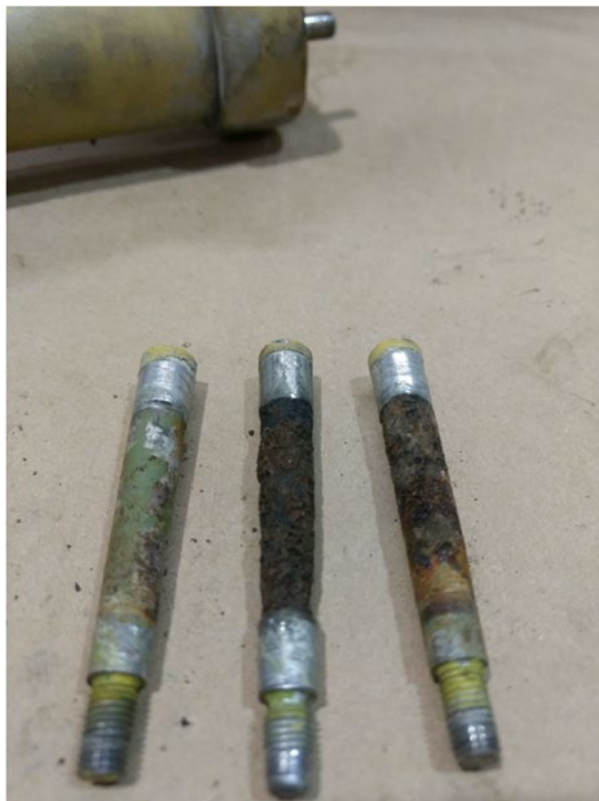
Figure 2  
2

Corroded taper pins
