| <b>Apex Aircraft</b><br>Bureau de Navigabilité<br>1, route de Troyes<br>21121 DAROIS - France<br>Tél +33 380 35 65 10<br>Fax +33 380 35 65 15<br>www.apex-aircraft.com | <b>S E R V I C E   B U L L E T I N</b><br><br>No. <b>030906</b> |
| <b>CAP10B - Wings - Inspection and service life</b> | <b>ATA : 050</b> |
| Supersedes : SB 16 all revs | |

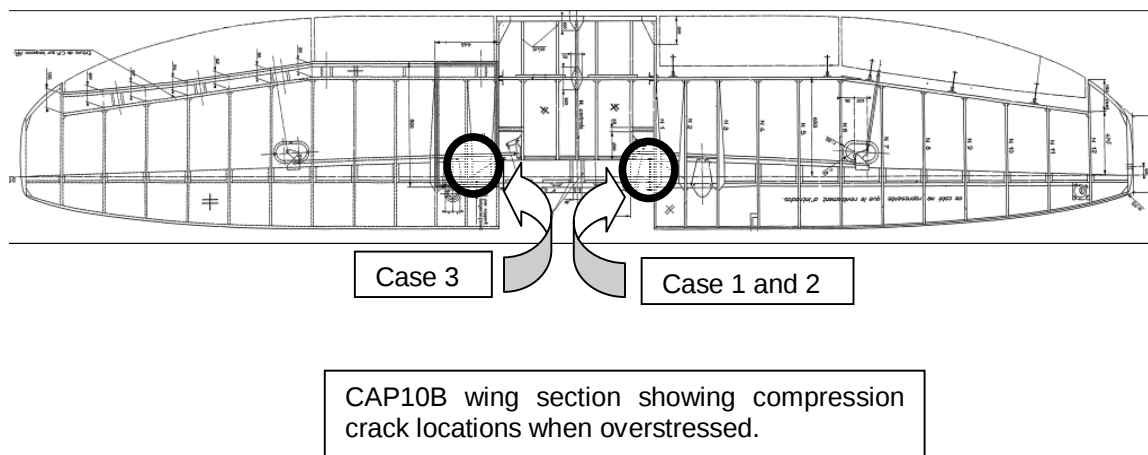
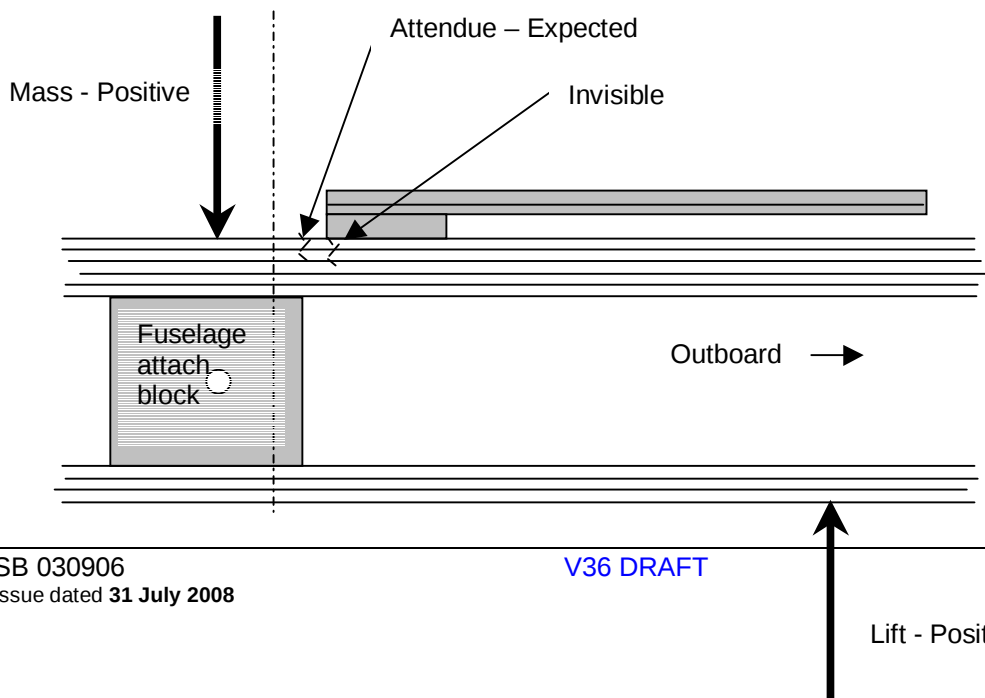
**CASE 1:** A fatal wing failure in Texas in June of 2003, was not prevented. In the Texas case, the wing failed at a pre-existing crack which was not in the Rib 1 inspection area. The crack was offset outboard slightly, possibly due to improper woodworking technique in the execution of SB 16, in 1992. When the skin and wingwalk support were routed to expose the likely area of compression cracks, the router cut some fibers of the spar cap. This 0.6 mm cutting of the spar may be commonplace, and only becomes an issue at overstress, when cracks begin. Such cracks are not visible because they start in the very corner of the inspection area.

The left spar failed at the edge of the inspection area, where a compression crack had failed the top one of five laminates completely, and progressed into the second laminate. This failure appears to pre-date the accident by some time.

On the right spar root, which did not fail, there was a visible compression crack. Also, there existed a larger compression crack in the right wing root hidden in the corner of the inspection area. The NTSB has recorded digital images.

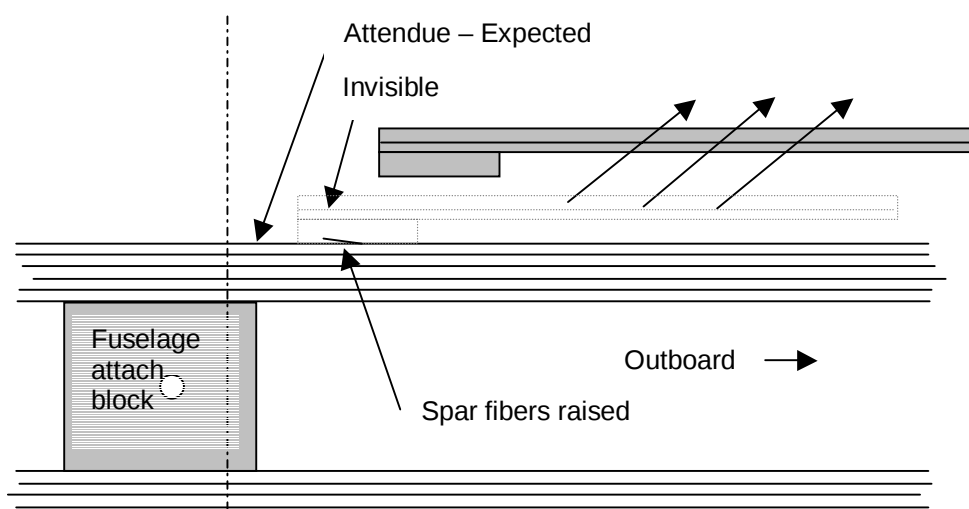
Shallow splits in the upper spar cap have been recently found between Rib 1 and 2 in two other CAP10B. The first became evident from detachment of the inboard forward end of the wing walk reinforcement. More significantly, the second of these had no evidence until the spar was uncovered. While these aircraft have previously been inspected for overloads, records were not kept of the load factor or masses involved. In both cases, the splits were less than 5 mm deep.

It is not certain that these splits are the result of tension from heavy negative flight loads, but this is the most likely reason. Preliminary experiments at Apex indicate that shear loads can create such splits. These could result from the wing-walk reinforcement, reacted by the wing-walk itself, shearing from the spar during heavy flexing loads.

This case causes the uncovering of the spar for all wooden spars

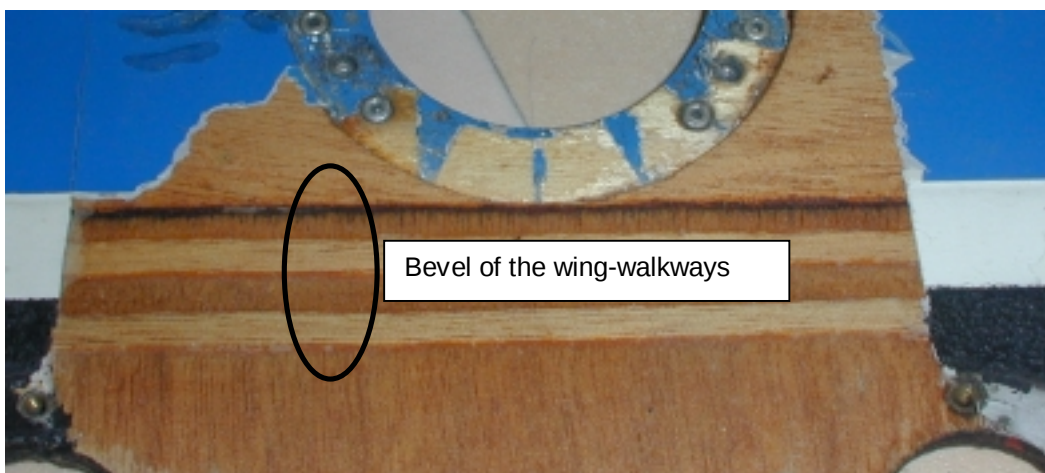
**Photo 1 :** part of wing-walkway bevel kept to trace the slope.

- a) Measure and record the slope of the wing-walkway bevel (for instance by keeping part of it) to allow preparing the replacement part (refer to following photo).

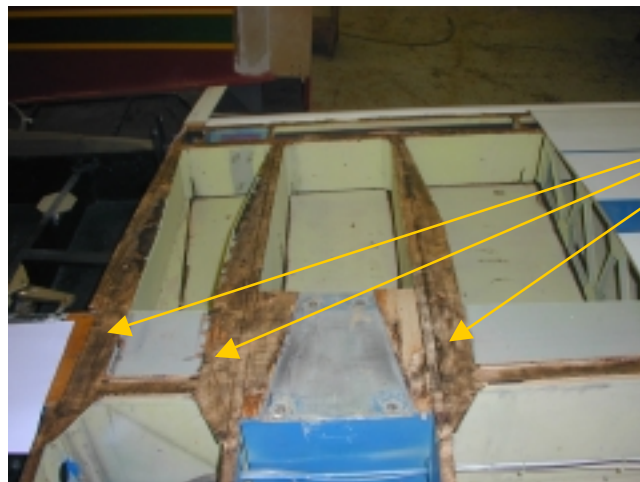
Wing-walkway  
reinforcement

**Photo 2 :** with skin removed.

Remove the wing upper surface skin from leading edge to trailing edge, from inboard of rib 4 to the fuselage on left and right, per illustration b. to do so, cut first between the ribs, then carefully remove the remaining skin from the ribs using chisel, scraper and sander. **Make sure not to damage the ribs.**

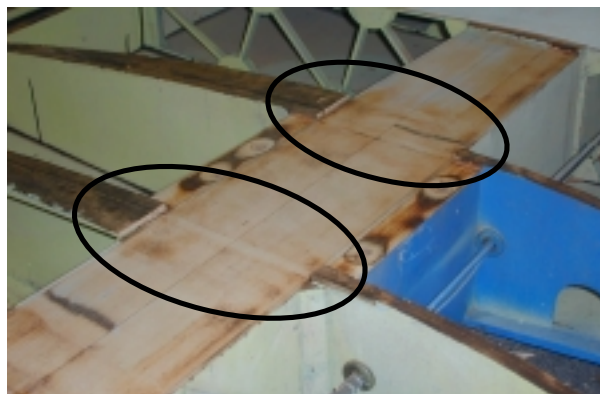
**Photo 3:** example of airplane with reinforcements in good condition. Therefore the only parts removed were covering the main spar.

- b) Tap test, and gently pull-test, all of the wingwalk reinforcements which are glued to spar. Log any locations where bond failure are suspected.
- c) Remove the reinforcements if any damage shown. If no damage shown, only cut and remove the parts of the reinforcements and the top of the ribs covering the main spar (refer to following example).
