SERVICE BULLETIN SUMMARY

### TITLE: NAVIGATION - GENERAL - REPLACE AOA PROBE CONIC PLATE BY AOA PROBE FLAT PLATE

SERVICE BULLETIN No.: A340-34-5093

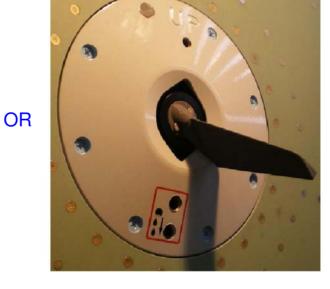
Figure A-FSAAA - Sheet 01

Following a recent in-service event, as a precautionary measure, Airbus requires to suspend the installation of the AOA (Angle Of Attack) conic plates as per Operator Information Transmission (OIT) No. 999.0086/12, currently performed through an Airbus monitored campaign with Service Bulletin No. A340-34-5081.

This modification requires the removal of the conic plates PN F3411060200000 and PN F3411060900000, and the installation of flat plates PN F3411007920200 (LH) / PN F3411007920300 (RH).

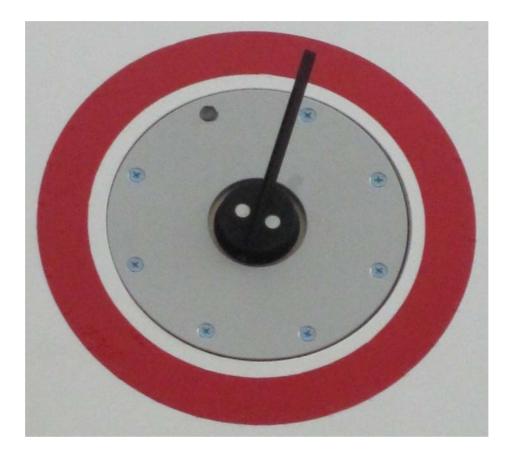
Figure A-FSAAA - Sheet 02

NEW AOA FLAT PLATES SHALL NOT BE PAINTED AND SHALL REMAIN AS DELIVERED.

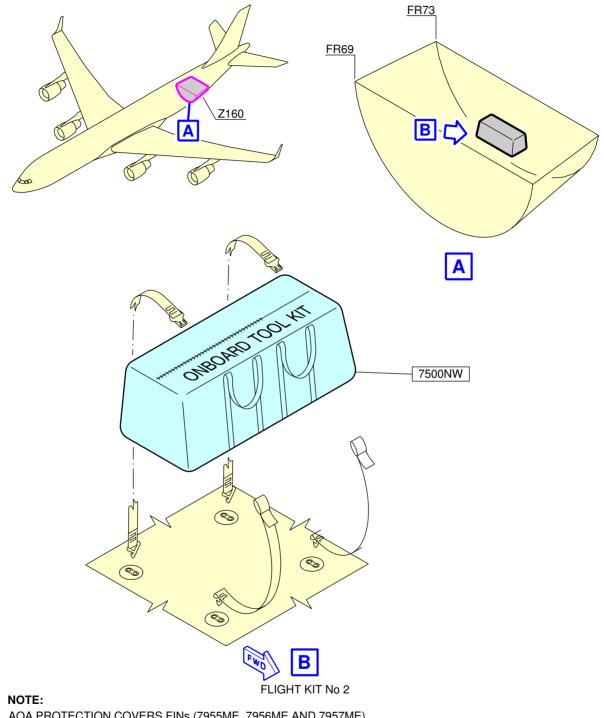
AOA PROTECTION COVERS FINs (7955ME, 7956ME AND 7957ME) ARE STORED IN FLIGHT KIT No 2 FIN (7500NW)

(3) Replace the AOA Protection Covers in the Flight Kit No 2 (FIN 7500NW).

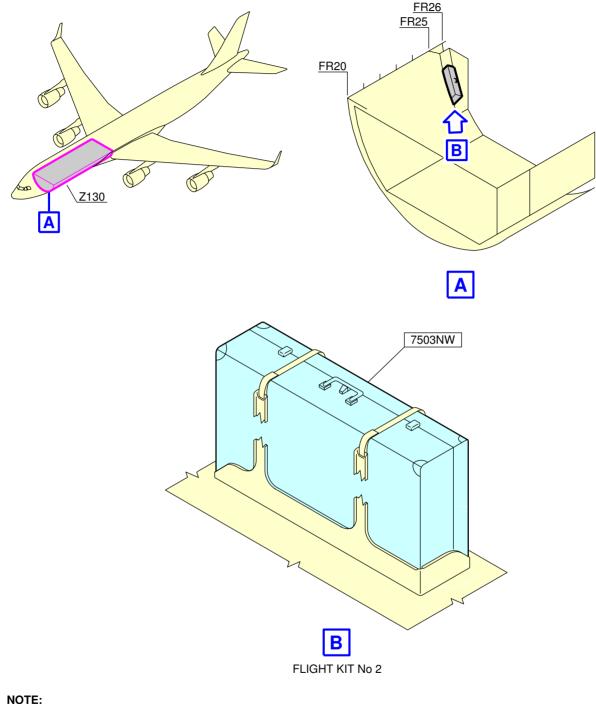
AOA PROTECTION COVERS FINs (7955ME, 7956ME AND 7957ME) ARE STORED IN FLIGHT KIT No 2 FIN (7503NW)

(3) Replace the AOA Protection Covers in the Flight Kit No 2 (FIN 7503NW).
