EASA Safety Information Bulletin

SIB No.: 2008-79
Issued: 19 August 2008

Subject: Unintended Single-Engine Take Off

Ref. Publication: Eurocopter Deutschland GmbH (ECD) Alert Service Information (ASI) EC135-A110 dated 15 July 2008.

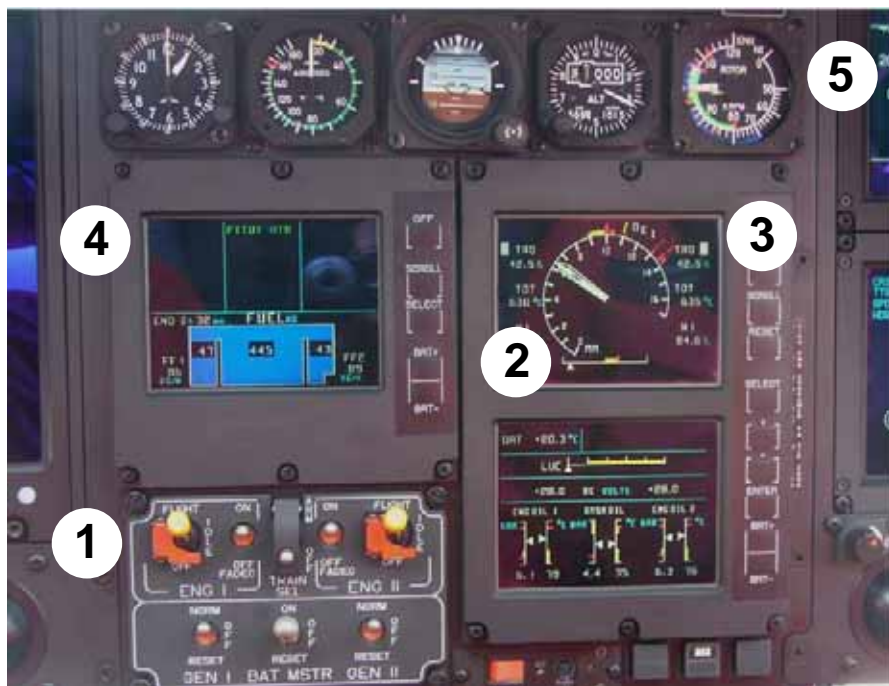
Indications during takeoff check with **both engines in FLIGHT**:

1. Position of both engine main switches in FLIGHT.
2. FLI needles matching, first limit to be checked TRQ.
3. FLI free of IDLE indication.
4. CAD free of cautions.
5. Triple RPM indicator check for N2 and rotor RPM to be matched.

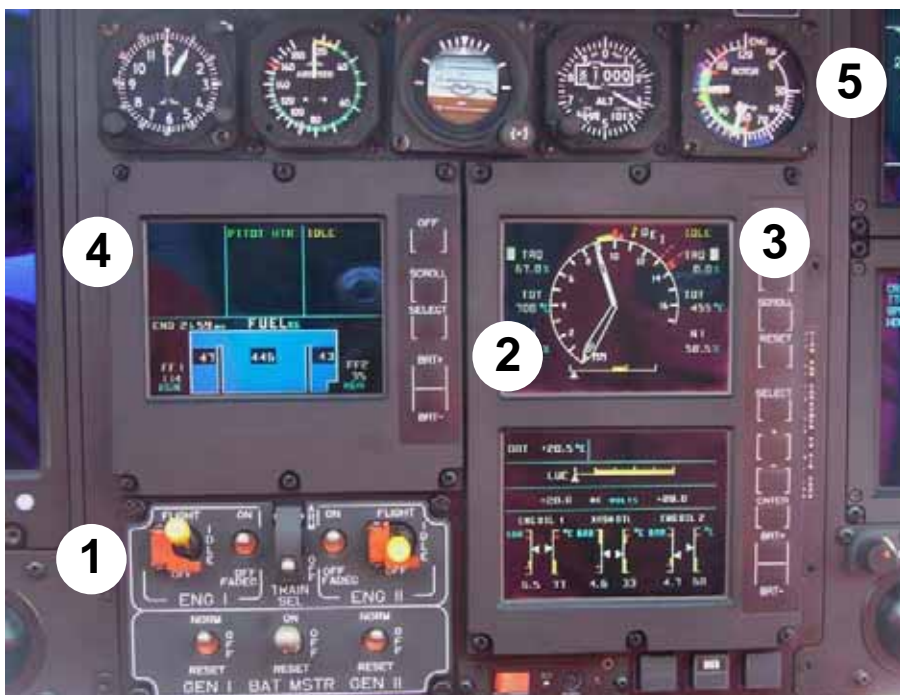
Indications during takeoff check with **one engine in IDLE**:

1. One engine main switch in IDLE.
2. FLI needle split.
3. FLI indicates IDLE.
4. CAD indicates IDLE.
5. Triple RPM indicator needle N2 and rotor RPM split.

Suggestion how to proceed in case of an unintended single engine takeoff:

- In case of OEI detection **before** Take Off Decision Point (TDP):

Collective Lever	– Adjustment to OEI limits or below Maintain N_{R0} 97%–103%
Ground Speed Prior to touchdown	– Reduce
Landing attitude	– Establish
Collective lever	– Raise as necessary to stop descent and cushion landing

- In case of OEI detection **after** Take Off Decision Point (TDP):

Collective Lever	– Adjustment to 30 sec. power Maintain N_{R0} 97%–103%
Speed	– Acceleration to V_{TOSS} (40KIAS)
Climb	– Initiate with V_{TOSS}
2nd engine	– Switch to FLIGHT
