## EASA Safety Information Bulletin

**SIB No.:** 2009-19  
**Issued:** 18 June 2009

**Subject:** Standard Practices - Turbine Engines Critical Parts Cleaning

**SUBJ:** Standard Practices/Structures – Engine Critical Parts Cleaning

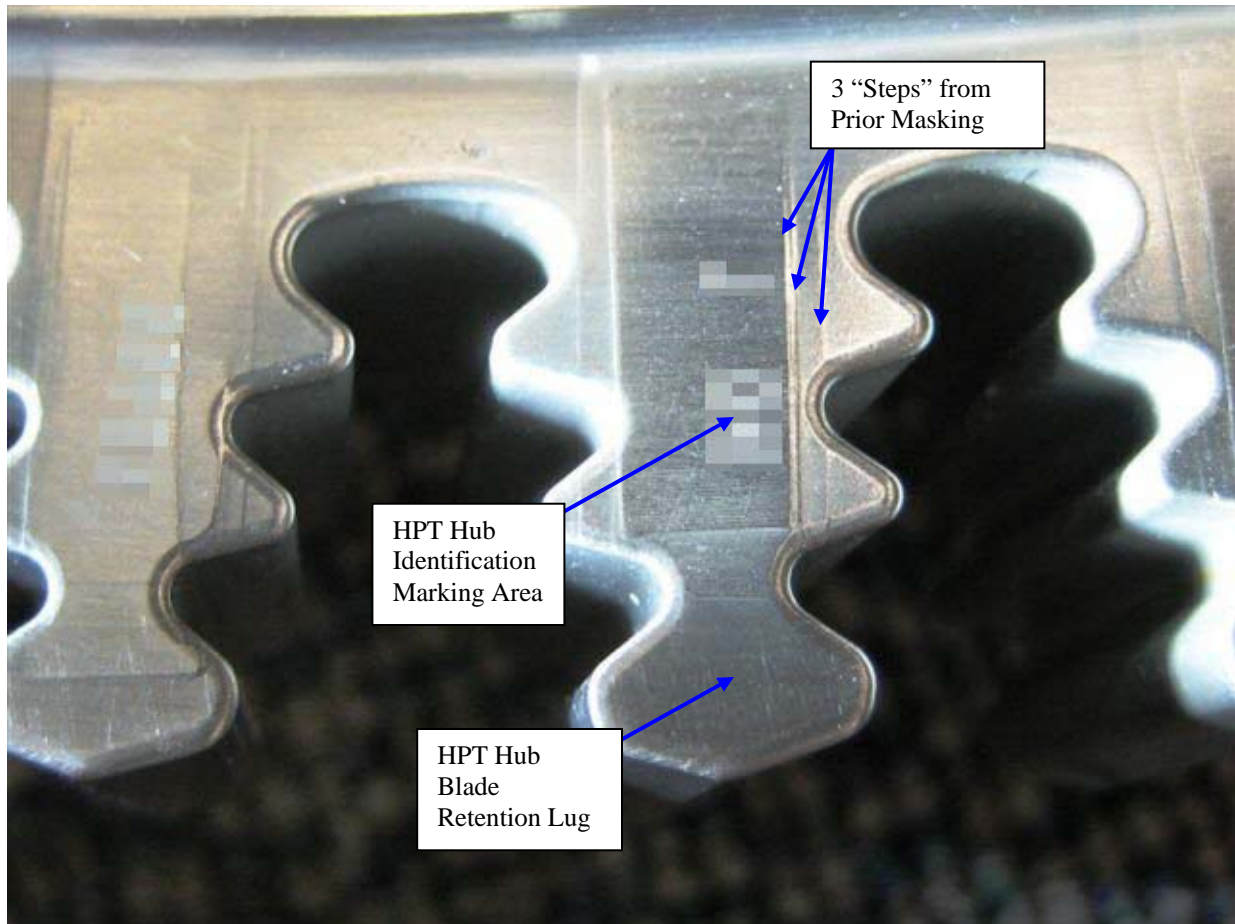
On August 6, 2008, a Pratt & Whitney model PW2037 turbofan engine experienced an uncontained failure of the high-pressure turbine (HPT) 2<sup>nd</sup> stage hub during takeoff. The root cause of the failure was determined to be associated with aggressive grit blast cleaning of the HPT hub at the prior shop visit. The aggressive grit blast removed an excessive amount of material in the hub blade retention lugs, which resulted in a significant increase in stress levels due to uneven loading transmitted by the turbine blades. High stresses resulted in cracking and separation of multiple blade retention lugs of the HPT hub and release of the HPT 2<sup>nd</sup> stage blades. The investigation concluded the root cause of the HPT hub failure to be due to a dimensional discrepancy of the hub blade retention lugs caused by aggressive grit blast cleaning. Further study of the grit blast cleaning procedure showed that excessive material removal can result if the manufacturers recommended control parameters are exceeded. This could also result in similar circumstances on other turbine engine parts that use a grit blast cleaning procedure.

2. Turbine engine repair stations should incorporate recurrent training programs for personnel that perform grit blast cleaning procedures.
3. Turbine engine repair stations should train inspectors and other appropriate personnel to be able to identify turbine engine critical rotating parts that might have been aggressively grit blasted. A visual inspection of part marking areas may provide evidence of potential aggressive grit blasting. If a “step” exists in the part marking area, the part may have been aggressively grit blasted (the step is a result of prior masking of part identification markings prior to performing grit blast cleaning, a typical standard shop practice). The sample photo in

Figure 1 shows a turbine disk that was aggressively grit blasted three times (3 individual “steps” can be seen in the photo).

**Figure 1 – HPT Hub Showing Evidence of Aggressive Grit Blast**

4. Parts which exhibit this “step” condition, as described in recommendation 3 above, should not be returned to service until a thorough evaluation is performed (which may include an extensive dimensional inspection of the part).
5. Anyone discovering suspected aggressive grit blasting on turbine engine critical rotating parts should forward information documenting the damage to the original engine manufacturer and the FAA Engine Certification Office.
