EASA Safety Information Bulletin

SIB No.: 2010-03
Issued: 13 October 2010

Subject: Carburetor Icing Prevention

Applicability: All piston engines with carburetors, installed on any aircraft.

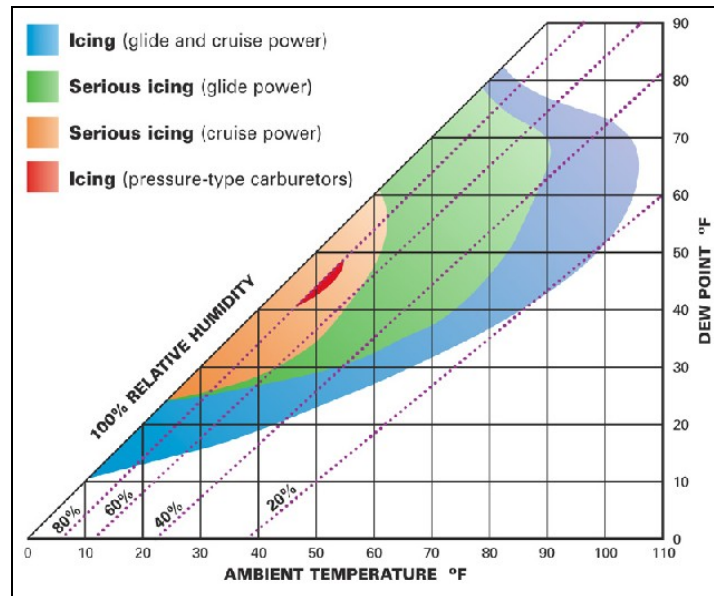
Pilots should be aware that carburetor icing doesn't just occur in freezing conditions, it can occur at temperatures well above freezing temperatures when there is visible moisture or high humidity. Icing can occur in the carburetor at temperatures above freezing because vaporization of fuel, combined with the expansion of air as it flows through the carburetor, (Venturi Effect) causes sudden cooling, sometimes by a significant amount within a fraction of a second. Carburetor ice can be detected by a drop in rpm in fixed pitch propeller airplanes and a drop in manifold pressure in constant speed propeller airplanes. In both types, usually there will be a roughness in engine operation. The graph below shows the probability of carburetor icing for various temperature and relative humidity conditions:
