EASA Safety Information Bulletin

SIB No.: 2010 – 06
Issued: 11 February 2010

Subject: Verification of the proper installation of Flight Control Cable–Turnbuckles

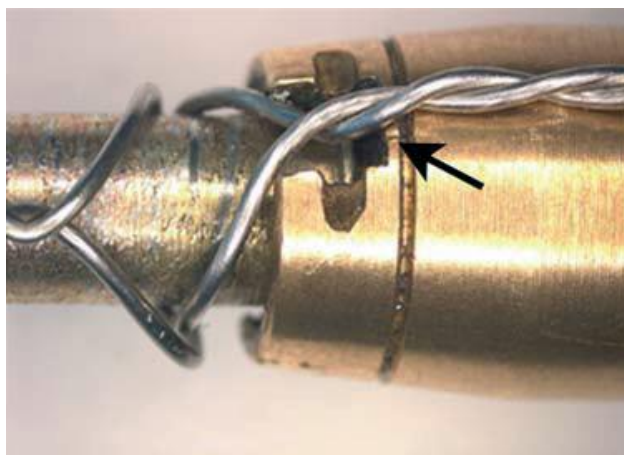
The probable cause of the accident was identified as the improper locking of a turnbuckle (Locking Clip missing) and subsequent inadvertent release of the pitch up control cable from the turnbuckle:

Fig. 1 Picture of the failed Turnbuckle: As shown in the red circle, the safety wire was cut by the groove originally designed to accommodate a locking clip. As a result, the flight control cable end at the right of the picture unscrewed and eventually got loose

- 1) At the next maintenance opportunity giving access to the turnbuckles of the flight control cables:
 - Determine whether the turnbuckles are designed to be locked with special locking devices, such as locking clips (i.e. are featuring grooves);

- In such cases, verify that the special locking devices are properly installed in the corresponding groove;
 - If the special locking devices are missing, install them in accordance with manufacturer's instructions and following standard maintenance practices;
