EASA Safety Information Notice

No.: 2008-28

Subject: Corrosion of #1 and #2 DC Starter/Generator Earth Points on Sikorsky S-76 Series Rotorcraft.

AWB 80-002 **Issue :** 1
Date : 03 April 2008

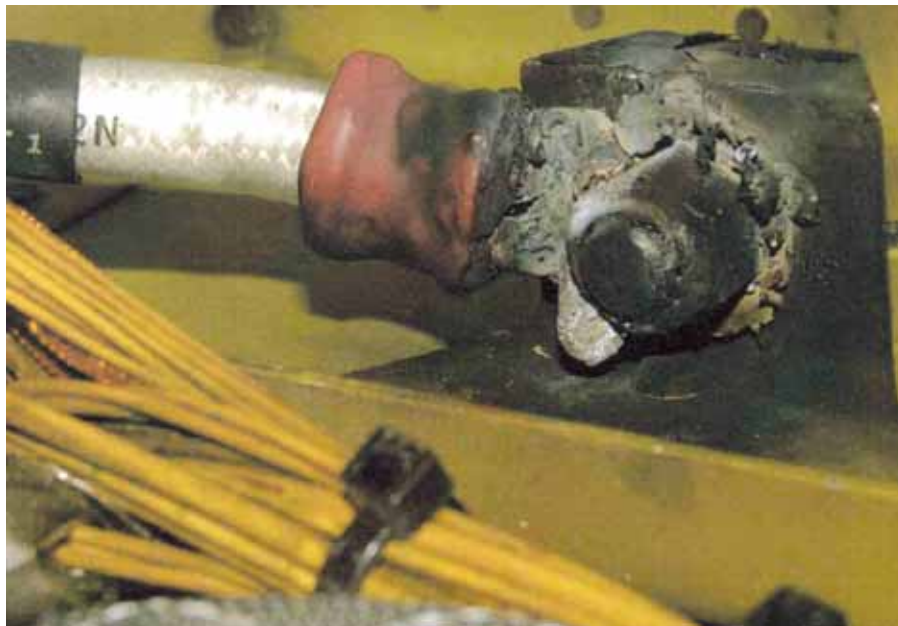
A recent investigation into the cause of a generator failure on a Sikorsky S76A rotorcraft, revealed that GRN FT1 and GRN FT 2 (#1 and #2 DC Starter/Generator earth points), had corroded and became loose, causing an open circuit which prevented the generator from operating.

Figure 1: Corroded and burnt Earth Terminal

- Have all DC Starter/Generator earth points inspected for correct torque and corrosion.
- Replace any DC Starter/Generator earth points which are found to be corroded or damaged.
- Re-torque and DC Starter/Generator earth points which are found to be loose or below recommended torque loading.
- Report all DC Starter/Generator earth points found to be corroded, under-torqued or damaged to CASA through the normal SDR reporting system.

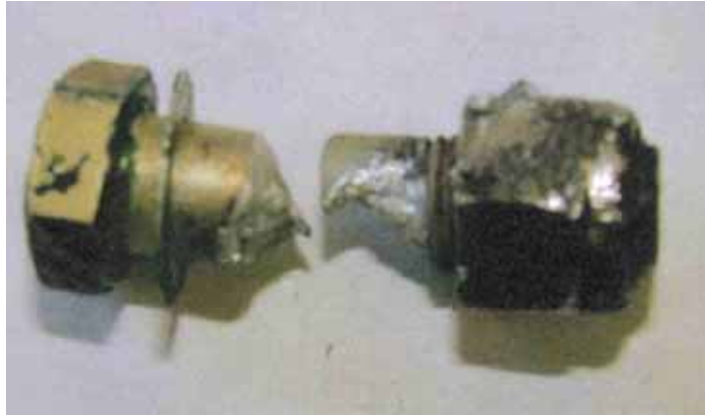
Figure 2: Corroded Earth Terminal Point
