EASA Safety Information

No.: 2006 - 03

Subject: Repairs for Messier-Bugatti carbon brakes by third parties invalidating the ETSO Authorisation

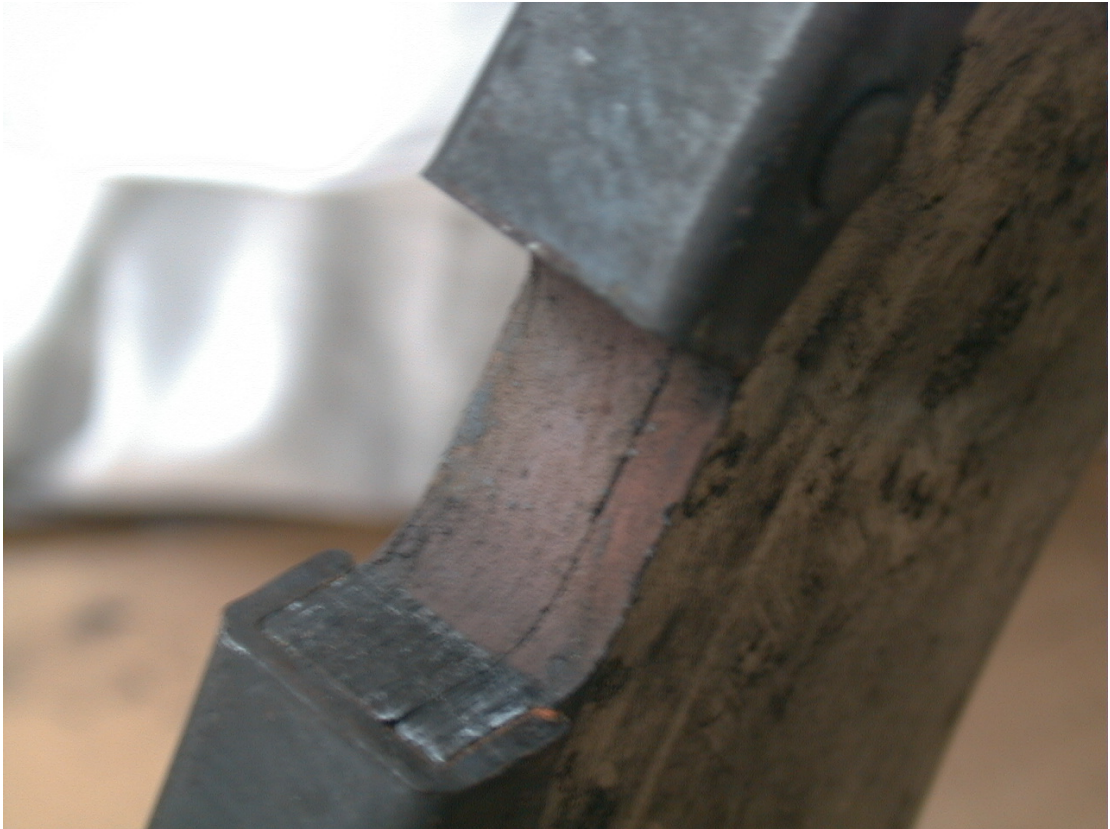
- C 3. modified dynamic thermal balance of disc resulting in well known reduced friction coefficient, and reduced braking performance.
Reported worn disc-half of extreme low thickness (1.5mm) could have resulted in disc failure with subsequent brake failure with total loss of brake efficiency and tire and wheel threats

Rotor R2 - Unbalanced " 2 for 1" + reddish Oxidation Inhibitor

Recommendation: In case a carbon brake that meets the above mentioned criteria and that still contains the ETSO marking is found, please report the case to EASA. In case you find a similar part, it should be tagged as not airworthy. Please inform EASA and the manufacturer immediately at the addresses stated below.

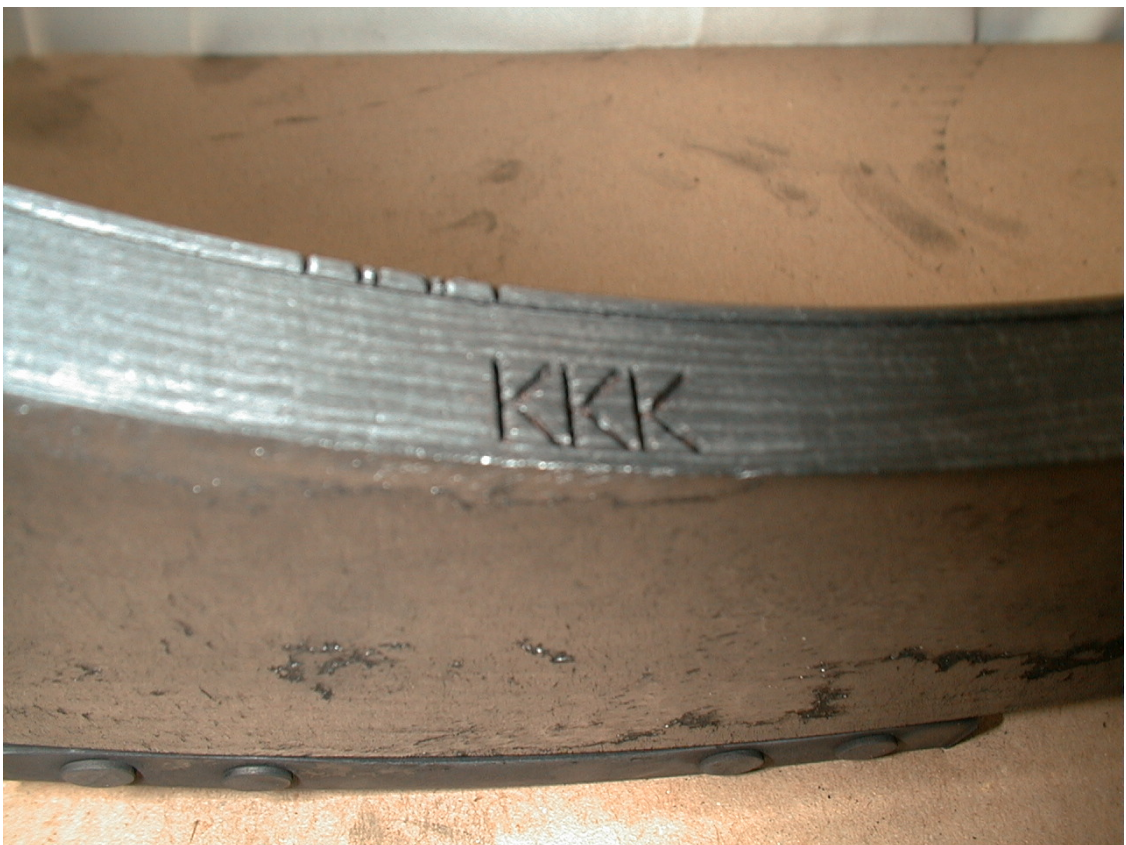
Rotor R2 - Unbalanced " 2 for 1" ($t_1=13\text{ mm}$ - $t_2=2.5\text{ mm}$)

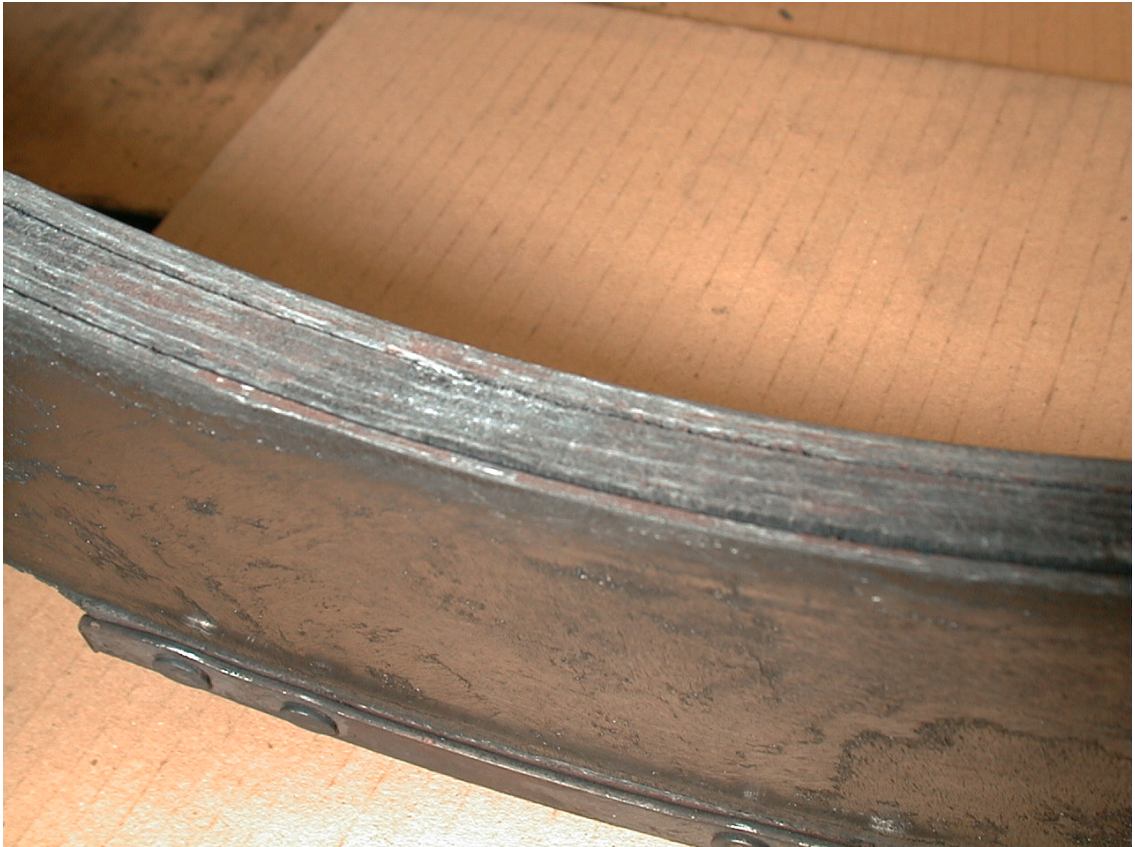
- C 4. thermal barriers created in disc by additional interfaces resulting in known loss of friction coefficient, much more severe than in above (c 3) also, same concern as above (c 3) regarding mechanical failure with much higher probability of occurrence

Rotor R1 – " 3 for 1" ($t=1.5$ -7- 2.5 mm) + reddish Ox. Inhib.

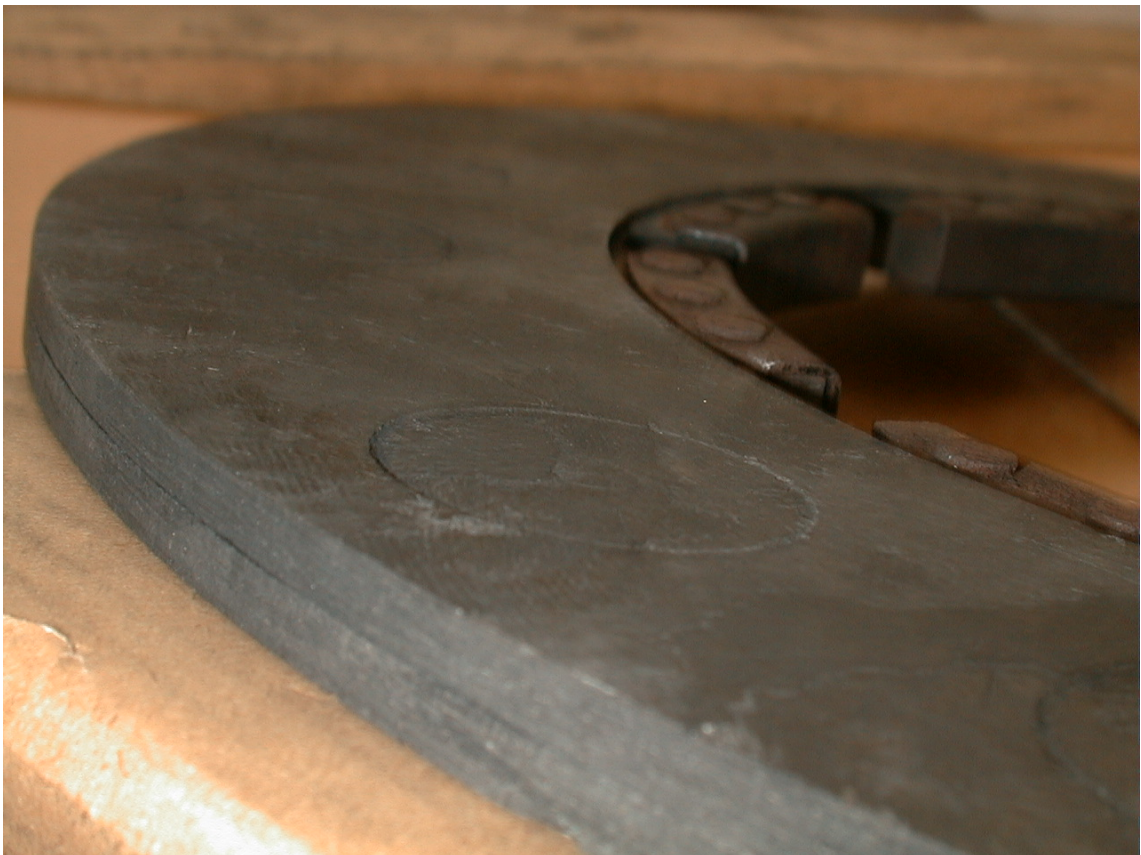
- C 5. thermal barrier created in stator disc by the interface resulting in known loss of friction coefficient
- C 6. untested configuration at Messier-Bugatti - expected loss of friction coefficient

Lateral Stator in 2 parts (unknown config.)

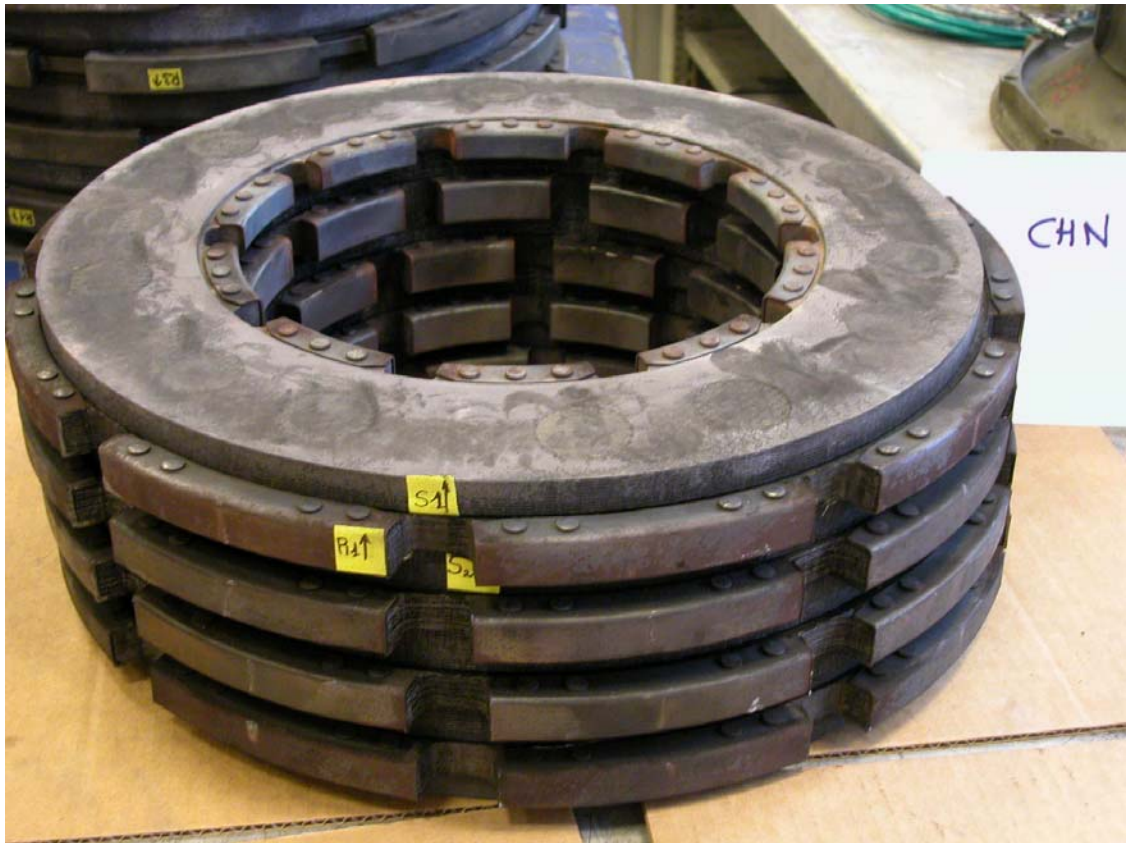
- C 7. new carbon material means new brake of totally unknown performances

Carbon Heat-Sink : Unknown carbon material
