SPECIAL AIRWORTHINESS
INFORMATION BULLETIN

SAIB: SW-09-44

SUBJ: Cabin door

This Special Airworthiness Information Bulletin (SAIB) informs you, owners or operators, of an airworthiness concern regarding possibility of separation of the cabin door while in flight for the following **Schweizer Models: 269A, TH-55A, 269A-1, 269B, 269C, serial numbers 001 through 1917, 269C-1, serial numbers 0001 through 347, and 269D, serial numbers 0001 through 0073.**

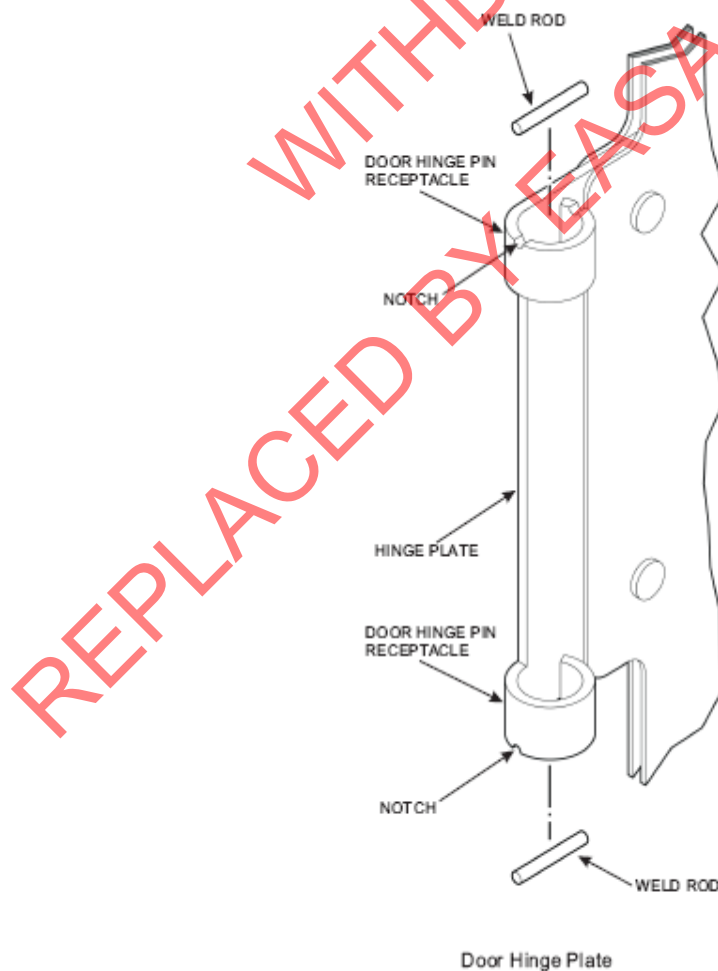
Since 2005, there have been several occurrences of the cabin door detaching from aircraft due to the serrated hinge pins coming off from the door hinge pins, allowing the door hinge pins to separate from the hinge pin receptacles on the cabin door. In December 2007, a cabin door was reported separated from an aircraft in flight as a result of separation of the serrated hinge pins from the door hinge pins. Schweizer decided a "fail safe" device was needed to preclude any future door losses, and the production hinges are now manufactured with caps to replace the open ends of the hinge pin receptacles. For those aircraft in the field, Schweizer issues service bulletins to provide an alternate method to retain the door hinge pins within the hinge pin receptacles for all affected aircraft. These service bulletins provide instructions to weld a stainless steel rod on the open ends of the hinge pin receptacles (Figure 1) to prevent the door hinge pins from falling out of the hinge pin receptacles when the serrated hinge pins are lost.

Figure1: Addition of rods to hinge pin receptacles per the service bulletin

We recommend all owners and operators comply with actions outlined in Schweizer Service Bulletins DB-026, C1B-028 and B-292 (as appropriate). It is recommended to conduct a visual check of the cabin door hinge installation before each flight until implementation of the appropriate service bulletin at the next available maintenance opportunity. The service bulletin action is not required when the new production hinge is installed.
