EASA	AIRWORTHINESS DIRECTIVE
 	<p>AD No.: 2009-0177</p> <p>Date: 05 August 2009</p> <p>Note: This Airworthiness Directive (AD) is issued by EASA, acting in accordance with Regulation (EC) No 216/2008 on behalf of the European Community, its Member States and of the European third countries that participate in the activities of EASA under Article 66 of that Regulation.</p>
<p>This AD is issued in accordance with EC 1702/2003, Part 21A.3B. In accordance with EC 2042/2003 Annex I, Part M.A.301, the continuing airworthiness of an aircraft shall be ensured by accomplishing any applicable ADs. Consequently, no person may operate an aircraft to which an Airworthiness Directive applies, except in accordance with the requirements of that Airworthiness Directive unless otherwise specified by the Agency [EC 2042/2003 Annex I, Part M.A.303] or agreed with the Authority of the State of Registry [EC 216/2008, Article 14(4) exemption].</p>

<p>Type Approval Holder's Name :</p> <p>None</p>	<p>Type/Model designation(s) :</p> <p>AS 202/15 "Bravo" aeroplanes</p>
SAS Number :	EASA SAS.A.067
Foreign AD :	Not applicable
Supersedure :	None
ATA 28	Fuel – Fuel Suction Tube – Inspections / Replacement
Manuf

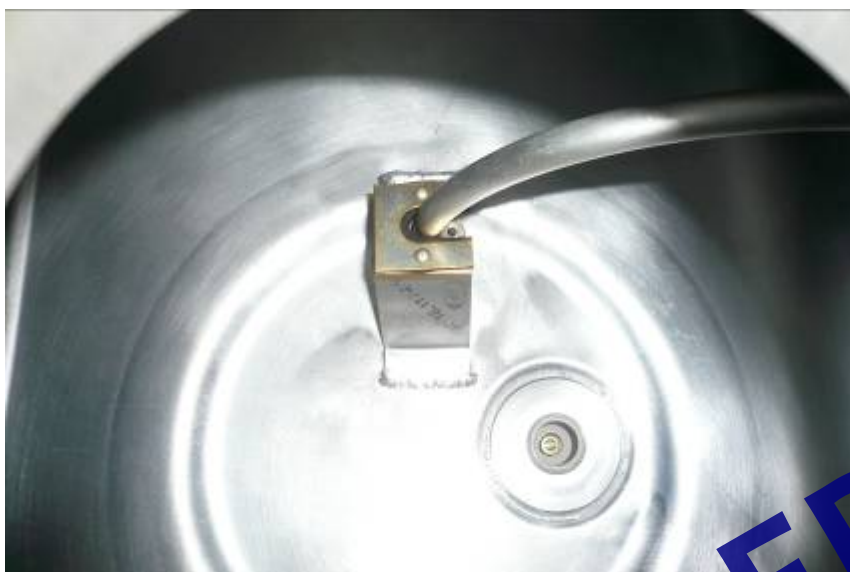
Photo 1

Area to be inspected as seen from top of the fuel tank with Fuel level sensor P/N SA 210-08095-01 removed

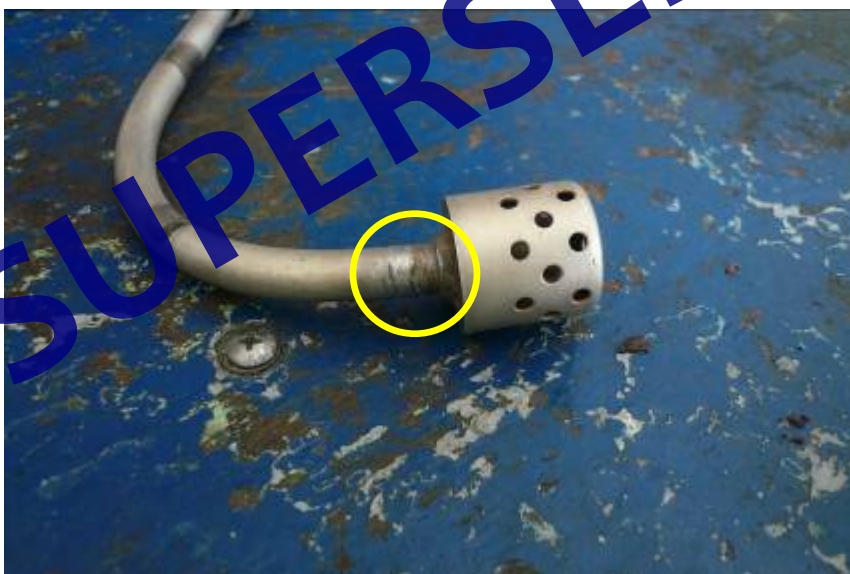
Photo 2

Example of signs of damage on Fuel suction tube assembly P/N SA202-18112-07

Effective Date:	19 August 2009
Required action(s) and Compliance Time(s):	<p>(1) Within 15 Flight Hours (FH) after the effective date of this AD, unless already accomplished within the last 50 FH, and thereafter at intervals not to exceed 500 FH from the last inspection, inspect for damage the fuel suction tube assembly P/N SA202-18112-07 in both fuel tanks.</p> <p>The fuel suction tubes are located inside the fuel tanks. To gain access, remove the fuel level sensor P/N SA210-08095-01 per chapter 28-40-01 of the AS 202 Shop Manual and Parts Catalogue. For the inspections, remove the fuel suction tube assembly and thoroughly inspect the interface area between the fuel suction tube assembly P/N SA202-18112-07 and its support P/N SA202-18112-25 (for the LH tank) and P/N SA202-18112-26 (for the RH tank).</p> <p>After reinstalling the fuel level sensor P/N SA210-08095-01 do a calibration test of the fuel indicating system per chapter 28-40-01 of the AS 202 Shop Manual and Parts Catalogue.</p> <p>(1.1) If any damage is found (dent, nick, fretting), before further flight replace the fuel suction tube assembly by a serviceable one or repair the fuel suction tube assembly in accordance with an approved-repair procedure.</p> <p>Note: See also photographs given in Appendix 1 of this AD.</p> <p>(2) The replacement or repair of the fuel suction tubes does not terminate the repetitive inspection requirements of paragraph (1) of this AD.</p> <p>(3) Within 30 days after any inspections, report all inspection results, negative or positive, to the Swiss Federal Office of Civil Aviation (FOCA). For that purpose, use the contact details as given in the 'Remarks' section of this AD.</p>
