| <b>EASA</b> | <b>AIRWORTHINESS DIRECTIVE</b> |
| | <p><b>AD No.: 2009-0233</b></p> <p><b>Date: 28 October 2009</b></p> <p>Note: This Airworthiness Directive (AD) is issued by EASA, acting in accordance with Regulation (EC) No 216/2008 on behalf of the European Community, its Member States and of the European third countries that participate in the activities of EASA under Article 66 of that Regulation.</p> |
| <b>ATA 28</b> | <b>Fuel – Fuel Suction Tube – Inspections / Replacement</b> |
| Applicability: | Model AS 202/15 and AS 202/18A aeroplanes, all serial numbers. |

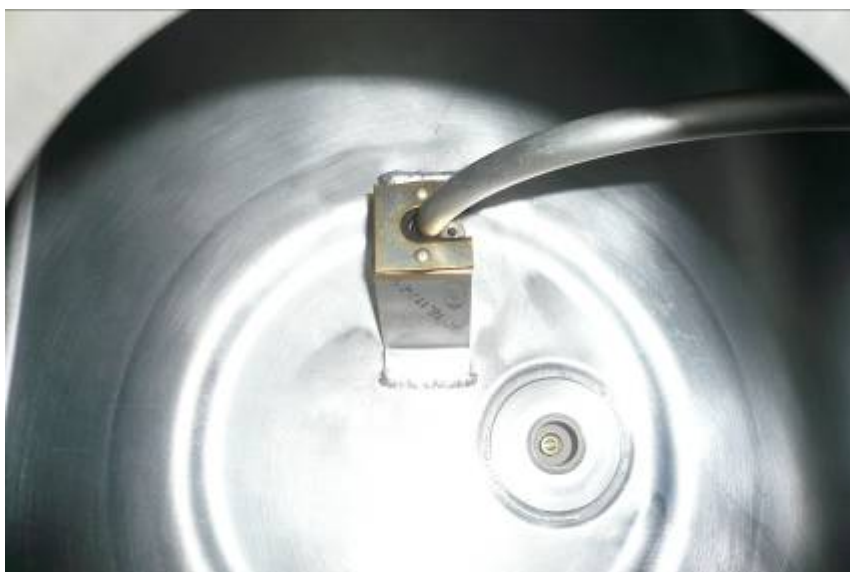
Photo 1

Area to be inspected as seen from top of the fuel tank with Fuel level sensor P/N SA 210-08095-01 removed

| Required action(s) and Compliance Time(s): | <p>(1) Within 15 Flight Hours (FH) after the effective date of this AD, unless already accomplished within the last 100FH, and thereafter at intervals not to exceed 500 FH from the last inspection, inspect for damage the fuel suction tube assembly P/N SA202-18112-07 in both fuel tanks.</p> <p>The fuel suction tubes are located inside the fuel tanks. To gain access, remove the fuel level sensor P/N SA210-08095-01 per chapter 28-40-01 of the AS 202 Shop Manual and Parts Catalogue. For the inspections, remove the fuel suction tube assembly and thoroughly inspect the interface area between the fuel suction tube assembly P/N SA202-18112-07 and its support P/N SA202-18112-25 (for the LH tank) and P/N SA202-18112-26 (for the RH tank).</p> <p>After reinstalling the fuel level sensor P/N SA210-08095-01 do a calibration test of the fuel indicating system per chapter 28-40-01 of the AS 202 Shop Manual and Parts Catalogue.</p> <p>(1.1) If any damage is found (dent, nick, fretting), before further flight replace the fuel suction tube assembly by a serviceable one or repair the fuel suction tube assembly in accordance with an approved-repair procedure.</p> <p>Note: See also photographs given in Appendix 1 of this AD.</p> <p>(2) The replacement or repair of the fuel suction tubes does not terminate the repetitive inspection requirements of paragraph (1) of this AD.</p> <p>(3) Within 30 days after any inspections, report all inspection results, negative or positive, to the Swiss Federal Office of Civil Aviation (FOCA). For that purpose, use the contact details as given in the 'Remarks' section of this AD.</p> |

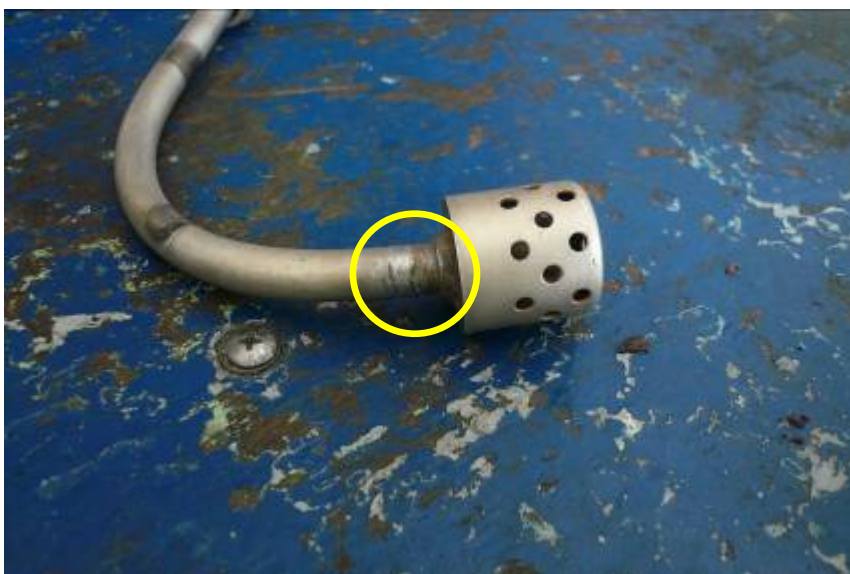
Photo 2

| Reason: | <p>Fuel suction tube assembly Part Number (P/N) SA202-18112-07 is mounted in Support P/N SA202-18112-25 (in the LH tank) and P/N SA202-18112-26 (in the RH tank). A rubber seal installed in the support is meant to prevent the suction tube assembly from fraying against the support.</p> <p>Fraying of the tube assembly against the support may cause the fuel suction tube to be damaged to such an extent that the metallic support protrudes inside the tube, therefore reducing the fuel flow section area. As a result insufficient fuel is delivered to the engine leading to fuel starvation.</p> <p>Investigation of a recent accident involving an AS 202/15 revealed that the above described failure condition was the most likely cause of the engine loss of power.</p> <p>AD 2009-0177 was issued to mandate initial and repetitive inspections of the fuel suction tube assemblies and the repair or replacement of any damaged fuel suction tube assemblies on all AS 202/15 aeroplanes.</p> <p>Further investigations revealed that the fuel tanks of the AS 202/18A aeroplanes are of a similar design to model AS 202/15 aeroplanes. For the reasons described above, this AD supersedes AD 2009-0177 and extends the requirements to model AS 202/18A aeroplanes.</p> |

Example of signs of damage on Fuel suction tube assembly P/N SA202-18112-07
