<b>EASA</b>	<b>AIRWORTHINESS DIRECTIVE</b>

<p><b>AD No.: 2010-0044R1</b></p> <p><b>Date: 19 September 2013</b></p> <p>Note: This Airworthiness Directive (AD) is issued by EASA, acting in accordance with Regulation (EC) No 216/2008 on behalf of the European Community, its Member States and of the European third countries that participate in the activities of EASA under Article 66 of that Regulation.</p>
<p>This AD is issued in accordance with EU 748/2012, Part 21.A.3B. In accordance with EC 2042/2003 Annex I, Part M.A.301, the continuing airworthiness of an aircraft shall be ensured by accomplishing any applicable ADs. Consequently, no person may operate an aircraft to which an AD applies, except in accordance with the requirements of that AD, unless otherwise specified by the Agency [EC 2042/2003 Annex I, Part M.A.303] or agreed with the Authority of the State of Registry [EC 216/2008, Article 14(4) exemption].</p>

<p><b>Type Approval Holder's Name :</b></p> <p>AIRBUS</p>	<p><b>Type/Model designation(s) :</b></p> <p>A340-200/-300 aeroplanes</p>
TCDS Number:	EASA.A.015
Foreign AD:	Not applicable
Revision:	This AD revises EASA AD 2010-0044 dated 17 March 2010, including the Correct

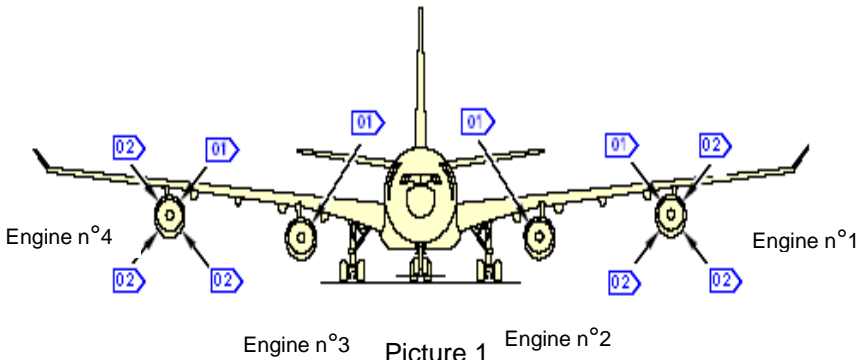
This AD is revised as, following its issuance, further investigation accomplished by Airbus have led to the conclusion that the modification as required by this AD removes the need for the repetitive operational tests as required by DGAC France AD 1999-265-117R2.
Effective Date:	Revision 1: 19 September 2013 Original Issue: 31 March 2010
Required Action(s) and Compliance Time(s):	<p>Required as indicated, unless already accomplished:</p> <ol style="list-style-type: none"> <li>(1) No later than 28 February 2011, do the actions specified in paragraph (3) of this AD on the upper inboard thrust reverser pivoting door of each engine, as identified by the label <b>01</b> in Picture 1 below.</li> <li>(2) No later than 31 December 2012, do the actions specified in paragraph (3) of this AD on the upper outboard thrust reverser pivoting doors of engines n°1 and n°4, and lower thrust reverser pivoting doors (inboard and outboard) of engines n°1 and n°4 as identified by the label <b>02</b> in Picture 1 below.</li> <li>(3) Replace the primary lock in accordance with the instructions defined in Airbus Service Bulletin (SB) A340-78-4037, and Remove the installed shim and replace the actuator in accordance with the instructions defined in Airbus SB A340-78-4038.</li> </ol> <div style="text-align: center;">
