EASA	EMERGENCY AIRWORTHINESS DIRECTIVE
 	AD No.: 2010-0063-E Date: 01 April 2010 Note: This Emergency Airworthiness Directive (AD) is issued by EASA, acting in accordance with Regulation (EC) No 216/2008 on behalf of the European Community, its Member States and of the European third countries that participate in the activities of EASA under Article 66 of that Regulation
This AD is issued in accordance with EC 1702/2003, Part 21A.3B. In accordance with EC 2042/2003 Annex I, Part M.A.301, the continuing airworthiness of an aircraft shall be ensured by accomplishing any applicable ADs. Consequently, no person may operate an aircraft to which an AD applies, except in accordance with the requirements of that AD, unless otherwise specified by the Agency [EC 2042/2003 Annex I, Part M.A.303] or agreed with the Authority of the State of Registry [EC 216/2008, Article 14(4) exemption].	
Type Approval Holder's Name : ATR - GIE Avions de Transport Régional	Type/Model designation(s) : ATR72-212A aeroplanes

TCDS Number : EASA.A.084	
Foreign AD : Not applicable	
Supersedure : None	
ATA 27	Flight Controls – Rudder Pedal Rods – Inspection / Replacement
Manufacturer(s):	ATR - GIE Avions de Transpo

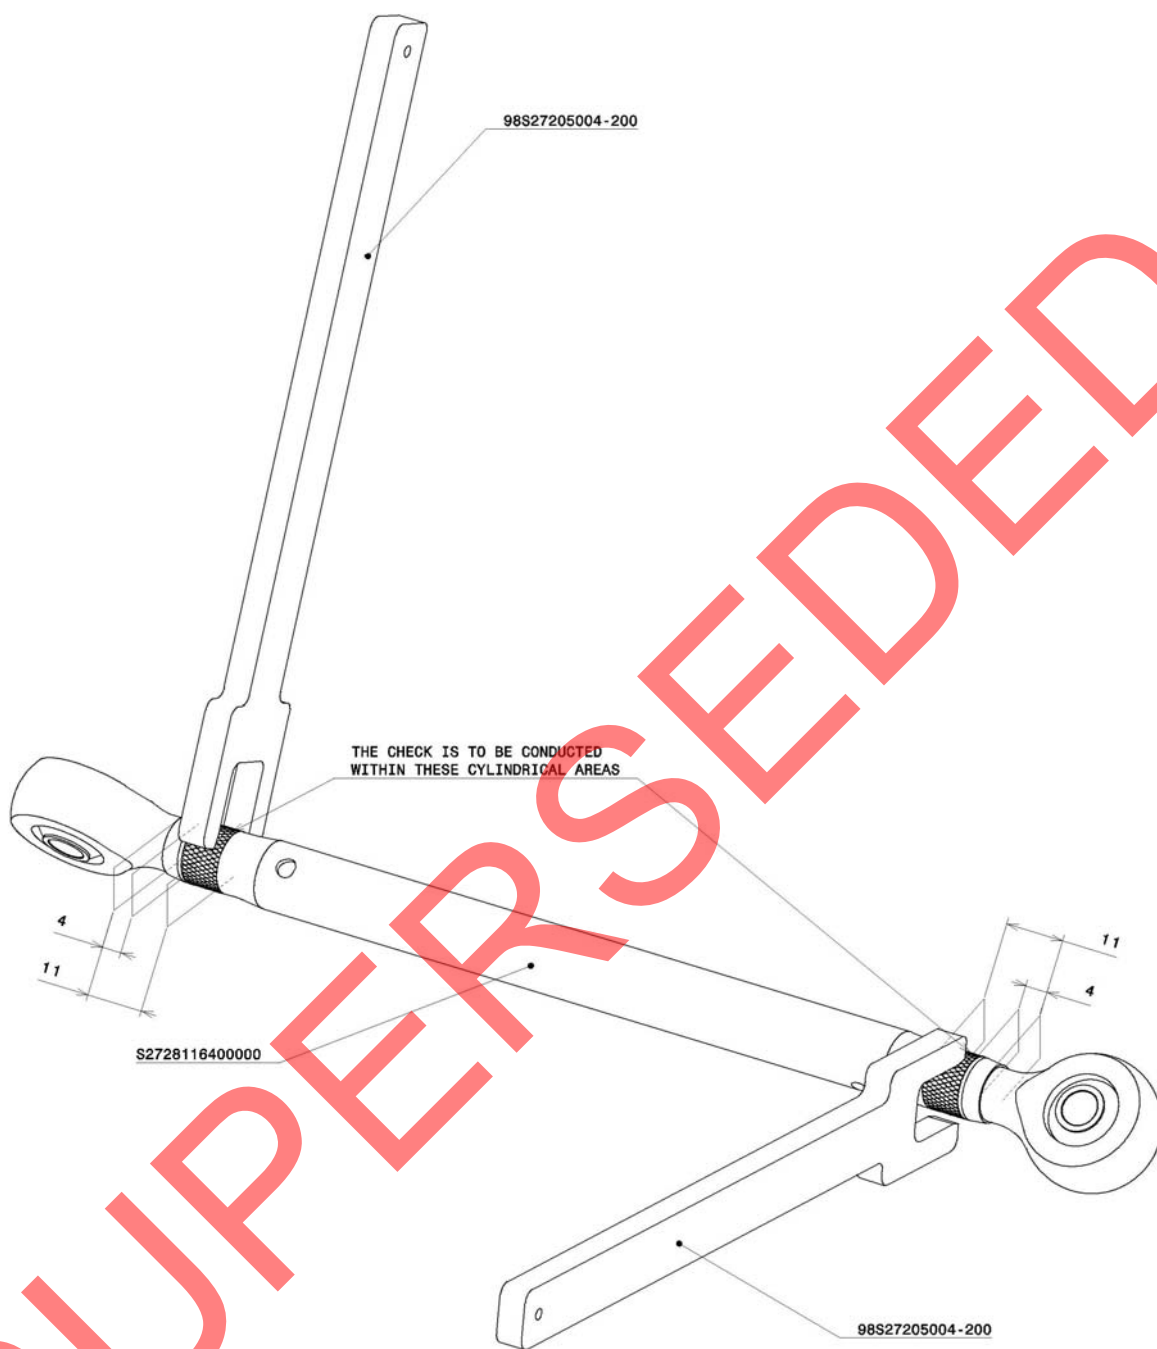
Appendix 1

Note: The design drawing of the rod specifies a diameter of 11 +/- 0.25 mm at this section.

- If the tool fits over the rod outer diameter, the rod must be replaced with a serviceable part.
- If the tool does not fit over the rod outer diameter, the rod can remain installed.
