EASA	AIRWORTHINESS DIRECTIVE
 	<p>AD No.: 2010-0183R1</p> <p>Date: 07 September 2010</p> <p>Note: This Airworthiness Directive (AD) is issued by EASA, acting in accordance with Regulation (EC) No 216/2008 on behalf of the European Community, its Member States and of the European third countries that participate in the activities of EASA under Article 66 of that Regulation</p>
<p>This AD is issued in accordance with EC 1702/2003, Part 21A.3B. In accordance with EC 2042/2003 Annex I, Part M.A.301, the continuing airworthiness of an aircraft shall be ensured by accomplishing any applicable ADs. Consequently, no person may operate an aircraft to which an AD applies, except in accordance with the requirements of that AD, unless otherwise specified by the Agency [EC 2042/2003 Annex I, Part M.A.303] or agreed with the Authority of the State of Registry [EC 216/2008, Article 14(4) exemption].</p>	
<p>Design Change Approval Holder : Agusta S.p.A. Keystone Helicopter Corporation Eurocopter UK Ltd</p>	<p>Type/Model designation(s) : AB139 and AW139 helicopters Sikorsky S-92A helicopters Eurocopter Deutschland MBB-BK117 C-2 and EC 135 helicopters</p>

<p>TCDS Number : EASA.R.006</p> <p>STC Numb

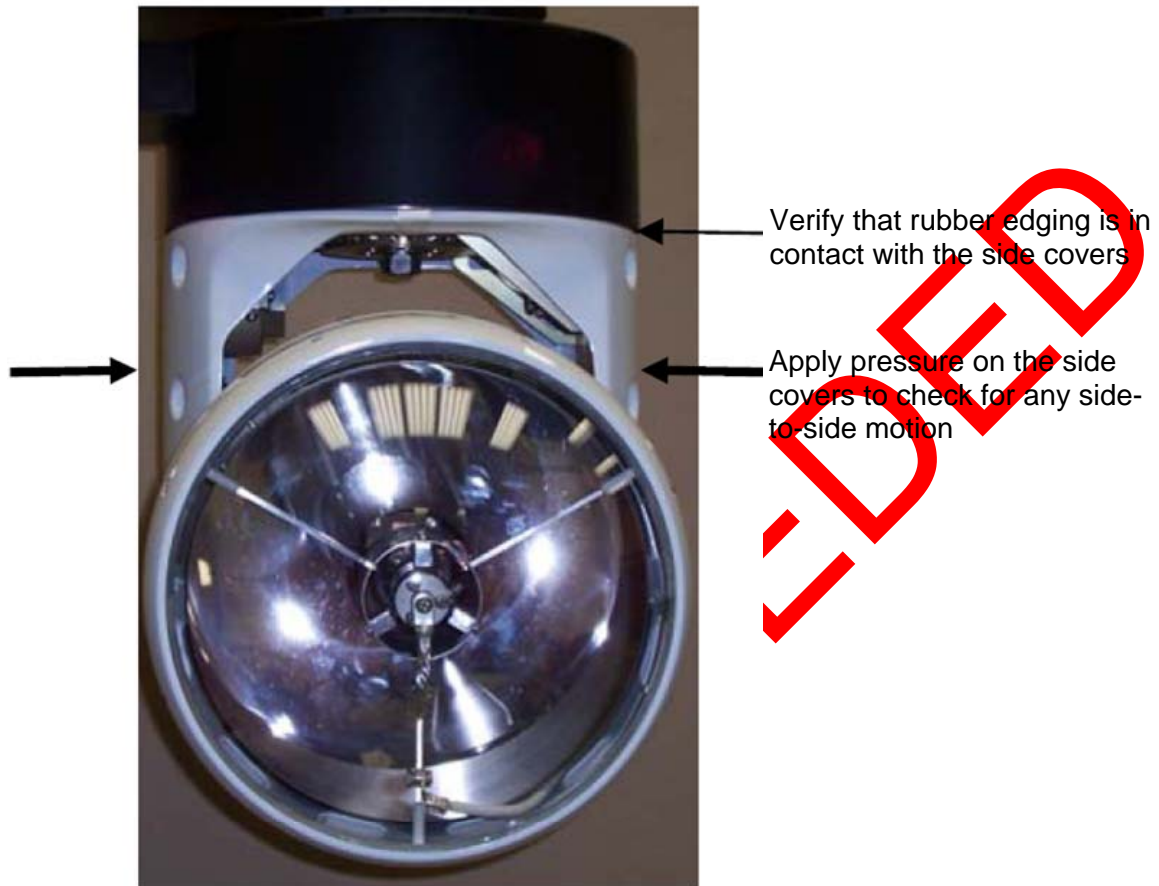
Appendix 1 – Photo showing location to be checked

Reason:	<p>An incident has been reported by a Maintenance Organisation of vibration associated with the Nightsun XP Searchlight. Investigation revealed that the Gimbal Azimuth Top Hex Nut was loose.</p> <p>This condition, if not detected and corrected, could lead to a gap between the rubber edging of the top shroud and the Gimbal frame, resulting in</p>

<p>degradation of pointing accuracy and stability performance and pose excessive vibration. If the nut were to entirely disengage, the Searchlight/Gimbal could disconnect from the helicopter and remain attached solely by the internal cable harness or separate totally, possibly resulting in damage to the helicopter or injury to persons on the ground.</p> <p>For the reasons described above, this AD requires repetitive pre-flight checks to verify correct installation and, if discrepancies are detected, the removal of the searchlight unit from the helicopter.</p> <p>This AD is considered to be an interim measure, until a modification has been developed, EASA approved and made available by the approval holder of the design change for in-service application.</p> <p>This AD has been revised to allow installation of replacement searchlight on already-modified helicopters. New installations remain prohibited, pending the availability of a design solution.</p>

Effective Date:	<p>Revision 1: 21 September 2010</p> <p>Original issue: 31 August 2010</p>
Required Action(s) and Compliance Time(s):	<p>Required as indicated, unless previously accomplished:</p> <p>(1) Before the next flight after 31 August 2010 [the effective date of the original issue of this AD], and thereafter before the first flight of each day, accomplish the following actions:</p> <p>(1.1) Visually check the searchlight installation Gimbal for a gap between the Top Shroud rubber edging (P/N 033381) and the side covers (P/N 033286). The edging should be in physical contact with the side covers.</p> <p>(1.2) Try to move the Searchlight laterally. No gap should appear between the Top Shroud rubber edging (P/N 033381) and the side covers (P/N 033286) and no play should be felt.</p> <p>Appendix 1 of this AD shows the area(s) to be checked.</p> <p>(2) If, during any of the checks as required by paragraph (1) of this AD, discrepancies are detected, before next flight, remove the searchlight assembly from the helicopter and contact the design (change) approval holder, as applicable to the installation.</p> <p>(3) From the effective date of this AD:</p> <p>(3.1) Do not install a Spectrolab Nightsun XP Gimbal Assembly P/N 033295 series on any helicopter as a replacement unit, unless the Gimbal assembly has passed the checks as required by paragraph (1) of this AD.</p> <p>(3.2) Do not modify a helicopter in accordance with any of the affected STC modifications or TC kit as affected by this AD.</p>
