EASA	AIRWORTHINESS DIRECTIVE

<p>AD No.: 2010-0237R1</p> <p>Date: 22 November 2010</p> <p>Note: This Airworthiness Directive (AD) is issued by EASA, acting in accordance with Regulation (EC) No 216/2008 on behalf of the European Community, its Member States and of the European third countries that participate in the activities of EASA under Article 66 of that Regulation</p>									
<p>This AD is issued in accordance with EC 1702/2003, Part 21A.3B. In accordance with EC 2042/2003 Annex I, Part M.A.301, the continuing airworthiness of an aircraft shall be ensured by accomplishing any applicable ADs. Consequently, no person may operate an aircraft to which an AD applies, except in accordance with the requirements of that AD, unless otherwise specified by the Agency [EC 2042/2003 Annex I, Part M.A.303] or agreed with the Authority of the State of Registry [EC 216/2008, Article 14(4) exemption].</p>										
<p>Design Change Approval Holder : Agusta S.p.A. Keystone Helicopter Corporation Eurocopter UK Ltd</p>	<p>Type/Model designation(s) : AB139 and AW139 helicopters Sikorsky S-92A helicopters Eurocopter Deutschland MBB-BK117 C-2 and EC 135 helicopters</p>									
<p>TCDS Number : EA

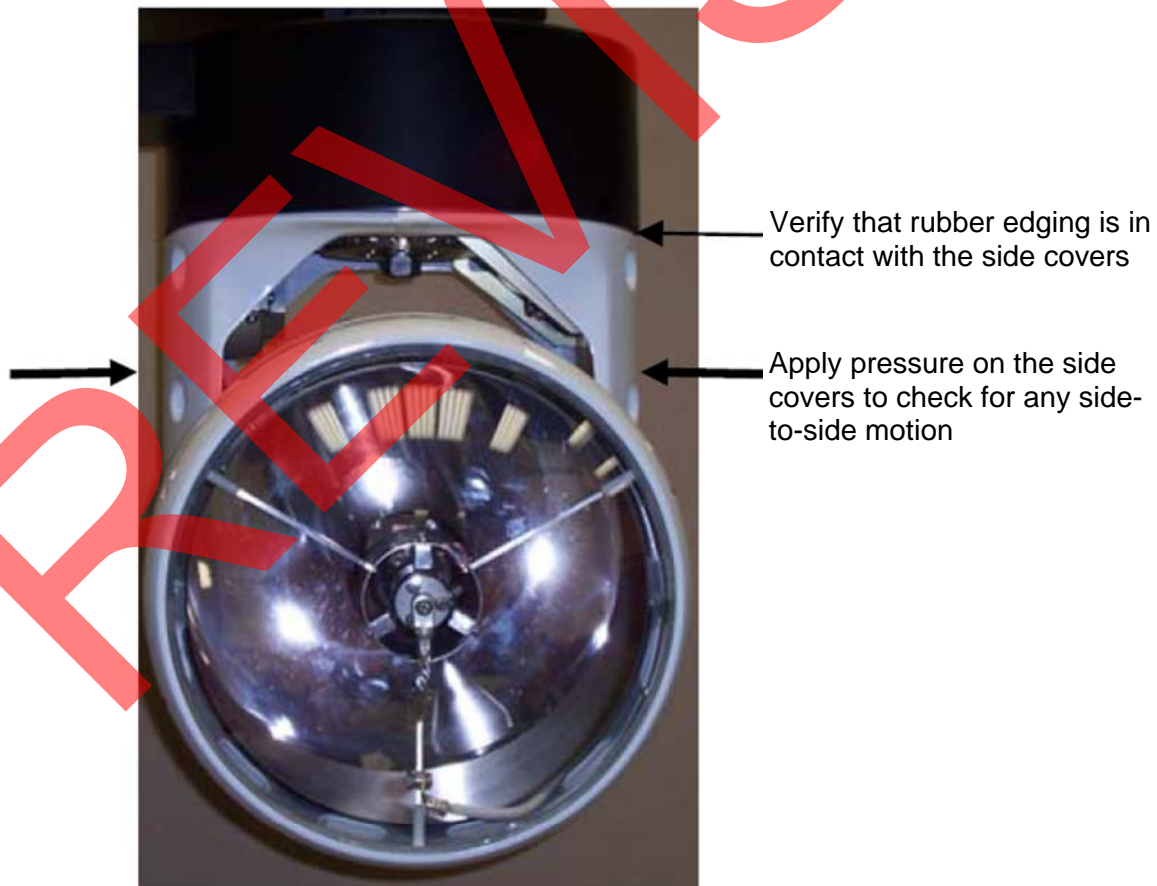
Appendix 1 – Photo showing location to be checked

Reason:	<p>An incident has been reported by a Maintenance Organisation of vibration associated with the Nightsun XP Searchlight. Investigation revealed that the Gimbal Azimuth Top Hex Nut was loose.</p> <p>This condition, if not detected and corrected, could lead to a gap between the rubber edging of the top shroud and the Gimbal frame, resulting in degradation of pointing accuracy and stability performance and pose excessive vibration. If the nut were to entirely disengage, the Searchlight/Gimbal could disconnect from the helicopter and remain attached solely by the internal cable harness or separate totally, possibly resulting in damage to the helicopter or injury to persons on the ground.</p> <p>EASA issued Emergency AD 2010-0183-E, later revised, as an interim measure to require repetitive inspections and, depending on findings, the removal of the searchlight from the helicopter.</p> <p>Spectrolab, the Searchlight manufacturer, has now developed a modification of the Searchlight installation that remedies the problem by replacing the Nightsun XP gimbal azimuth top hex nut with a dual-locking nut. This action includes re-identification of the gimbals as either P/N 033295-3 or P/N 033295-4 and assigns accordingly a new airworthy revision standard to the P/N of the modified Nightsun XP Searchlight Assembly.</p> <p>One of the affected approval holders, Eurocopter UK Ltd, subsequently developed the EASA-approved modifications which allow embodiment of the Spectrolab design changes on helicopters modified by Eurocopter UK STC.</p> <p>For the reasons described above, EASA AD 2010-0237 was issued, retaining the inspection requirements of AD 2010-0183R1, which was superseded, required removing the searchlight from the helicopter and allowed, for the affected Eurocopter Deutschland GmbH helicopters, modification of the searchlight installation by installing a modified searchlight assembly, having a higher revision standard and a new P/N Gimbal assembly.</p> <p>Since AD 2010-0237 was published, the other affected approval holders have developed their own modifications, which have been approved by EASA, to allow embodiment of the Spectrolab design change on Agusta AB139 and AW139 helicopters, and on Sikorsky S-92A helicopters modified by Keystone STC, respectively.</p> <p>This AD is therefore revised to include reference to Agusta Bollettino Tecnico (BT) 139-231 and Keystone Helicopter Corporation Service Bulletin (SB) 10-11 revision C, which provide the terminating action instructions for the AB139, AW139 and S-92A helicopters affected by this AD. In addition, this AD reduces the applicability to helicopters that have Gimbal Assembly P/N and Searchlight Assembly P/N as defined in Table 1 of the Applicability section of this AD.</p>

Effective Date:	<p>Revision 1: 06 December 2010</p> <p>Original issue: 30 November 2010.</p>
Required Action(s) and Compliance Time(s):	<p>Required as indicated, unless previously accomplished:</p> <p>(1) Before the next flight after 31 August 2010 [the effective date of EASA AD 2010-0183-E], and thereafter before the first flight of each day, accomplish the following actions:</p> <p>(1.1) Visually check the searchlight installation Gimbal for a gap between the Top Shroud rubber edging (P/N 033381) and the side covers (P/N 033286). The edging should be in physical contact with the side covers.</p> <p>(1.2) Try to move the Searchlight laterally. No gap should appear between the Top Shroud rubber edging (P/N 033381) and the side covers (P/N 033286) and no play should be felt.</p>

<p>Appendix 1 of this AD shows the area(s) to be checked.</p> <p>(2) If, during any of the checks as required by paragraph (1) of this AD discrepancies are detected, before next flight, remove the searchlight assembly from the helicopter and contact the design (change) approval holder, as applicable to the installation.</p> <p>(3) Within 30 days after 30 November 2010 [the effective date of the original issue of this AD], irrespective of findings, remove the searchlight assembly from the helicopter, as applicable to the installation, or,</p> <p>(3.1) For Eurocopter Deutschland GmbH helicopters, install a P/N 033338 Revision F Searchlight Assembly, in accordance with the instructions of Eurocopter UK Ltd Service Bulletin (SB) 135787-467, SB 1351151-472, or SB 1451167-473, as applicable to helicopter Model.</p> <p>(3.2) For Agusta helicopters, install a P/N 033338 Revision F Searchlight Assembly, in accordance with the instructions of Agusta BT 139-231.</p> <p>(3.3) For Sikorsky helicopters, install a P/N 033338-3 Revision E Searchlight Assembly, or a P/N 033704 Revision D Searchlight Assembly, as applicable to the installation, in accordance with the instructions of Keystone Helicopter Corporation SB 10-11 rev. C.</p> <p>(4) Modification of a helicopter as required by paragraph (3) of this AD constitutes terminating action for the repetitive inspection requirements of this AD.</p> <p>(5) From the effective date of this AD:</p> <p>(5.1) Do not install a Spectrolab Nightsun XP Gimbal Assembly P/N 033295-1 or P/N 033295-2 on any helicopter as a replacement unit.</p> <p>(5.2) Do not modify a helicopter by installing a Spectrolab Nightsun XP Searchlight Assembly affected by this AD, unless in compliance with paragraph (3.1), (3.2), or (3.3) of this AD, as applicable to helicopter type.</p>
