EASA	AIRWORTHINESS DIRECTIVE
 	<p>AD No.: 2010-0237</p> <p>Date: 16 November 2010</p> <p>Note: This Airworthiness Directive (AD) is issued by EASA, acting in accordance with Regulation (EC) No 216/2008 on behalf of the European Community, its Member States and of the European third countries that participate in the activities of EASA under Article 66 of that Regulation</p>
<p>This AD is issued in accordance with EC 1702/2003, Part 21A.3B. In accordance with EC 2042/2003 Annex I, Part M.A.301, the continuing airworthiness of an aircraft shall be ensured by accomplishing any applicable ADs. Consequently, no person may operate an aircraft to which an AD applies, except in accordance with the requirements of that AD, unless otherwise specified by the Agency [EC 2042/2003 Annex I, Part M.A.303] or agreed with the Authority of the State of Registry [EC 216/2008, Article 14(4) exemption].</p>	
<p>Design Change Approval Holder : Agusta S.p.A. Keystone Helicopter Corporation Eurocopter UK Ltd</p>	<p>Type/Model designation(s) : AB139 and AW139 helicopters Sikorsky S-92A helicopters Eurocopter Deutschland MBB-BK117 C-2 and EC 135 helicopters</p>

<p>TCDS Number : EASA.R.006</p> <p>STC Numbers

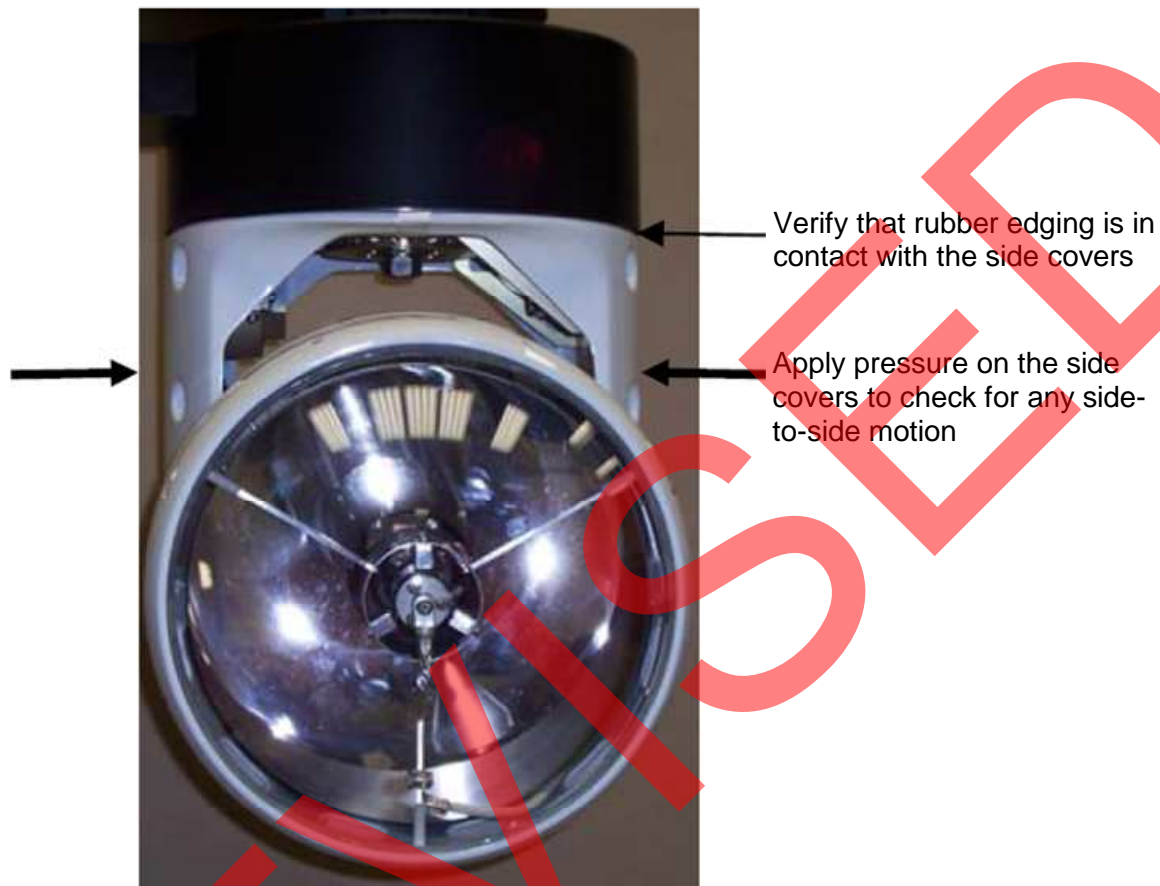
Appendix 1 – Photo showing location to be checked

Reason:	<p>An incident has been reported by a Maintenance Organisation of vibration associated with the Nightsun XP Searchlight. Investigation revealed that the Gimbal Azimuth Top Hex Nut was loose.</p> <p>This condition, if not detected and corrected, could lead to a gap between the rubber edging of the top shroud and the Gimbal frame, resulting in degradation of pointing accuracy and stability performance and pose</p>

Effective Date:	30 November 2010.
Required Action(s) and Compliance Time(s):	<p>Required as indicated, unless previously accomplished:</p> <ol style="list-style-type: none"> (1) Before the next flight after 31 August 2010 [the effective date of EASA AD 2010-0183-E], and thereafter before the first flight of each day, accomplish the following actions: <ol style="list-style-type: none"> (1.1) Visually check the searchlight installation Gimbal for a gap between the Top Shroud rubber edging (P/N 033381) and the side covers (P/N 033286). The edging should be in physical contact with the side covers. (1.2) Try to move the Searchlight laterally. No gap should appear between the Top Shroud rubber edging (P/N 033381) and the side covers (P/N 033286) and no play should be felt. <p>Appendix 1 of this AD shows the area(s) to be checked.</p> (2) If, during any of the checks as required by paragraph (1) of this AD discrepancies are detected, before next flight, remove the searchlight assembly from the helicopter and contact the design (change) approval holder, as applicable to the installation. (3) Within 30 days after the effective date of this AD, irrespective of findings, remove the searchlight assembly from the helicopter, as applicable to the installation, or, for Eurocopter Deutschland GmbH helicopters, install the Searchlight in accordance with the instructions of the appropriate Eurocopter UK Ltd Service Bulletin listed in the Reference Publications. (4) Modification of a helicopter as required by paragraph (3) of this AD constitutes terminating action for the repetitive inspection requirements of this AD. (5) From the effective date of this AD: <ol style="list-style-type: none"> (5.1) Do not install a Spectrolab Nightsun XP Gimbal Assembly P/N 033295 series on any helicopter as a replacement unit, or (for Eurocopter Deutschland GmbH helicopters) unless the affected searchlight has been installed in accordance with the instructions of the appropriate Eurocopter UK Ltd Service Bulletin listed in the Reference Publications.
