<b>EASA</b>	<b>AIRWORTHINESS DIRECTIVE</b>									
 	<p><b>AD No.: 2010-0237R2</b></p> <p><b>Date: 14 December 2010</b></p> <p>Note: This Airworthiness Directive (AD) is issued by EASA, acting in accordance with Regulation (EC) No 216/2008 on behalf of the European Community, its Member States and of the European third countries that participate in the activities of EASA under Article 66 of that Regulation</p>									
<p>This AD is issued in accordance with EC 1702/2003, Part 21A.3B. In accordance with EC 2042/2003 Annex I, Part M.A.301, the continuing airworthiness of an aircraft shall be ensured by accomplishing any applicable ADs. Consequently, no person may operate an aircraft to which an AD applies, except in accordance with the requirements of that AD, unless otherwise specified by the Agency [EC 2042/2003 Annex I, Part M.A.303] or agreed with the Authority of the State of Registry [EC 216/2008, Article 14(4) exemption].</p>										
<p><b>Design Change Approval Holder :</b></p> <p>Agusta S.p.A. Keystone Helicopter Corporation Eurocopter UK Ltd</p>	<p><b>Type/Model designation(s) :</b></p> <p>AB139 and AW139 helicopters Sikorsky S-92A helicopters Eurocopter Deutschland MBB

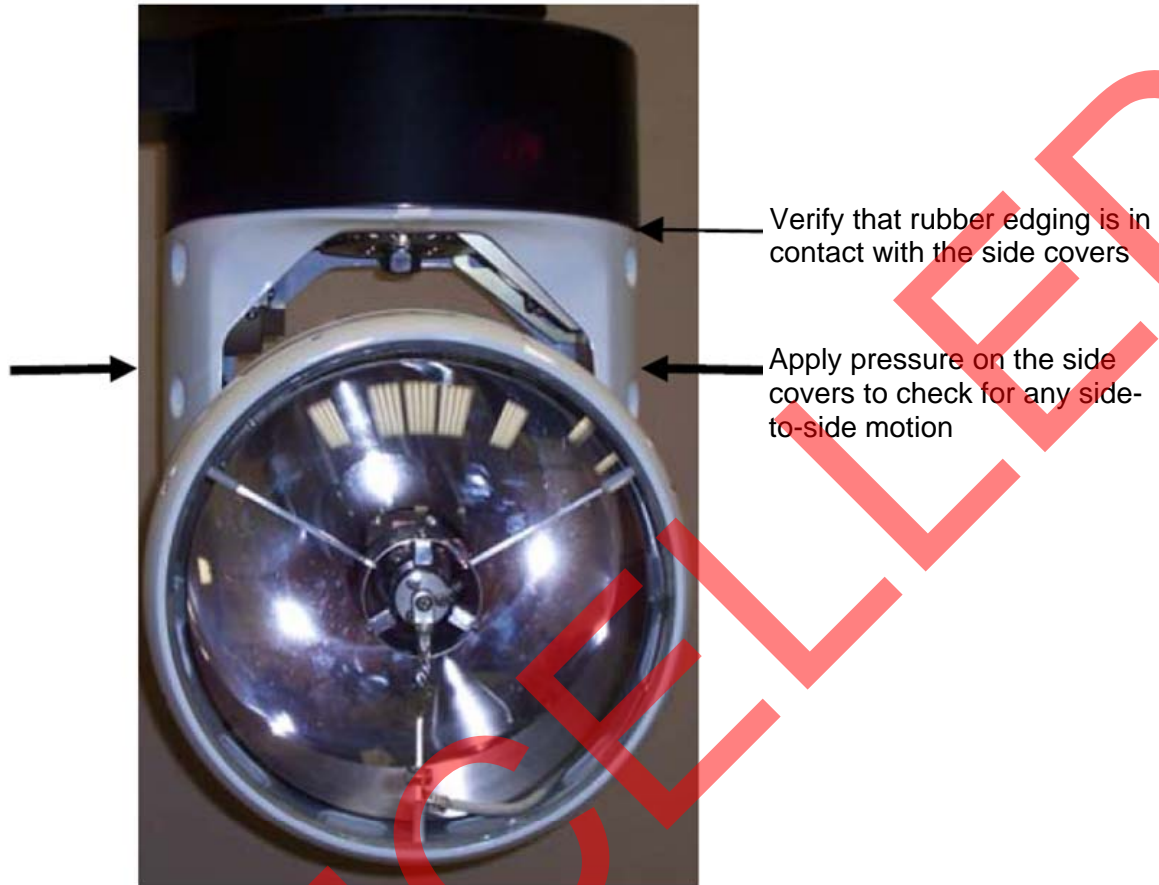
Appendix 1 – Photo showing location to be checked

Reason:	<p>An incident has been reported by a Maintenance Organisation of vibration associated with the Nightsun XP Searchlight. Investigation revealed that the Gimbal Azimuth Top Hex Nut was loose.</p> <p>This condition, if not detected and corrected, could lead to a gap between the rubber edging of the top shroud and the Gimbal frame, resulting in degradation of pointing accuracy and stability performance and pose excessive vibration. If the nut were to entirely disengage, the Searchlight/Gimbal could disconnect from the helicopter and remain attached solely by the internal cable harness or separate totally, possibly resulting in damage to the helicopter or injury to persons on the ground.</p> <p>EASA issued Emergency AD 2010-0183-E, later revised, as an interim measure to require repetitive inspections and, depending on findings, the removal of the searchlight from the helicopter.</p> <p>Spectrolab, the Searchlight manufacturer, has now developed a modification of the Searchlight installation that remedies the problem by replacing the Nightsun XP gimbal azimuth top hex nut with a dual-locking nut. This action includes re-identification of the gimbals as either P/N 033295-3 or P/N 033295-4 and assigns accordingly a new airworthy revision standard to the P/N of the modified Nightsun XP Searchlight Assembly.</p> <p>One of the affected approval holders, Eurocopter UK Ltd, subsequently developed the EASA-approved modifications which allow embodiment of the Spectrolab design changes on helicopters modified by Eurocopter UK STC.</p> <p>For the reasons described above, EASA AD 2010-0237 was issued, retaining the inspection requirements of AD 2010-0183R1, which was superseded, required removing the searchlight from the helicopter and allowed, for the affected Eurocopter Deutschland GmbH helicopters, modification of the searchlight installation by installing a modified searchlight assembly, having a higher revision standard and a new P/N Gimbal assembly.</p> <p>Since AD 2010-0237 was published, the other affected approval holders have developed their own modifications, which have been approved by EASA, to allow embodiment of the Spectrolab design change on Agusta AB139 and AW139 helicopters, and on Sikorsky S-92A helicopters modified by Keystone STC, respectively.</p> <p>Revision 1 of this AD was issued to include reference to Agusta Bollettino Tecnico (BT) 139-231 and Keystone Helicopter Corporation Service Bulletin (SB) 10-11 revision C, which provide the terminating action instructions for the AB139, AW139 and S-92A helicopters affected by this AD. In addition, this AD reduces the applicability to helicopters that have Gimbal Assembly P/N and Searchlight Assembly P/N as defined in Table 1 of the Applicability section of this AD.</p> <p>Revision 2 of this AD is issued to allow installation of a Searchlight Assembly with a higher Revision number than required by this AD, provided that the applicable (Supplemental) Type Certificate holder has certified the installation of a Searchlight Assembly with that Revision number.</p>

<p>side covers.</p> <p>(1.2) Try to move the Searchlight laterally. No gap should appear between the Top Shroud rubber edging (P/N 033381) and the side covers (P/N 033286) and no play should be felt.</p> <p>Appendix 1 of this AD shows the area(s) to be checked.</p> <p>(2) If, during any of the checks as required by paragraph (1) of this AD discrepancies are detected, before next flight, remove the searchlight assembly from the helicopter and contact the design (change) approval holder, as applicable to the installation.</p> <p>(3) Within 30 days after 30 November 2010 [the effective date of the original issue of this AD], irrespective of findings, remove the searchlight assembly from the helicopter, as applicable to the installation, or,</p> <p>(3.1) For Eurocopter Deutschland GmbH helicopters, install a P/N 033338 Revision F Searchlight Assembly, in accordance with the instructions of Eurocopter UK Ltd Service Bulletin (SB) 135787-467, SB 1351151-472, or SB 1451167-473, as applicable to helicopter Model.</p> <p>(3.2) For Agusta helicopters, install a P/N 033338 Revision F Searchlight Assembly, in accordance with the instructions of Agusta BT 139-231.</p> <p>(3.3) For Sikorsky helicopters, install a P/N 033338-3 Revision E Searchlight Assembly or a P/N 033704 Revision D Searchlight Assembly, as applicable to the installation, in accordance with the instructions of Keystone Helicopter Corporation SB 10-11 rev. C.</p> <p>(3.4) For all helicopters, installation of a Searchlight Assembly with a higher Revision number than those required by paragraphs (3.1), (3.2), or (3.3) of this AD, as applicable to type design (change), is allowed, provided that the applicable (Supplemental) Type Certificate holder has certified the installation of a Searchlight Assembly with that Revision number.</p> <p>(4) Modification of a helicopter as required by paragraph (3) of this AD constitutes terminating action for the repetitive inspection requirements of this AD.</p> <p>(5) From the effective date of this AD:</p> <p>(5.1) Do not install a Spectrolab Nightsun XP Gimbal Assembly P/N 033295-1 or P/N 033295-2 on any helicopter as a replacement unit.</p> <p>(5.2) Do not modify a helicopter by installing a Spectrolab Nightsun XP Searchlight Assembly affected by this AD, unless in compliance with paragraph (3.1), (3.2), (3.3) or (3.4) of this AD, as applicable to helicopter type.</p>
