EASA	AIRWORTHINESS DIRECTIVE

<p>AD No.: 2012-0064</p> <p>Date: 20 April 2012</p> <p>Note: This Airworthiness Directive (AD) is issued by EASA, acting in accordance with Regulation (EC) No 216/2008 on behalf of the European Community, its Member States and of the European third countries that participate in the activities of EASA under Article 66 of that Regulation.</p>	
<p>This AD is issued in accordance with EC 1702/2003, Part 21A.3B. In accordance with EC 2042/2003 Annex I, Part M.A.301, the continuing airworthiness of an aircraft shall be ensured by accomplishing any applicable ADs. Consequently, no person may operate an aircraft to which an AD applies, except in accordance with the requirements of that AD unless otherwise specified by the Agency [EC 2042/2003 Annex I, Part M.A.303] or agreed with the Authority of the State of Registry [EC 216/2008, Article 14(4) exemption].</p>		
<p>Type Approval Holder's Name : ATR-GIE Avions de Transport Régional</p>	<p>Type/Model designation(s) : ATR 42-500 and ATR 72-212A aeroplanes</p>

<p>TCDS Number: EASA.A.084</p>		
<p>Foreign AD: Not applicable</p>		
<p>Supersedure: This AD supersedes EASA Emergency AD 2010-0063-E dated 01 April 2010.

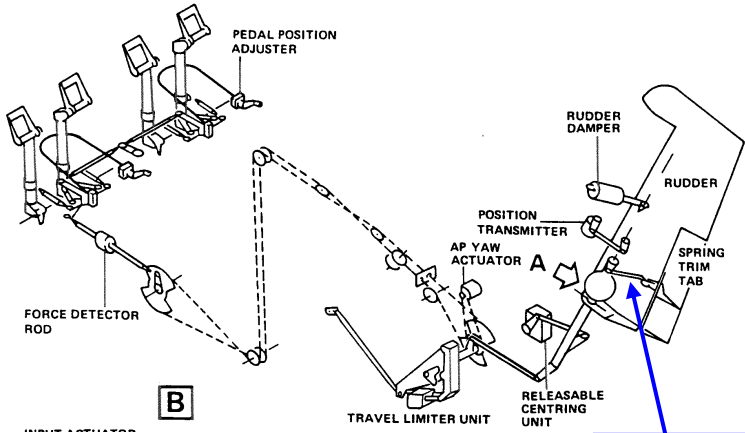
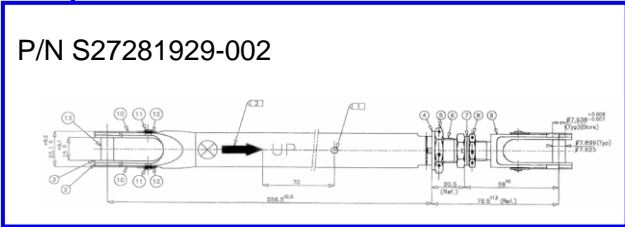
Appendix 1 - Rudder tab control rod location

- (5) In addition to the actions required by paragraphs (1), (2), (3) and/or (4) of this AD, as applicable, for aeroplanes (MSN) listed in the applicability paragraph of this AD, except MSN 671, 673 and 769 to 784 inclusive, within 24 months after the effective date of this AD, inspect the rudder tab control rod P/N S27281929-002 for batch number identification, in accordance with the instructions of the applicable ATR Aircraft Maintenance Manual / Job Instruction Card (AMM/JIC) 27-20-00 DVI 10000. Refer to Appendix 1 of this AD for rod location.

- (6) If, during the inspection as required by paragraph (5) of this AD, the rudder tab control rod is found belonging to batch number 2107267 or 2120855, or if the batch number is unreadable, before next flight, replace the rod with a serviceable one in accordance with the instructions provided in AMM/JIC 27-21-42 RAI 10000, and identify the removed rod as unserviceable component.
