EASA	AIRWORTHINESS DIRECTIVE

<p>AD No.: 2012-0192 [Correction: 24 September 2012]</p> <p>Date: 21 September 2012</p> <p>Note: This Airworthiness Directive (AD) is issued by EASA, acting in accordance with Regulation (EC) No 216/2008 on behalf of the European Community, its Member States and of the European third countries that participate in the activities of EASA under Article 66 of that Regulation.</p>
<p>This AD is issued in accordance with EC 748/2012, Part 21.A.3B. In accordance with EC 2042/2003 Annex I, Part M.A.301, the continuing airworthiness of an aircraft shall be ensured by accomplishing any applicable ADs. Consequently, no person may operate an aircraft to which an AD applies, except in accordance with the requirements of that AD, unless otherwise specified by the Agency [EC 2042/2003 Annex I, Part M.A.303] or agreed with the Authority of the State of Registry [EC 216/2008, Article 14(4) exemption].</p>

<p>Design Approval Holder's Name: ATR-GIE Avions de Transport Régional</p>	<p>Type/Model designation(s): ATR 72-212A aeroplanes</p>
TCDS Number:	EASA A.084
Foreign AD:	Not applicable
Supersedure:	None
ATA 54	Nacelles and Pylons – Engine Shock Mount Pick-up Fittings –

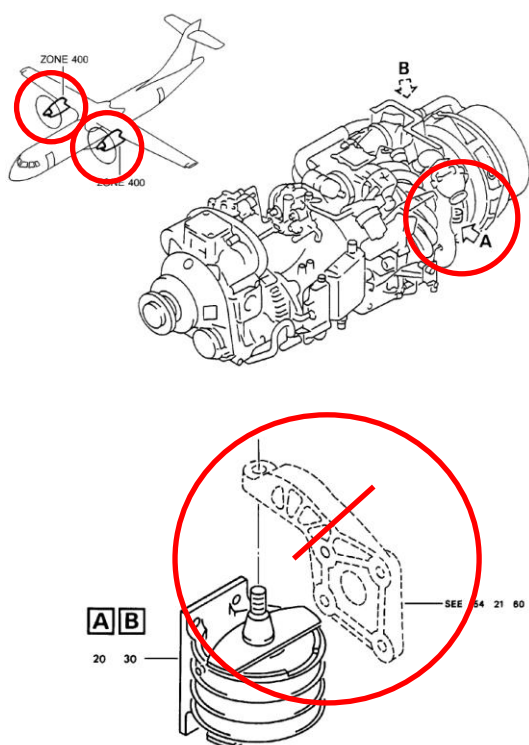
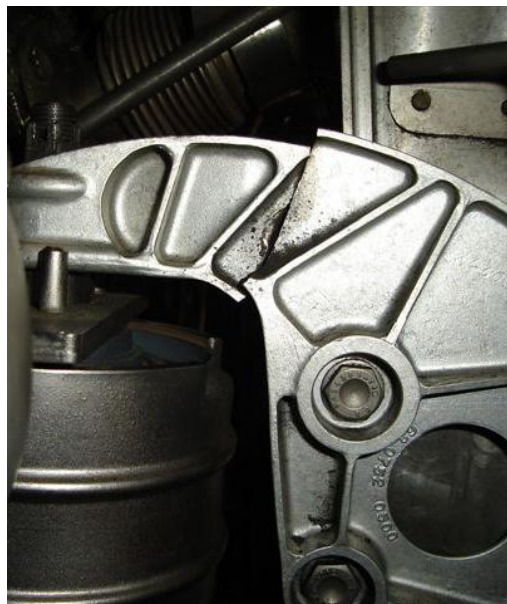
Figure 1: Shock mount pick-up fitting potential failure

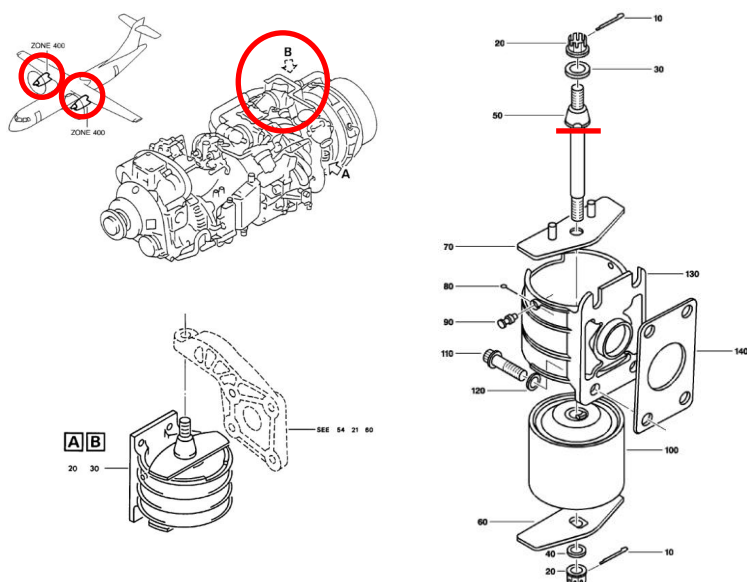
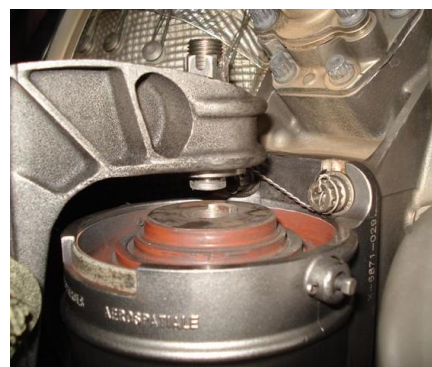
Figure 2: Shock mount cone bolt potential failure
