**TITLE: NAVIGATION - GENERAL - REPLACE AOA PROBE CONIC PLATE BY
AOA PROBE FLAT PLATE**

MODIFICATION No.: 203295S32646

SERVICE BULLETIN No.: A340-34-4273

REVISION No.: 00 - Jan 30/13

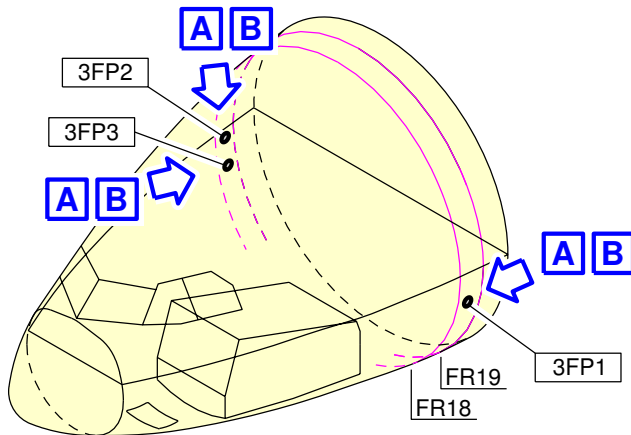
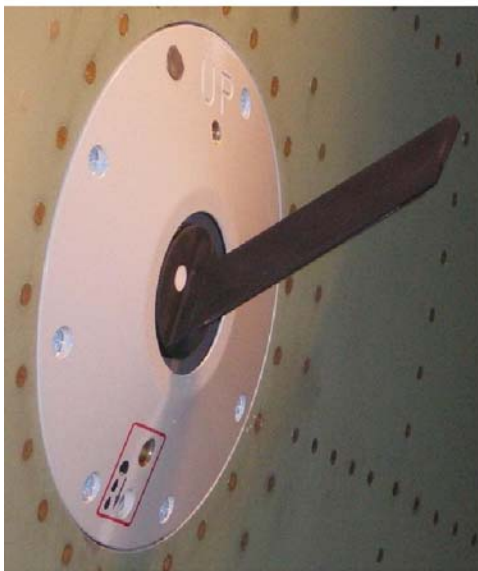
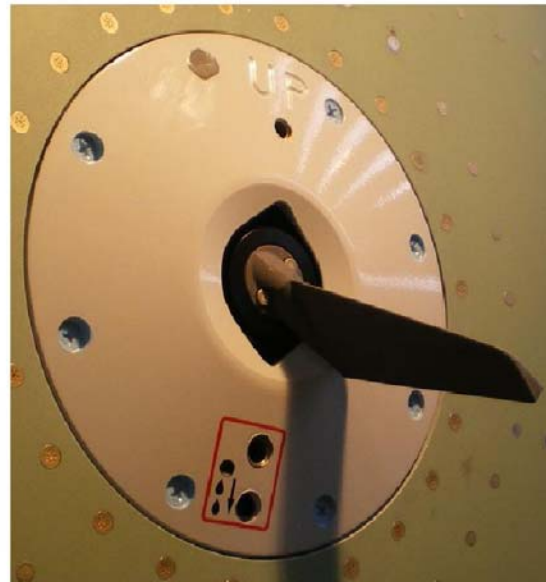
Figure A-FSAAA - Sheet 01

Following a recent in-service event, as a precautionary measure, Airbus requires to suspend the installation of the AOA (Angle Of Attack) conic plates as per Operator Information Transmission (OIT) No. 999.0086/12, currently performed through an Airbus monitored campaign with Service Bulletin No. A340-34-4250.

This modification requires the removal of the conic plates PN F3411060200000 and PN F3411060900000, and the installation of flat plates PN F3411007920200 (LH) / PN F3411007920300 (RH).
