EASA	AIRWORTHINESS DIRECTIVE

<p>AD No.: 2013-0062</p> <p>Date: 11 March 2013</p> <p>Note: This Airworthiness Directive (AD) is issued by EASA, acting in accordance with Regulation (EC) No 216/2008 on behalf of the European Community, its Member States and of the European third countries that participate in the activities of EASA under Article 66 of that Regulation.</p>
<p>This AD is issued in accordance with EC 1702/2003, Part 21A.3B. In accordance with EC 2042/2003 Annex I, Part M.A.301, the continuing airworthiness of an aircraft shall be ensured by accomplishing any applicable ADs. Consequently, no person may operate an aircraft to which an Airworthiness Directive applies, except in accordance with the requirements of that Airworthiness Directive unless otherwise specified by the Agency [EC 2042/2003 Annex I, Part M.A.303] or agreed with the Authority of the State of Registry [EC 216/2008, Article 14(4) exemption].</p>

<p>Design Approval Holder's Name :</p> <p>Mecaer Aviation Group S.p.A.</p>	<p>Type/Model designation(s) :</p> <p>NH-300C helicopters</p>
<p>TCDS Number(s) : EASA.R.143</p>	
<p>Foreign AD : Not applicable</p>	
<p>Supersedure: This AD supersedes EASA AD No. 2011-0

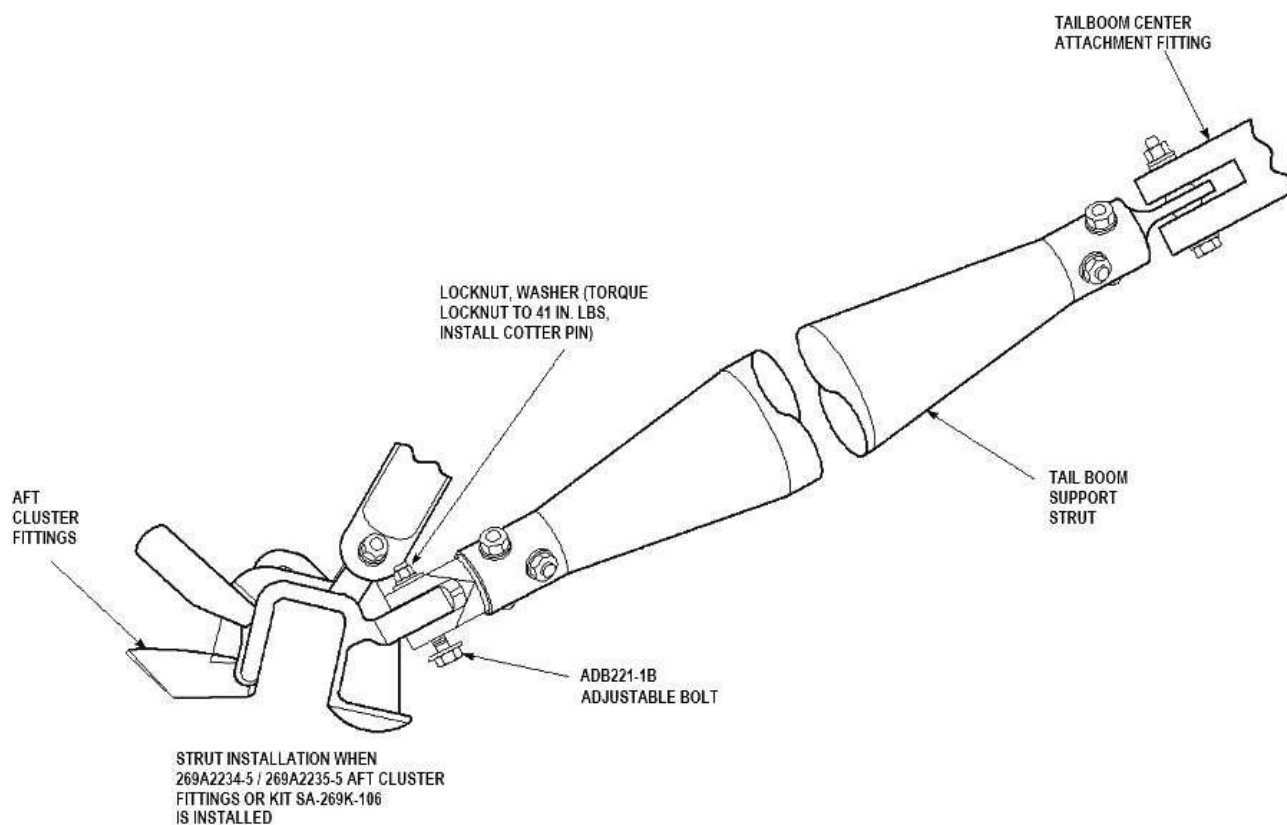
Figure 1. – Tailboom Support Strut Adjustable Diameter Bolt Inspection - Replacement

<p>modification kit P/N SA-269K-106 to verify that there is sufficient drag torque, that both locknuts are properly torqued and, if necessary, their replacement.</p> <p>This AD, which supersedes AD 2011-0027 partially retaining its requirements, additionally requires to modify each adjustable diameter bolt included in the aft cluster fitting modification kit P/N SA-269K-106 or to install a different adjustable diameter bolt, allowing the installation of a secondary safety mechanism: a cotter pin which prevents separation of strut and driveshaft from the helicopter and subsequent loss of control of the helicopter.</p>
Effective Date:	25 March 2013
Required Action(s) and Compliance Time(s):	<p>Required as indicated, unless already accomplished:</p> <ol style="list-style-type: none"> (1) Within 25 FH or 30 days after 15 March 2011 [effective date of AD 2011-0027], whichever occurs first, inspect the tailboom aft cluster fitting strut to determine whether the aft cluster fitting modification kit P/N SA-269K-106 is installed. (2) If modification kit P/N SA-269K-106 is installed, before next flight after 11 March 2011 [effective date of AD 2011-0027], remove the two locknuts, P/N MS21043-3, installed on the adjustable diameter bolts attaching the tailboom struts to the aft cluster fittings. Reinstall the locknuts while determining the locknut drag torque. If the drag torque is 2 in-lbs or more, retorque the locknut to 23 inch-pounds (in-lbs) plus maximum drag torque of 18 in-lbs for a final torque of 41 in-lbs. If the drag torque is less than 2 in-lbs, replace the locknuts with serviceable locknuts and torque to 23 in-lbs plus a maximum drag torque of 18 in-lbs for a final torque of 41 in-lbs. (3) Within 10 FH after the effective date of this AD, replace each adjustable diameter bolt P/N ADB221-1A with an adjustable diameter bolt P/N ADB221-1B, install washer and locknuts P/N MS21043-3 using torque values specified in paragraph (2) of this AD, and install cotter pins on the adjustable diameter bolts, P/N MS24665-132 or MS24665-151 as shown in Appendix 1, Figure 1. of this AD. (4) From the effective date of this AD, do not install aft cluster fitting modification kit P/N SA-269K-106 on any helicopter, unless in accordance with the requirements of this AD.
