EASA	AIRWORTHINESS DIRECTIVE
 	<p>AD No.: 2013-0280</p> <p>Date: 26 November 2013</p> <p>Note: This Airworthiness Directive (AD) is issued by EASA, acting in accordance with Regulation (EC) No 216/2008 on behalf of the European Community, its Member States and of the European third countries that participate in the activities of EASA under Article 66 of that Regulation.</p>
<p>This AD is issued in accordance with EU 748/2012, Part 21.A.3B. In accordance with EC 2042/2003 Annex I, Part M.A.301, the continuing airworthiness of an aircraft shall be ensured by accomplishing any applicable ADs. Consequently, no person may operate an aircraft to which an AD applies, except in accordance with the requirements of that AD, unless otherwise specified by the Agency [EC 2042/2003 Annex I, Part M.A.303] or agreed with the Authority of the State of Registry [EC 216/2008, Article 14(4) exemption].</p>	
<p>Design Approval Holder's Name: ATR-GIE AVIONS de TRANSPORT RÉGIONAL</p>	<p>Type/Model designation(s): ATR 72 and 42 aeroplanes</p>

TCDS Number:	EASA A.084
Foreign AD:	Not applicable
Supersedure:	None
ATA 25	Equipment / Furnishing – Type III Emergency Exit Door – Inspection / Modification
Manufa

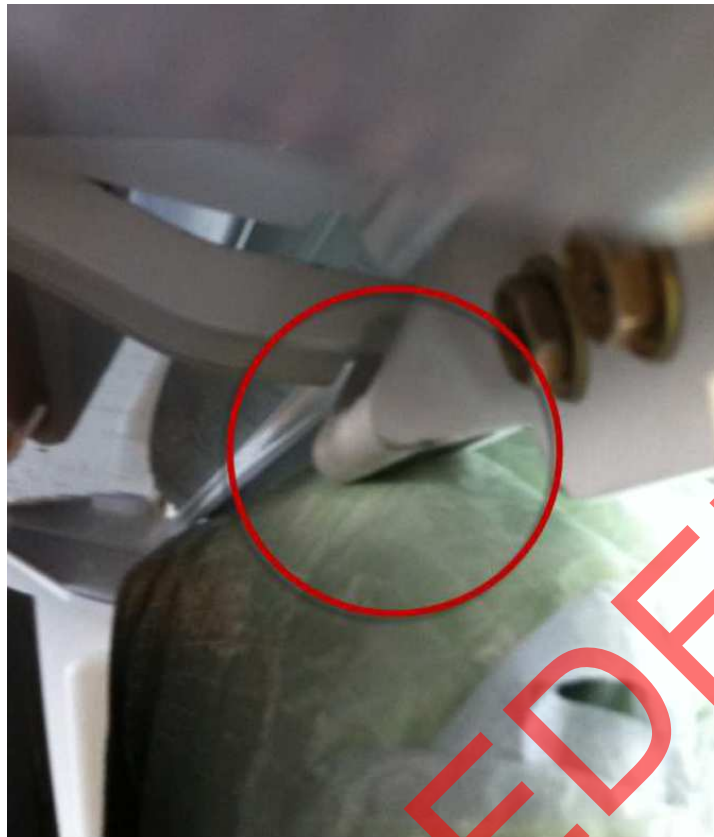
Reason:	<p>Interference between a Type III Emergency Exit door opening and the surrounding passenger cabin furnishing was detected during a production check.</p> <p>Subsequent investigation identified an insufficient gap between the Emergency Exit door internal skin structure and the overhead stowage compartment fitting, installed on the rail, as a cause of the interference.</p> <p>This condition, if not detected and corrected, could prevent an unobstructed opening of both Type III Emergency Exit doors in case of emergency evacuation.</p> <p>For the reasons described above, this AD requires a one-time check of the gap</p>

Figure 2: Picture of an interference between the door internal skin and the fitting

between the Type III Emergency Exit door internal skin and a relevant fitting and, depending on findings, the accomplishment of applicable corrective action(s). This AD is considered to be a temporary measure and further actions may follow.
Effective Date:	10 December 2013
Required Action(s) and Compliance Time(s):	<p>Required as indicated, unless accomplished previously:</p> <p>(1) Within 2 months after the effective date of this AD, measure the gap between each Type III Emergency Exit door, left hand (LH) and right hand (RH), and the overhead stowage compartment fitting installed on the rail, by unlocking and slightly rotating the LH and RH Type III Emergency Exit door, remaining on their lower fittings. Use a shim gauge 6 mm (0.236 in) thick, to measure the gap between the doors internal skin and the relevant fittings, P/N S2522924620000 (LH) and P/N S2522924620100 (RH).</p> <p>Note 1: For illustrations refer to the applicable ATR Illustrated Parts Catalogue (IPC) 25-23-02 fig 87 item 90/100 and to Appendix 1 of this AD.</p> <p>Note 2: It might be necessary to locally pull on the door blanket to correctly see the door internal skin.</p> <p>(2) If, during the measurement as required by paragraph (1) of this AD, a gap equal to or more than 6 mm (0.236 in) is detected, before next flight, re-install the LH and RH Type III Emergency Exit door, in accordance with the instructions of the applicable ATR Aircraft Maintenance Manual (AMM) / Job Instruction Card (JIC) 52-21-00 RAI 10000.</p> <p>(3) If, during the measurement as required by paragraph (1) of this AD, a gap less than 6 mm (0.236 in) is detected, before next flight remove the fitting, P/N S2522924620000 LH or P/N S2522924620100 RH, as applicable, and measure the gap between the Type III Emergency Exit door internal skin, LH and RH, and the overhead stowage compartment hooks in accordance with the accomplishment instructions of ATR SB ATR42-25-0180 or ATR72-25-1141, as applicable to aeroplane model, and, depending on findings, accomplish the follow-on actions as specified in paragraph (3.1) or (3.2) of this AD, as applicable.</p> <p>(3.1) If, during the measurement as required by paragraph (3) of this AD a gap equal to or more than 6 mm (0.236 in) is detected, before next flight, re-install the LH and RH Type III Emergency Exit door in accordance with the instructions of ATR SB ATR42-25-0180 or ATR SB ATR72-25-1141, as applicable to aeroplane model.</p> <p>(3.2) If, during the measurement as required by paragraph (3) of this AD a gap less than 6 mm (0.236 in) is detected, before next flight, contact ATR to obtain approved repair instructions and accomplish the repair accordingly.</p>
